## MONITORING OF INTERACTIONS OF A MONUMENTAL HISTORICAL COMPLEX LOCATED ON AN EARTH EMBANKMENT

**Abstract.** The Camaldolese Monastery was built in the seventeenth-century on a man-made hill raised on a Wigry lake island in the north-eastern part of Poland. Over the following two hundred years, the Monastery buildings were subjected to destructive weathering processes and underwent significant demolition during the two World Wars. Subsequently, the complex was reconstructed and renewed. All the Monastery buildings were raised on two earth terraces varying in height from 6 to 8 m. The terraces were formed of crushed bricks and stone debris that filled up the underground structures built earlier. The hill is composed of different geotechnical layers and their influence on the stability of the whole hill, displacement and deformation of the buildings have been monitored. The results of the monitoring are presented in the paper. The thickness of backfilled soil layers varies from 1 to 5 m and an assessment of layer parameters is influencing the actual state and future renovation of the Monastery buildings. In 2004, the Monastery buildings were affected by dynamic forces of an earthqu

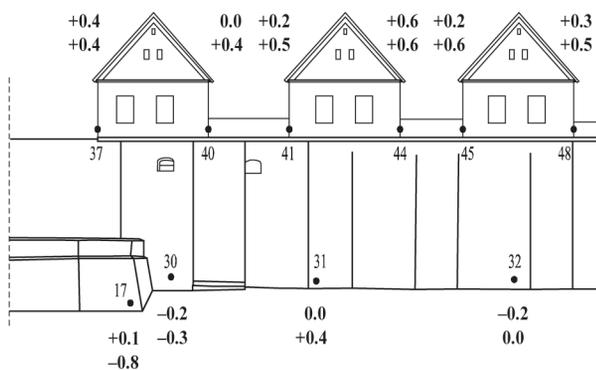
Fig. 8. Benchmarks on the hermitages

The relative benchmark stability indicates displacements of –4.5 mm at points 11 of the Garden Tower and points 19 of the Boiler House. Hermitages of the lower terraces and the southern wall showed displacements from +0.9 to –1.3 mm. Cracks in the hermitages were widened by +0.7 mm. Also, cracks in the wall of the Boiler House widened from +0.5 to +1.3 mm. The northern retaining wall exposed an increase of vertical displacements from –0.6 to –1.1 mm and the northern part of the wall displaced from –0.7 to –1.7 mm. Vertical displacements of the NE of the corner of the eastern wall achieved –13 mm.

Horizontal deflections and the widths of cracks remain the main method of horizontal deformation measurements. Significant increase of the crack widths amounting +0.7 mm was measured in the walls of the lower hermitages. The northern retaining wall exposed an increase of the crack widths from +0.2 to +1.7 mm. The southern retaining wall does not indicate horizontal displacements, while the eastern corner indicates the displacement of –3 mm in the outward direction. The eastern retaining wall shows displacements from +3 to +6 mm.

Four years of monitoring have shown that the structures of the eastern and southern retaining walls and lower terrace hermitages considered as hazardous in behaviour are generally stable and do not display any dangerous displacements. Water percolation and infiltration

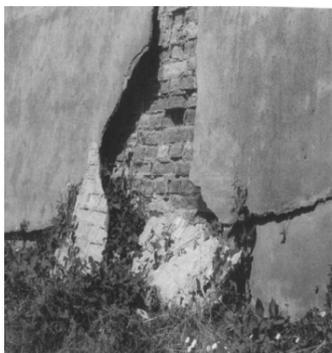
Fig. 9. Delamination of the eastern retaining wall lining

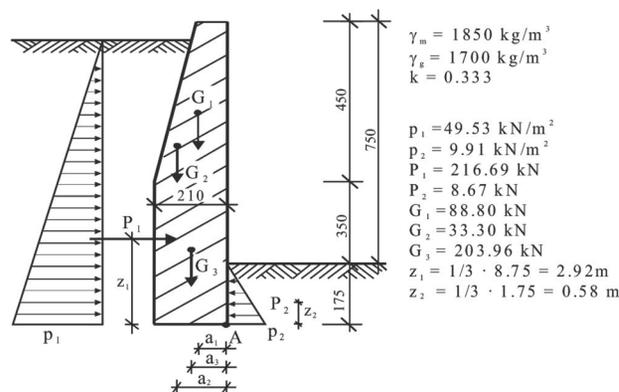
Fig. 11. Diagram of the loading to the eastern retaining wall

It follows from the analysis of loadings shown in Figure 11 that the retaining wall fails to fulfil the required conditions of the overturning stability of the structure:

$$M_w = 216.69 \cdot 2.92 = 632.74 \text{ [kNm]}; \quad (3)$$

$$M_u = 88.80 \cdot 0.6 + 33.30 \cdot 1.5 + 203.96 \cdot 1.05 + 8.68 \cdot 0.58 = 322.42 \text{ [kNm]}; \quad (4)$$

$$M_u = 322.42 \text{ [kNm]} < M_w = 632.74 \text{ [kNm]}. \quad (5)$$

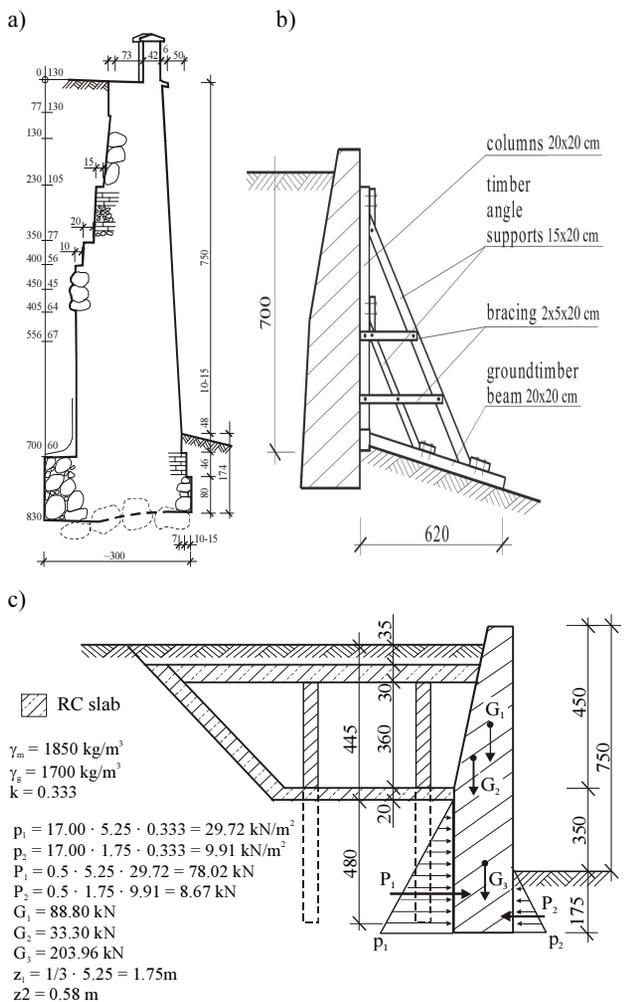
Fig. 12. Protection of the retaining walls: a) retaining wall diagram; b) timber bracings for temporary support; c) diagram of the unloading chamber behind the eastern retaining wall

The massive retaining wall in Figure 12a subjected to increased horizontal soil pressure and environmental destructions was temporarily protected using timber bracings and supports, which is shown in Figure 12b.

The unloading structure in the form of a chamber in the upper part of the wall securing its stability is presented in Figure 12c.

$$M_w = 78.02 \cdot 1.75 = 136.56 \text{ [kNm]}; \quad (6)$$

$$M_u = 409.43 \text{ [kNm]} > M_w = 136.56 \text{ [kNm]}. \quad (7)$$

Instead of timber bracing presented in Figure 12b, the stability of the wall can be protected applying an anchoring system of the wall. The tieback ground anchor system was considered but the final cost eliminated this method of wall protection.

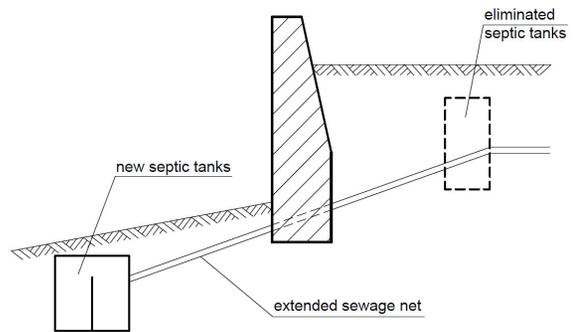
Fig. 13. New concept of the sewage system improvement

Some immediate sources of water and sewage leakage were eliminated. New concept of elimination of the old leaking sewage septic tanks and replacing them to the Hill outside is shown in Figure 13.

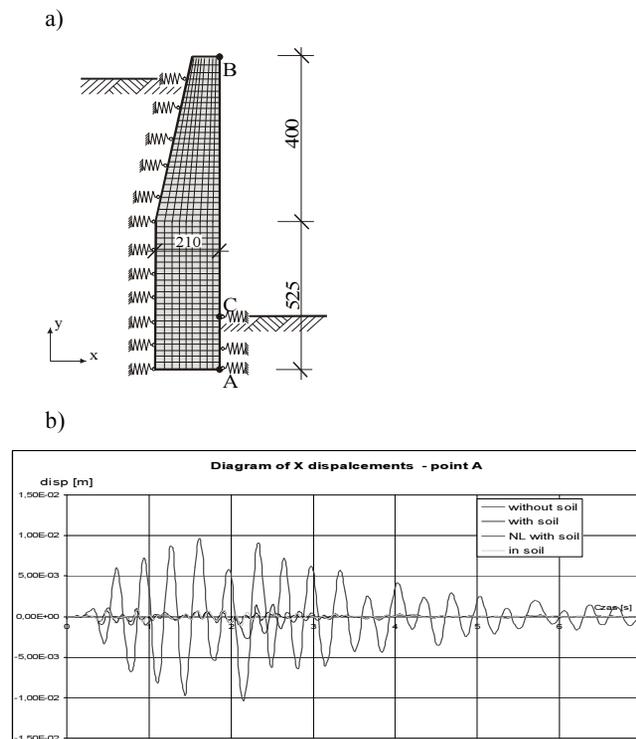
Supplementary initial investigations of dynamic effects were analysed and some of the selected results are presented in the form of displacements in Figure 14 (Malusza, Miedzialowski 2008).

Fig. 14. Model of dynamic response of soil-retaining wall (a); displacement diagram (b)
