## DEGRADATION OF THE MAIN GAS PIPELINE MATERIAL AND MECHANISMS OF ITS FRACTURE

Received 18 Mar 2014; accepted 04 Sep 2014

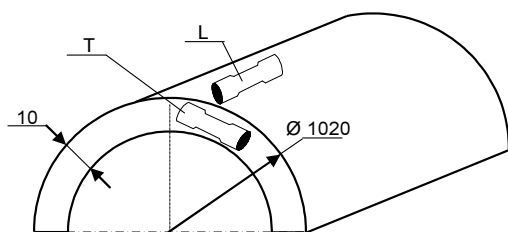
A section of the main gas pipeline “Kyiv – West of Ukraine-1” (KWU-1) was investigated after 40 years of operation under ground. The gas pipeline has a diameter of 1020 mm, wall thickness of 10 mm, and a rubber-bituminous insulation. The failure of insulation caused formation of the corrosive damage on the external surface of pipes in the form of spots, pits and cavities of different size and depth due to the interaction between the pipe metal and the medium. Lack of insulation on the analyzed section of the main gas pipeline KWU-1 from steel 17G1S according to TU 1-150-67 caused the formation of multiple corrosive damage on the external surface. A fragment was cut from the pipe during repair (Fig. 1), in order to evaluate the metal damage.

Fig. 1. Scheme of the investigated fragment of the service-exposed pipeline KWU-1

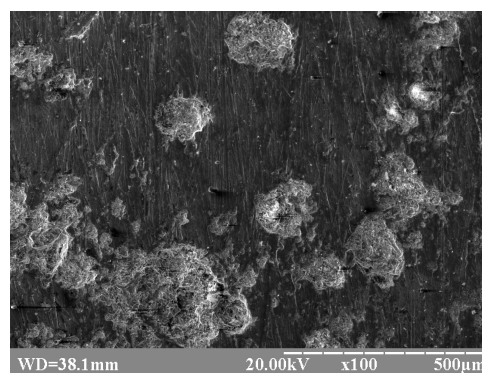
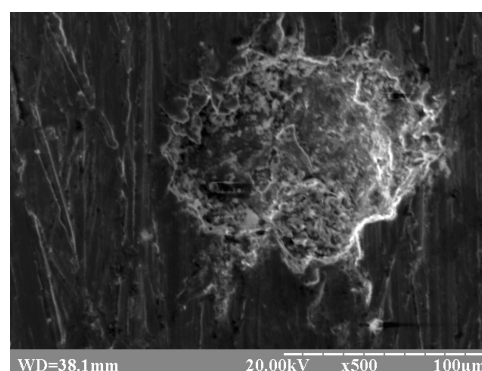
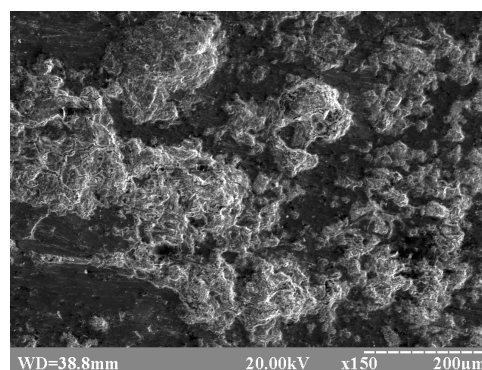
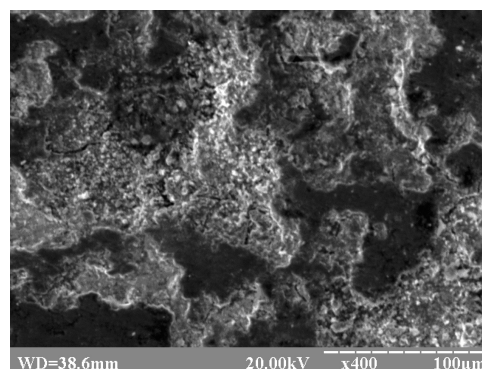
Fig. 2. Pitting (a, b) and corrosive pits (c, d) found on the external surface of the gas pipeline after 40 years of operation

In places of contact between the pipe metal and the corrosive medium, the acidification of the medium takes place under the insulation, which facilitates a reduction in the surface energy and hastens failure of the passivating film. The most active elements of the soil electrolytes are the halide chloride ion  $\text{Cl}^-$  and the adsorbed hydrogen (Ghajar *et al.* 2013; Kotrechko *et al.* 2004).

As a result of microplastic deformation, the destabilization of the internal energetic state takes place on local sections of the pipe material, and the sensitivity to stress concentrators increases under the effect of hydrogen. Moreover, cyclic loading lowers the plasticity of the deformed metal, thus increasing its liability to the corrosive cracking under the effect of the hydrogenous medium (Nykyforchyn *et al.* 2010).

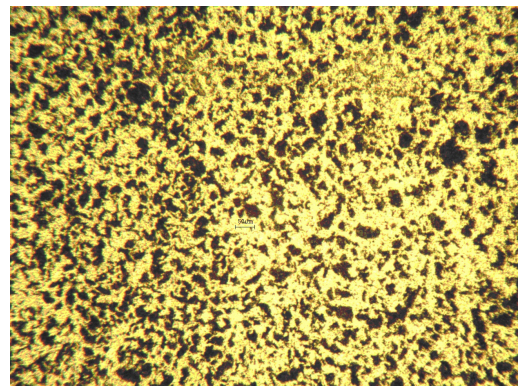
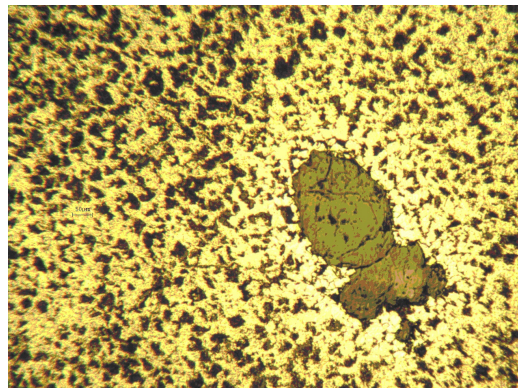
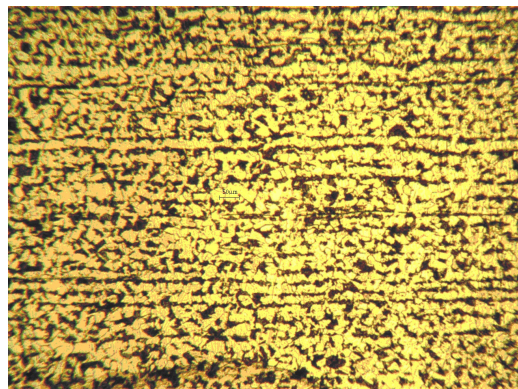
The templates cut in the axial direction are characterized by the clear-cut damage of the ferritic-pearlitic structure (Fig. 3a, b). A partial decarbonation of the pearlitic grains is detected on polished sections. Numerous defects in the form of laminations are found, which are oriented along the rolling direction and formed due to the hydrogenation of metal. These defects are called hydrogen lamination and hydrogen cracking (Nykyforchyn *et al.* 2010). Obviously, cracks nucleated on grain boundaries and propagated under the action of stresses by the “stress–corrosion” scheme (Lublińska *et al.* 2007). As is known, it is the localisation of the degradation processes between rolling fibers (Fig. 3c) that causes a significant reduction in the impact toughness of the service-exposed pipelines (Baron 2012).

In our opinion, the said defects testify to the overstrained condition of the analysed section (possibly, due to a local subsidence of soil), moreover, an increase in the internal stress caused the localisation of structural damage and its coalescence in the direction perpendicular to the maximum tensile stresses. A change in the density of metal damage is accompanied by a change in its geometry, size and spatial orientation, which preconditions a change in microhardness of the surface layers (Teirlinck *et al.* 1988). One of the main reasons for the appearance of the said defects is damage and loss of adhesive properties of the pipe coating, which caused the penetration of ground water into the pipe surface. Atomic hydrogen penetrated into the metal and accumulated in micropores and structural defects (Fig. 3b). In parallel, the decarbonation of metal developed due to blocking of carbon atoms by hydrogen atoms, thus decreasing the material plasticity (Kadkhodapour *et al.* 2011).

Fig. 3. Microstructure of gas pipeline after 40 years of operation ( $\times 200$ ): a – in the transverse direction, where a – external surface; b – internal surface; c – along the pipe axis

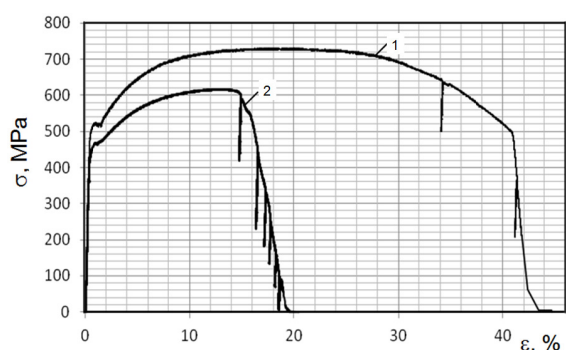
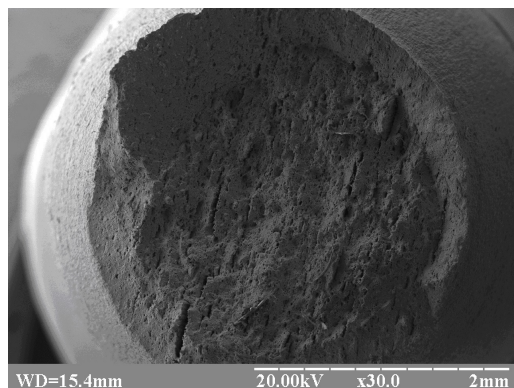
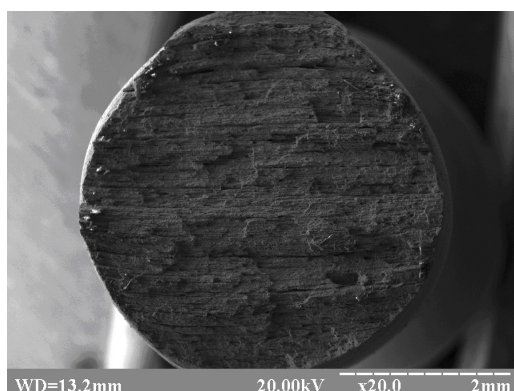
It is known that long-term operation causes changes in the kinetics of deformation defects accumulation in the structural material (Yasnii *et al.* 2012), and the level of the structural and mechanical damage of the material has an immediate effect on the regularities in the material failure (Fig. 4b, c).

Fig. 4. Complete static tension curves for the service-exposed 17G1S steel: a – cut in the longitudinal (1) and transverse (2) directions after 40 years of operation under ground; b – microfracture of specimens cut in the longitudinal direction; c – microfracture of specimens cut in the transverse direction

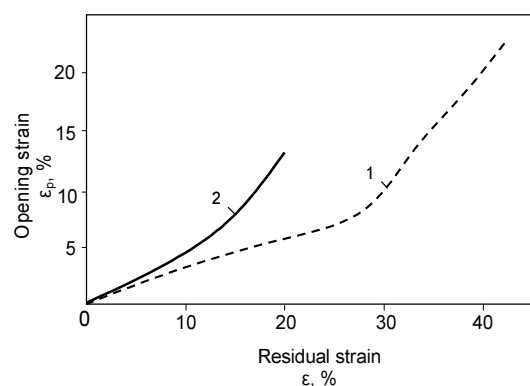
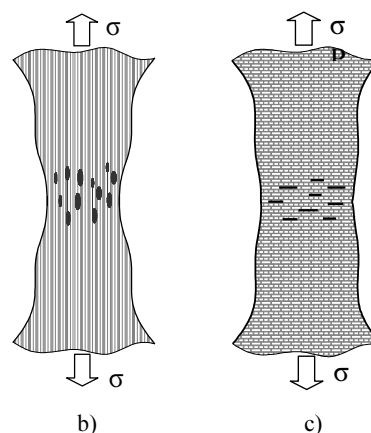
The presented data testifies to the fact that degradation, first of all hydrogenation, raises the degree of the material opening, due to which some essential differences between the deformation properties are observed (Fig. 5a). As is seen, in qualitative terms, the kinetics of the damage accumulation process in specimens with different degrees of deformation is similar to the insignificant strains, when deformation processes are localized in the vicinity of structural formations (macrolevel), in particular, a difference between the loosening strains of specimens at low strains ( $\epsilon = 8\%$ ) was 2%. However, at strains equal to 20%, the difference between the loosening strains was 16%.

So, the specimens cut in the longitudinal direction have better deformation properties (Fig. 5b). Lower strength and plasticity of the specimens cut in the transverse direction are connected with the processes of the preliminary hydrogenation and multiple lamination of the structure of the internal material layers (Fig. 5c). The said defects impede the involvement of the material mesovolumes in the plastic deformation process, which is confirmed by low values of the residual strain (Makarov 2000). Significant differences were also observed in the slopes of the descending branches of the stress-strain curves, which testify to a big difference between the mechanisms of macrofailure.

Fig. 5. Visualization: a – dependence of loosening strains on the residual strain for the specimens of the longitudinal direction of cutting (1) and transverse direction of cutting (2); b – scheme of the deformation behavior of specimens cut in the longitudinal direction from the service-exposed pipe; c – scheme of the deformation behavior of specimens cut in the transverse direction from the service-exposed pipe

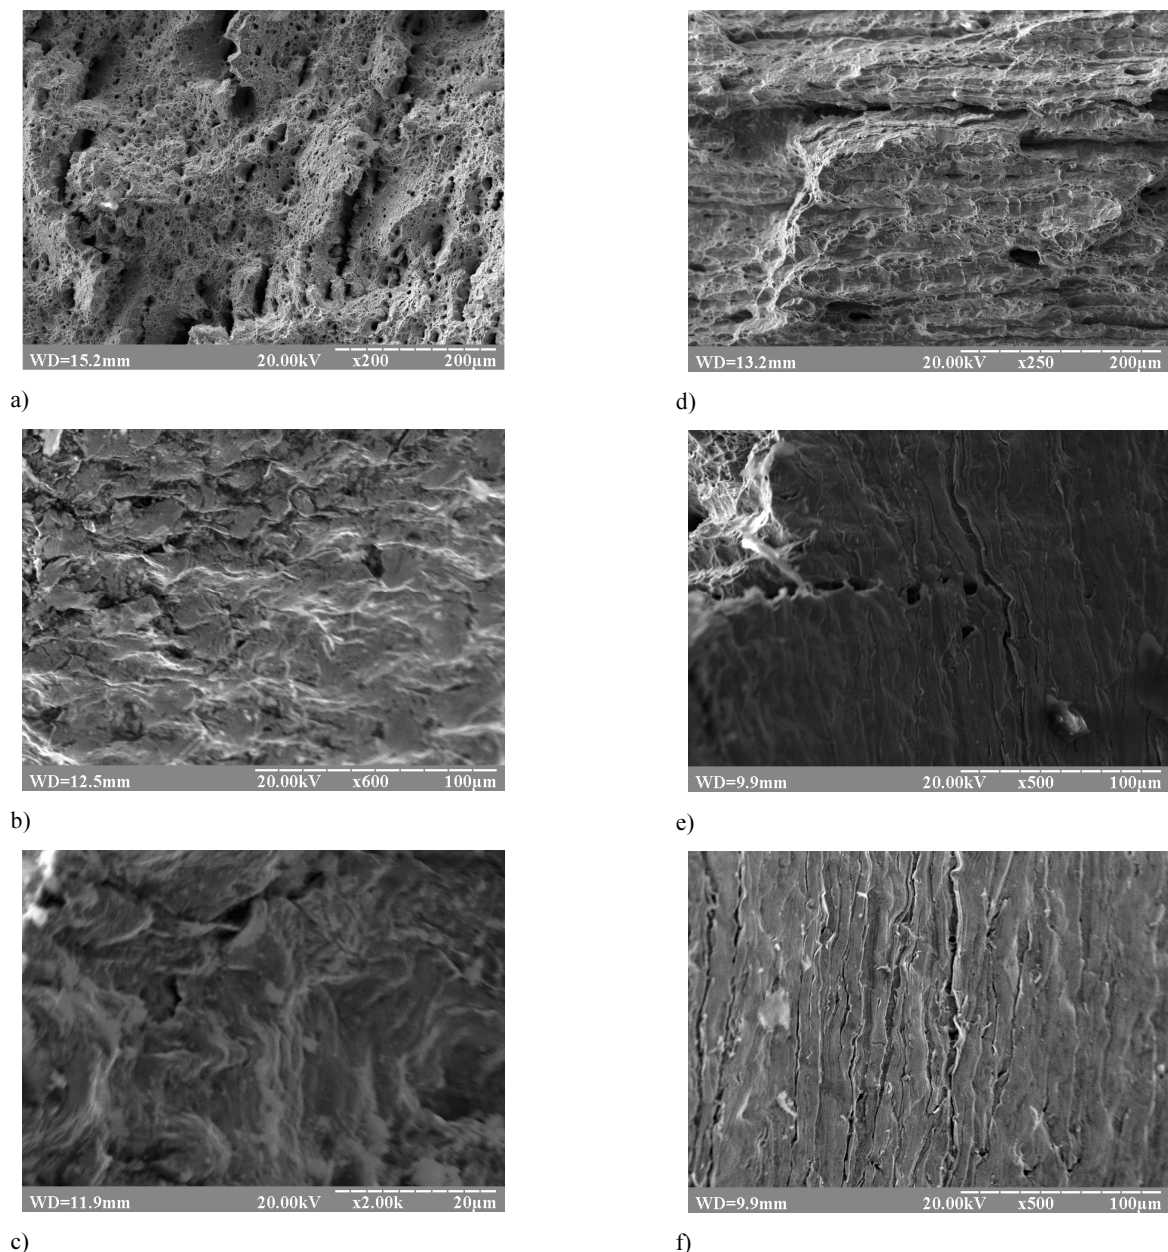
- the *transverse direction of cutting*. The view of the lateral specimen surface testifies to the brittle failure (Fig. 6d). At the same time, the presence of multiple cracks testifies to the partial relaxation of stresses during deformation. It is shown that due to the stress concentration in the vicinity of microcracks the first

Fig. 6. Fracture surfaces – a, d and lateral surfaces d, e, f of specimens from service-exposed steel 17G1S: (a) of the longitudinal (a–c) and transverse (d–f) direction of cutting after 40 years of operation
