INVESTIGATION OF TRAFFIC-INDUCED VIBRATION IN VILNIUS ARCH-CATHEDRAL BELFRY

Romualdas Kliukas¹, Arūnas Jaras², Rimantas Kačianauskas³

Abstract. The influence of city traffic-induced vibration on Vilnius Arch-Cathedral Belfry is investigated. Two sources of dynamic excitation are studied. Conventional city traffic is considered to be a natural source of excitation while excitation imposed artificially by moving a heavily loaded truck is considered to be the source of increased risk excitation. The influence of induced vibrations is recorded by accelerometers located in various positions of the Belfry's structures and shown by accelerograms. Dynamic effects are evaluated by considering acceleration magnitudes and response spectra. A comparative analysis of both effects is presented and conclusions and recommendations are provided.

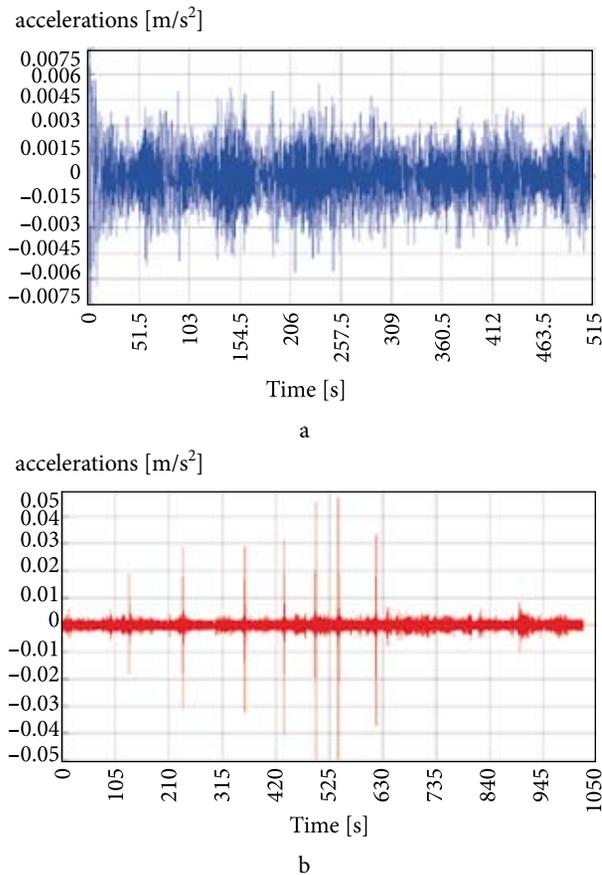
Fig. 5a presents the histogram of accelerations in the horizontal direction of the Belfry (at the level of 21.7 m) caused by conventional city traffic. It reflects the background dynamic effect (the usual vibration level) on the building structures. In this case, the accelerations values do not exceed 0.00765 m/s^2 .

While Fig. 5b presents the histogram of accelerations in the same direction at the same level, it is caused by the heavily loaded truck running seven times over a localized artificial road surface irregularity. In this case, the corresponding seven peaks of accelerations are observed. It shows that the effect of heavily loaded trucks on the accelerations values at the level of 21.7 m is by about 6.5 times higher compared to usual vibration level and reaches 0.0498 m/s^2 .

Fig. 5. The accelerograms obtained by using the 3rd sensor (in horizontal direction, at the level of 21.7 m) for two typical city traffic stages: a) conventional city traffic; b) a heavily loaded truck moving trough a localized road surface irregularity

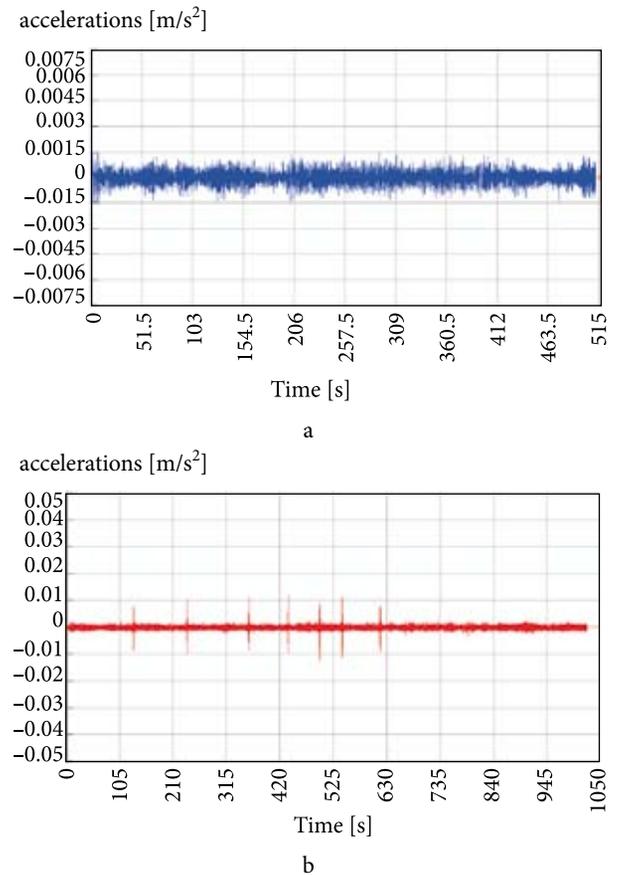
Fig. 6a presents the histogram of accelerations in the vertical direction of the Belfry (at the level of 7.8 m)

Fig. 6. The accelerograms obtained by using the 9th sensor (in vertical direction, at the level of 7.80 m) for two typical city traffic stages: a) conventional city traffic; b) a heavily loaded truck moving trough a localized road surface irregularity

caused by conventional city traffic. It reflects the background dynamic effect (usual vibration level) to the building structures. In this case, the acceleration value does not exceed 0.002 m/s^2 .

Fig. 6 b presents the histogram of accelerations in the same direction and at the same level but it is caused by a heavily loaded truck running seven times over a localized artificial road surface irregularity. The recorded seven peaks of accelerations show that the dynamic effect of heavily loaded trucks on the Belfry's vertical 'jumping' at the level of 7.8 m is by about 6 times higher compared to usual vibration level and reaches 0.0120 m/s^2 .

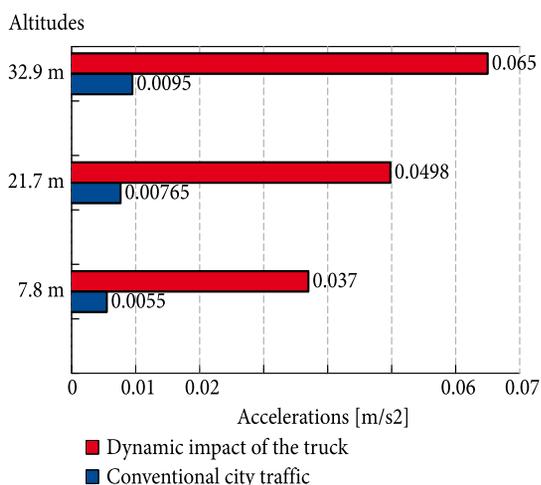
The graph in Fig. 7 illustrates horizontal peak acceleration at the various altitudes of the building (in the direction perpendicular to Sventaragis street) caused by a heavily loaded truck moving through a localized road surface irregularity and conventional city traffic respectively.

Fig. 7. The distribution histogram of horizontal accelerations along the vertical axis of the Belfry accelerations [m/s²]

In the case of conventional city traffic, the acceleration values (usual vibration level) do not exceed 0.01 m/s^2 . According to Polish code PN-85/B-02170 (having no Lithuanian equivalent), it may be stated that dynamic loads are insignificant.

However, while the heavily loaded truck was moving through a localized road surface irregularity (dynamic impact), the acceleration values were much higher: at the 4th floor level (7.80 m) – 0.037 m/s^2 while at the 7th floor level (32.9 m) the value increased up to 0.065 m/s^2 . According to Polish code PN-85/B-02170, it may be stated that in this case, dynamic loading may be dangerous for the structures considered.

4. The effective regulation of transport routes and the appropriate maintenance of the road surface in Vilnius Old Town and other districts may essentially decrease dynamic loading caused by traffic.

5. To ensure the effective maintenance of the Belfry's structures, a system of monitoring transport induced dynamic effects and their consequences could be recommended.

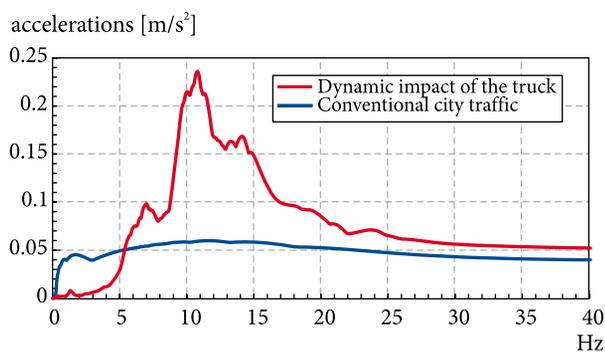
Fig. 8. The response spectra of the Belfry's accelerations obtained using the 3rd sensor (in horizontal direction, at the level of 21.7 m) for two typical transport traffic stages (with 5% damping)

Two resonance frequencies were identified. The first resonance occurring at $\sim 1.3 \text{ Hz}$ can be attributed to the natural frequencies of the building structures while the second resonance frequency of $\sim 10.8 \text{ Hz}$ is attributed to the influence of the traffic.

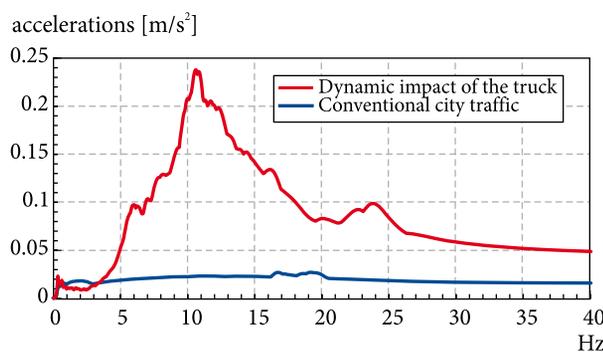
Fig. 9. The response spectra of the Belfry's accelerations obtained by using the 9th sensor (in vertical direction, at the level of 7.80 m) for two typical city transport traffic stages (with 5% damping)

2. The details of dynamic effects were described in terms of the response spectra of accelerations. Two resonance frequencies were identified. The first resonance occurring at the frequency of ~1.3 Hz can be attributed to the natural frequencies of the building structures while the highest resonance frequency of ~10.8 Hz is attributed to the influence of city traffic.
