RELIABILITY OF KAROSA BUSES RUN BY A JOINT-STOCK COMPANY 'VILNIUS BUSES'

Abstract. In the paper the data on operating reliability of KAROSA buses run by a joint-stock company 'Vilnius buses' are presented. The pneumatic front suspension and an automatic gearbox are investigated. The failures of these units and their causes are considered and some recommendations to increase the reliability of the equipment are provided. The need for using high-quality materials in maintaining the vehicles is demonstrated by the study of an actual case of highly corroded bearings.

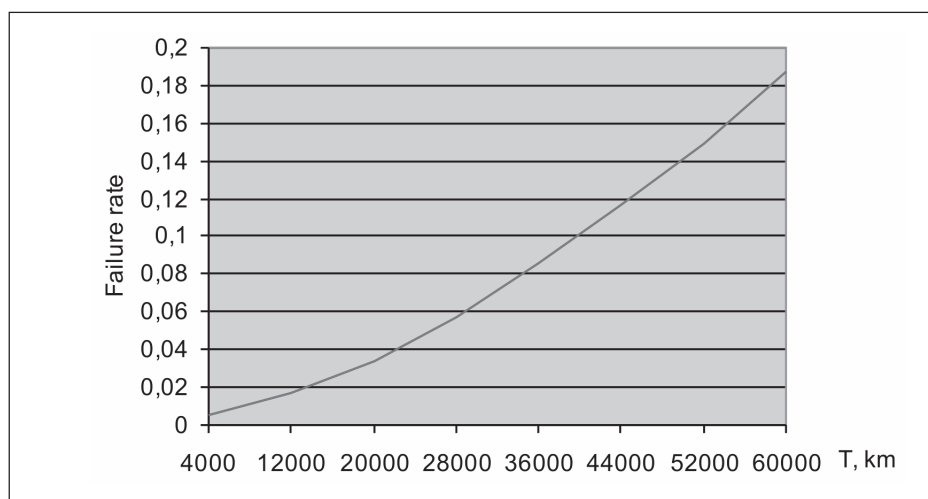
Fig 1. Shock absorber failure rate $\lambda(T)$

The reliability of shock absorber is higher with the average expected work-to-failure reaching 88,4 thous. km (Table 1). However, it is even more important to identify its failures and their causes because this unit plays an essential part in the suspension. The cases when piston rod lubricators leak oil are common for the parts of the second group. When rubber gaskets are aging their elasticity is reduced and cracks are formed. As a result the insulation of the unit is broken down.

The data obtained prove that slowly developing shock absorber defects may remain unnoticed for a long time, but they may cause road accidents. Therefore, shock absorbers should be inspected every 20 thous. km of a bus run.

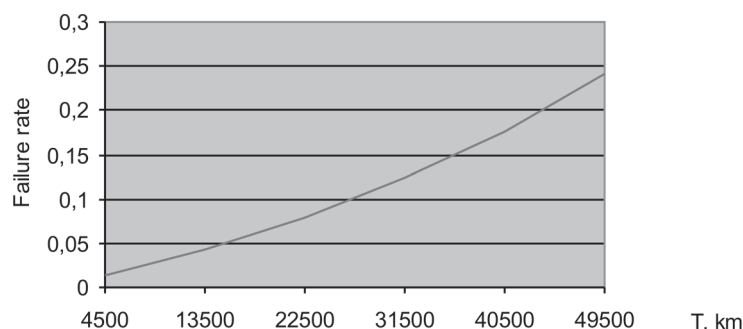
The causes of the control keyboard failure identified during the repair are worn-out or oxidized contacts. These defects are easily removed by dismantling and cleaning the unit and replacing the faulty contacts. However, these seemingly slight defects may cause failure of gearbox resulting in friction surfaces damage and even causing accidents. The mechanical

Fig 2. Failure rate of control keys $\lambda(T)$

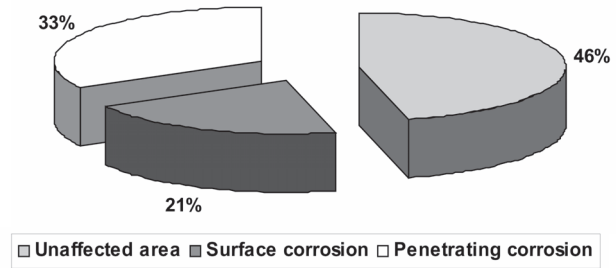
- both main and connecting rod bearings are affected by corrosion;
- corrosion affects only the inner side of the lower inserts;
- the largest areas affected by corrosion are in the main bearings.

It is clear that the observed defects were caused by a liquid which collected in bearings (on their lower inserts) because its unit weight was higher than that of the engine oil Statoil Max Way 15W–40 ($\rho \approx 0,885 \text{ g/cm}^3$).

This state is more stable in the main bearings (because centrifugal forces are inactive). The data on corrosion-affected areas are given in Figs 3, 4.

Since the engine was filled with high quality fresh oil, it could be polluted only by a cooling liquid leaked

Fig 3. Inner surface damages of the lower insert of the crankshaft bearing

from a poorly insulated cooling system. Examining the oil remaining in the engine we could observe hardly any changes in its consistence (e.g. flakes, jelly). Since engine oil was discharged before dismantling the engine, it could not be properly examined and assessed.

The cooling liquid (ethylene glycol) was getting into the engine oil in small amounts because the cooling system was deteriorating and leaking it. However, it was not detected by any sensor or maintenance worker.

8. The case study of heavy corrosion of the crankshaft bearings and the analysis of its causes demonstrate the importance of high quality maintenance liquids and their proper application.

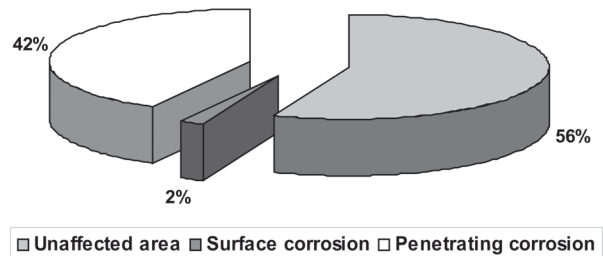
Fig 4. Inner surface damages of the lower insert of the connecting rod bearing

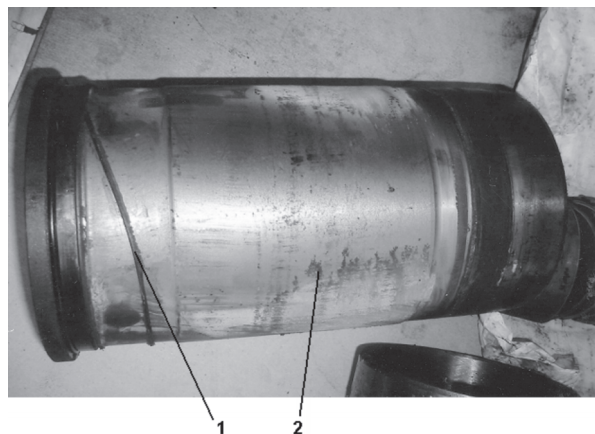
When examining cylinder hubs hardened and cracked rubber gaskets were detected and large areas damaged by cavitation erosion were found (Fig 5). These damages could be caused by the cooling liquid.

This occurs when a low grade or improper cooling liquid is used.

At the period of inspection TOSOL A diluted with distilled water (up to 50 %) was poured into the cooling system of KAROSA B-741 for economic purposes. Its boiling point is 108 °C.

However, MAXIGEL manufactured by the company 'Elf' which is recommended by the manufacturer starts boiling at +126 °C when diluted with water up to 56 %. The whole process having great negative effects may proceed as follows: the cooling liquid started boiling when heated up to ~100–180 °C, then the boiling ceased when it was cooled and after a certain time the liquid was heated and started boiling again. It is clear that a short time was needed for the cooling liquid to start boiling again and this was how it could

Fig 5. Surface damages of the cylinder hub: 1 – damaged rubbergasket; 2 – surface areas damaged by cavitation corrosion

damage cylinder hub surfaces and rubber gaskets. The use of a not suitable cooling liquid may be explained by inadequate evaluation of its negative effect on the engine and by the intention to cut expenses on maintenance materials.

Slow deterioration of an engine and its cooling system not detected by the enterprise sensors and other facilities could be observed by periodically checking oil and determining its operational characteristics [10].
