ON WHEEL-RAIL CONTACT SURFACE PHENOMENA WITH STRUCTURAL CHANGES AND 'WHITE ETCHING LAYERS' GENERATION

Libor Beneš

Submitted 27 April 2011; accepted 21 June 2011

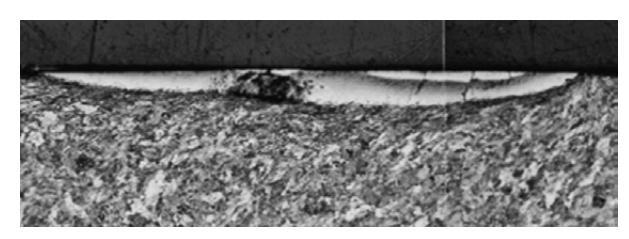
When viewed in a light microscope, the crosssection of an operated rail (Fig. 1) shows *riffle bands*, (surface corrugation of the rail head) in a layer approximately $10\div100 \mu$ m thick, without a structural contrast, which is resistant to etching of metallographic samples and shows a white colour after etching with Nital. This layer is often considered or identified as martensite. As this layer exhibits exceptional fragility (referred to as WEL since Chapter 1, the abbreviation derives from the English term 'White Etching Layer'), propagation of defects known as *squat* or *shelling* and occurrence of defects is observed in the rail head. All of the above result in background noise when the wheel travels along the rail and exhibit a detrimental effect on the service life of the rail and of the wheel axle (Lojkowski *et al.* 2001).

Fig. 1. White Etching Layer (WEL) on the surface of the rail (Wang 2002) – Nital, magn. 100x

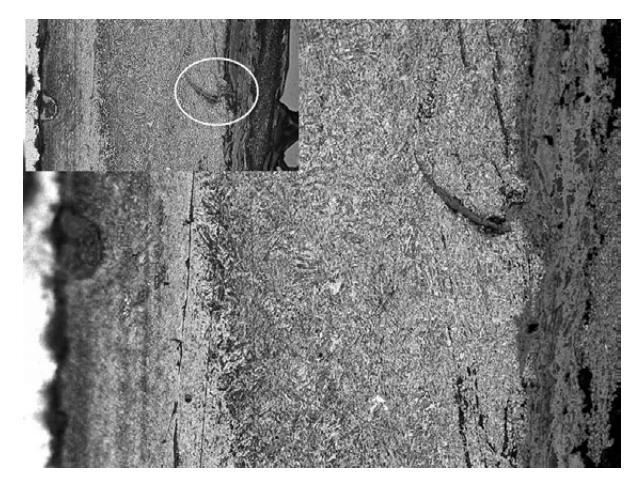
The analyses performed show that the WEL itself consists of several sub-layers; this suggests gradual generation of the layer during operational exposure (see Fig. 2). The figure also shows a tendency to layer delamination along the boundary with unaffected mass in the sub-surface area of the rail head, which is the result of a high hardness gradient and, therefore, of local stress conditions acting on both sides of the boundary area. The cumulative effect of the tangential shearing components in the area of contact causes separation of material masses from the rail head and is the cause of occurrence of the studied defects on the surface.

Fig. 2. Microstructure of the studied rail-segment after annealing on 250°C / 4hrs – etched in NITAL, magn. 250x and 50x, respectively

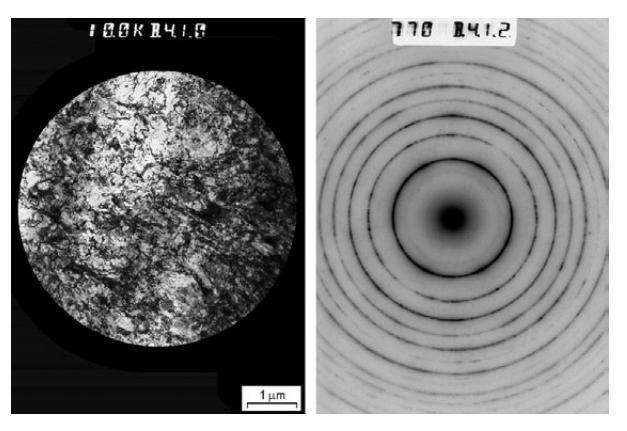
Fig. 3. TEM-image of the region where the selected electron diffraction was carried out; the obtained annular diffraction pattern proved that the microstructure consists of very small ferrite grains with random orientation

Annular diffractions (see Fig. 3) show that only ferrite is present in the material; presence of carbides may be expected; however, the diffraction sensitivity in the situation is not sufficient as to show carbides in the image.

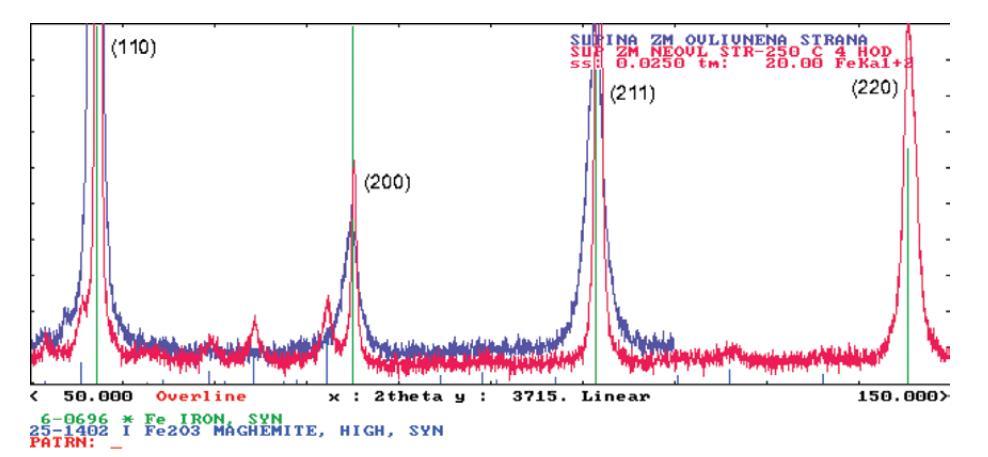
Comparison of the achieved results clearly indicates that a thin layer of Fe oxides was formed on the non-influenced side as a result of tempering. Interestingly, such oxidation products were not identified in the influenced side in any temperature. There is a highly plausible explanation that the presence of the 'nanostructure' component in the rail surface increases its resistance to corrosion.

Fig. 4. X-ray diffraction plot made on the non-influenced side of the rail-chip after the next annealing 250°C/4 hrs (including comparison with the influenced side)
