## DETERMINATION OF MALL BUILDING VERTICAL DISPLACEMENTS BY SEDIMENTARY MARKS

**Abstract.** The purpose of this paper is to determine the optimal method of researching the vertical displacements of buildings and stability of the marks, on the basis of which it is possible to make a conclusion about the subsidence of the researched building. Methodology. The main task of geodetic observations for buildings monitoring is to identify changes in the spatial position of load-bearing structures (vertical and horizontal displacements) to assess the risk of structures destruction, dismantling unstable structures, forecasting accidents. In this paper we offered to carry out monitoring by a method of high – precision geometrical leveling on the established geodetic marks, according to one scheme with constant points of devices installation. For testing this method 13 cycles of II class leveling were conducted to determine the vertical displacements of sedimentary marks of the “Shuvar” mall building. To detailed determination of the building deformation, namely its sediment on two floors, we laid 70 marks in the floor on the first floor and 41 marks on the second floor. Stainless steel ancho

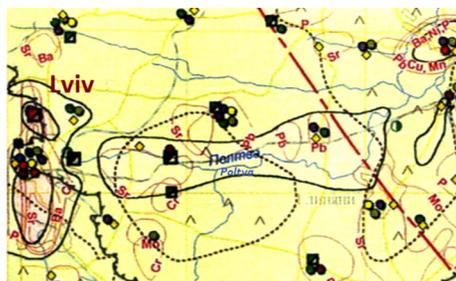
Figure 1. Schematic map of ecological state of geological environment (source: Gherasimov et al., 2004)

According to the map of ecological state of the geological environment (Figure 1), the area where the object of study is located belongs to the unfavorable zone, which includes areas of medium ecological risk of air, soil and water pollution by heavy metals and other chemicals.

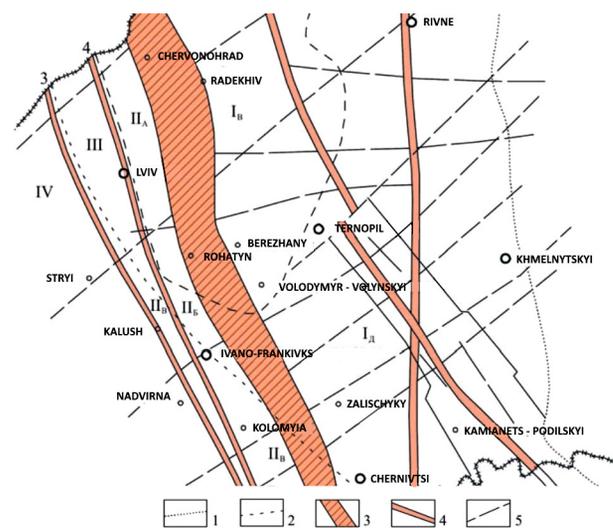
Note: 1 – the boundary of the Lviv Paleozoic depression; 2 – the boundary of the Pre-Carpathian Depression; 3 – Novovolynsk and Radekhiv-Rohatyn-Monastyr faults (Teis-seira-Thornquist zone); 4 – the main faults of the north-western direction (3-3 – Gorodotsko-Kapusky; 4-4 – Rava-Rusky), 5 – the main faults of the north-eastern and sublatitudinal direction (Krupsjkyj, 2014).

Figure 2. Tectonic zoning of the studied region (source: Krupsjkyj, 2014)

which are part of the trans-European suture zone (Teis-seira-Thornquist zone). The modern tectonic structure of the region has a block character. Some blocks are limited by zones of deep faults, the main of which have north-eastern and north-western directions (Figure 2). The territory of Lviv is actually located on the edge of the Lviv Paleozoic Depression in the area of the Rava-Rusky deep fault (marked 4-4 in Figure 2). Such tectonic location can cause horizontal and vertical tectonic movements and landslides. It should also be noted that in the territories of industrial and urban agglomerations, which are the territories of large cities, the karst process is intensified due to man-made factors (Informacijnyj shhorichnyk, 2013, 2020; Gherasimov et al., 2004).

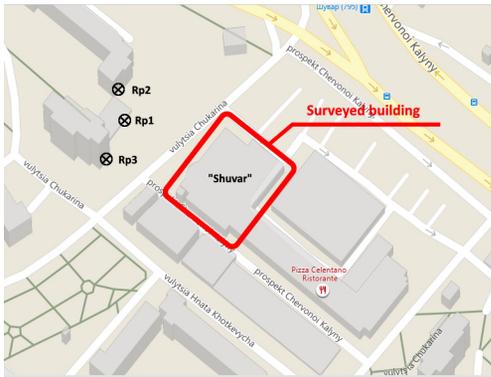
Figure 3. Location of wall benchmarks

To determine the vertical displacements of the object under study we laid three wall benchmarks before the observations: Rp1 (directorate building of “Shuvar” mall), Rp2 (nine-storey building on the right side of the entrance to the directorate) and Rp2 (column of a twelve-storey building on the left side of the entrance to the directorate) (Figure 3). All benchmarks are laid in buildings that have different foundations and are operated for a long time, which allows to control the stability of their height position with high accuracy.

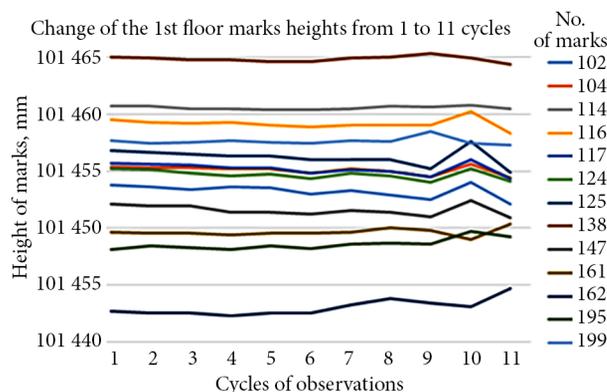
Figure 4. The schedule of heights change of the chosen marks of the first floor during 11 cycles

The schedule of heights change of the chosen marks of the first floor within 11 cycles is constructed (Figure 4). As can we seen from Figure 4, the heights of marks from 1 to 9 cycles were almost unchanged, except marks 161 and 162, whose heights gradually increased from 6 to 8 cycles,

slightly decreased to 10 cycle and increased again from 10 to 11 cycles, but these changes occurred within 2.5 mm. Marks 114, 138 and 199 changed their height up to 1 mm during the whole period, i.e. they are the most stable. All other selected marks up to 9 cycle remained almost unchanged, from 9 to 10 cycles rose (within 2 mm), and from 10 to 11 fell (within 2 mm). That is, in general, all marks, on which regular observations were made, did not experience critical uplift or subsidence.

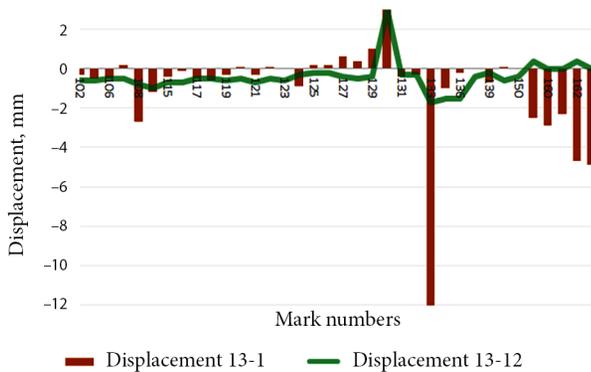
Figure 5. Graph of shift of marks between 13 and 1 cycle, and 13 and 12 cycle of observations on the first floor of the building

Figure 5 shows a graph of displacements of marks between the 13th and 1st cycles, and the 13th and 12th cycles of observations on the first floor of the building. As we can see from the graph, most marks have been subsided. The mark No. 133 subsided the most on about 12 mm, the other marks shifted to  $-5$  mm. Marks 107, 120, 122, 125–130 were raised, the highest value was reached by the mark No. 130 up to 3 mm. Between the 13th and 12th cycles, the displacements acquired mainly negative values (subsidence) up to 1 mm, mark No. 133 has the maximum by  $-1.8$  mm, small positive values of displacements (lifting) have marks 130 (+2.5 mm), 159–166 (up to +0.5 mm).

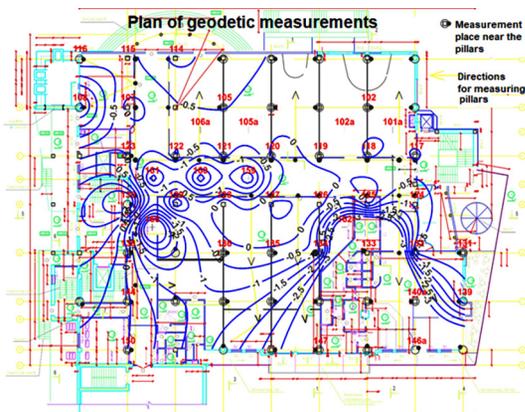
Figure 6. Isolines of vertical displacements of sedimentary marks of the first floor according to 1–13 cycles

Based on the results of the calculated displacements, isolines of vertical displacements of sedimentary marks of the first floor were constructed according to the data of 1–13 cycles (Figure 6). As we can see from this figure, the largest subsidence has the part of the building near the stairwell (western part), partly the central and north-eastern part.
