## DETERMINING THE LOCATION OF MALAYSIA AIRLINES FLIGHT MH370

Atınç PIRTI<sup>1\*</sup>, M. Ali YUCEL<sup>2</sup>, Ramazan Gürsel HOŞBAŞ<sup>1</sup>

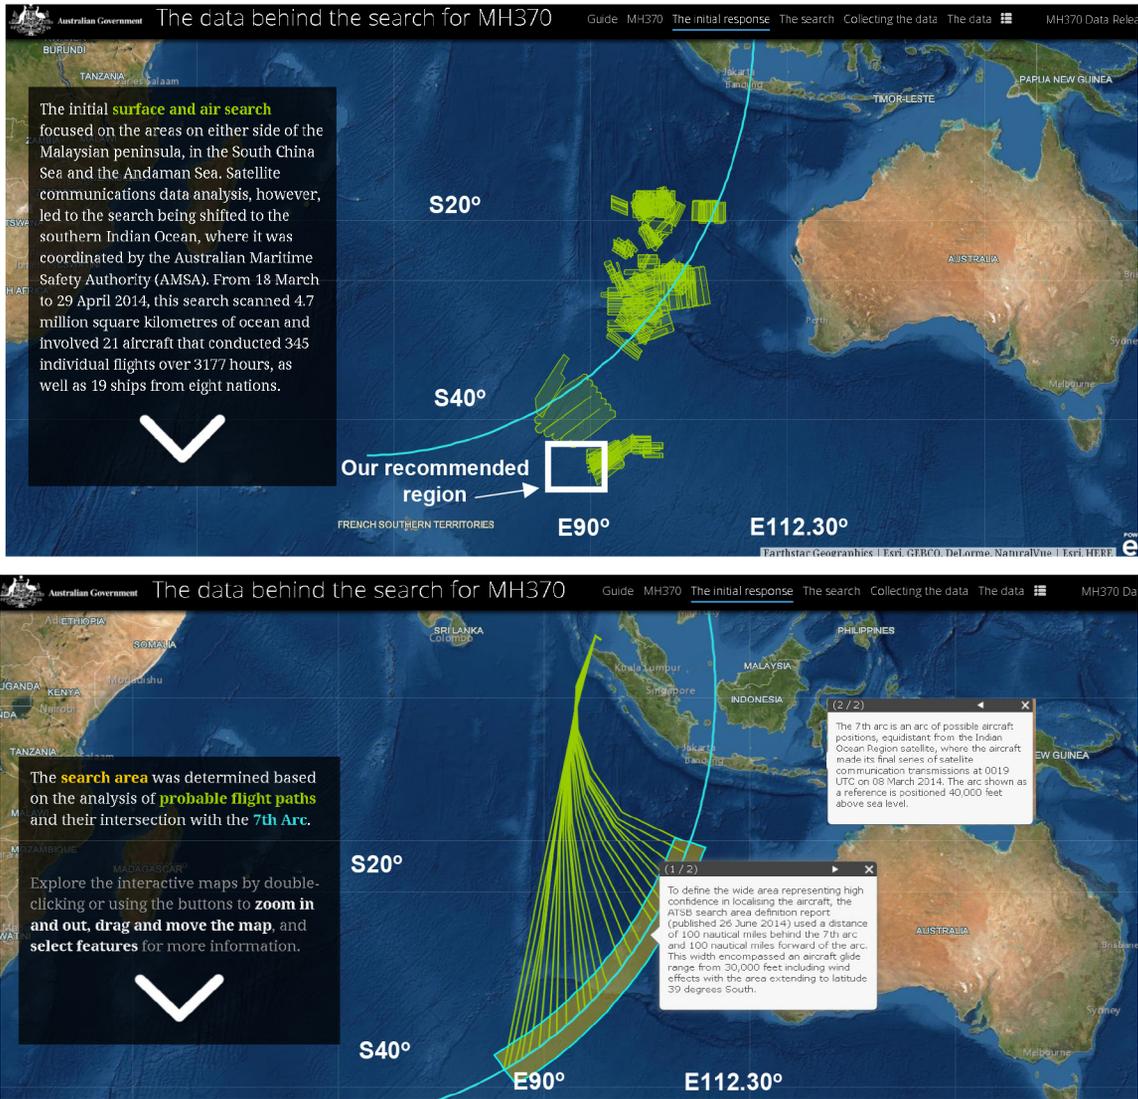
Figure 9. Maps where the Australian research team conducted the search and our recommended region (white rectangular) (Australian Government, 2015, 2017)

On 28 April 2014, the surface search for MH370 coordinated by the Australian Maritime Safety Authority (AMSA) was concluded and the ATSB assumed responsibility for conducting the underwater search for the aircraft, see Figure 9 (Australian Government, 2015, 2017). In our study, the investigation of the area where the plane crashed was made by taking into account the maximum and minimum range that the plane could reach depending on the amount of fuel remaining, the location of the debris pieces, and the ocean current direction and speeds (Figure 10). The region we recommend as a result of our investigation is marked on the map in a white rectangle (Figures 9 and 10). A small portion of the area we propose

has already been searched by the Australian research group. However, the rest of the region was not included in the study (Figure 9). Where the French and Chinese satellite imaged the aircraft wreckage, the ocean current velocity was 7500 km/year northeast. In this region, there is current at a speed of 20.5 km per day. 15 days after the disappearance, 50 km northwest of the AMSA point is reached by traveling 307.5 km in the opposite direction (southwest) from the place detected in the French satellite image. Where the Chinese satellite detected the aircraft remains, there is a current of 20.5 km per day. In this image, which was obtained 10 days after the disappearance, a 205 km journey in the opposite direction (southwest) reaches a region 70 km northeast of the place indicated by the AMSA point. Therefore, it is foreseen that researches should be carried out in the area between 42° S–45° S latitudes and 87° E–92° E longitudes given in Figure 10.

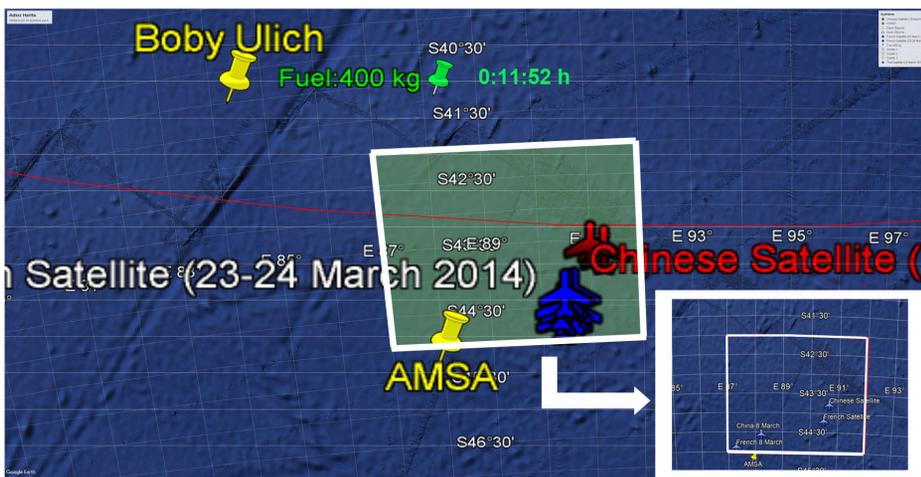
Figure 10. Illustration of the area where the plane is predicted to crash on the map (white rectangular-green region)
