EVALUATION OF THE LOW-COST DEPTH CAMERAS FOR NON-DESTRUCTIVE TESTING

Noura Y. ALGHANIM¹, Tarig ALI¹, Ahmed ELAKSHER²✉, Mohammad ALHAMAYDEH¹

¹Civil Engineering Department, American University of Sharjah, Sharjah, UAE

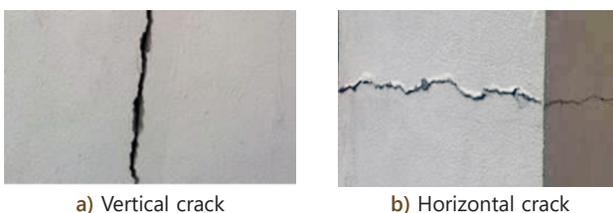
Figure 1. Cracks

Thin	<1 mm
Medium	1–2 mm
Wide	>2 mm

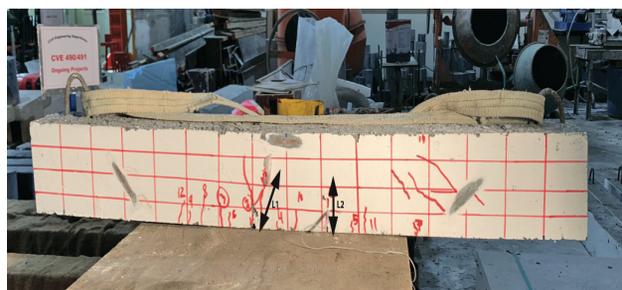
Figure 3. Experimental setup of Mix#2 with defined cracks

- The steps of the experimental procedure is illustrated in the workflow in Figure 4 below. Step [0]: Marking the grids on the surface of the beam.
- Step [1]: Defining the beam with its major crack regions (Figure 3). This involves the measurement of the crack length using a measuring tape.

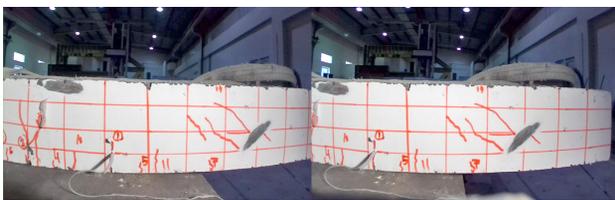
Figure 5. ZED Explorer of Mix#2

- Step [2]: Place the ZED camera at a one-meter distance orthogonal to the concrete surface of the beam created with Mix#2. The image was then taken and exported to the ZED Explorer program (Figure 5).
- Step [3]: The images are then exported to the ZED Depth Viewer software in order to create depth map, and the 3D point cloud for Mix#2. The image is converted to tri-axis data and colorized in order to identify the cracks in the rendering software as shown in Figure 6. The image is then transformed to ZED explorer to generate a 3D point cloud image of the crack as shown in Figure 7.

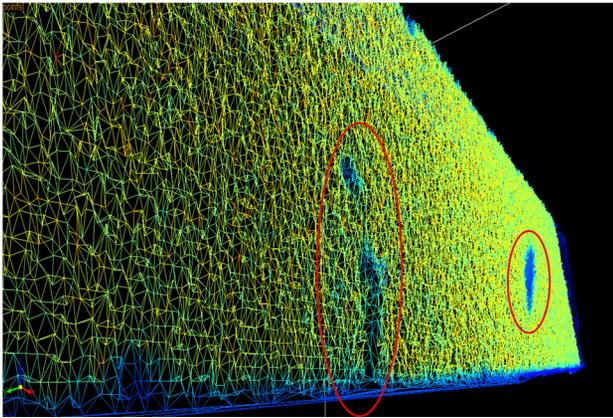
Figure 8. Mesh of Mix#2

- Step [4]: The 3D point cloud is then exported to the ZEDfu program in order to create the 3D mesh of the surface as illustrated in Figure 8.
- Step [5]: The length is first roughly measured by locating the farthest two points a single segment (Figure 9).

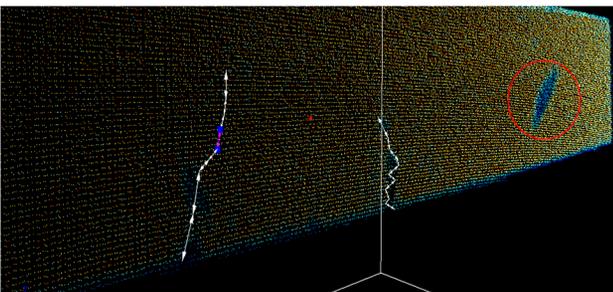
Figure 10. Defined points on Mix#2 for multiple segment assessment

- Step [6]: A set of partial segments of the crack shape are aggregated to attain a more accurate assessment by digitalizing the crack. Ten segments were defined for this differential assessment (Figure 10). The selection of the points was based on locating localized regions around the crack. This is because the crack is a void, which requires locating regions within its proximity and relying on reasonable estimation. When the voids were too large, we used the surface model to allocate the points instead of the 3D mesh model in order to get location within the voids.

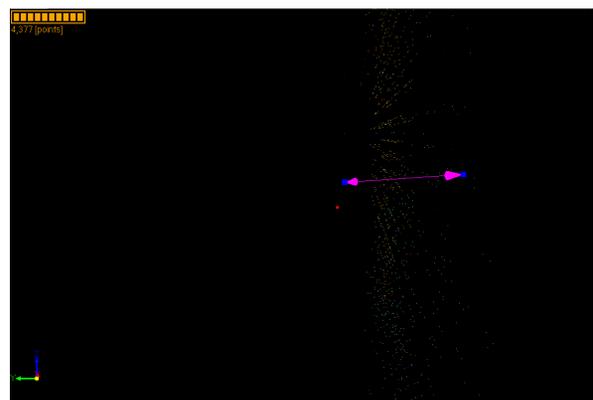
Figure 13. Perpendicular depth points of Mix#2

- Step [9]: The 3D model of the crack can be rotated sideways after slicing in order to conveniently measure the depth of the crack. The farthest points between the crack regions were chosen as shown in Figure 13. Then, the distance between the two points was measured by the taking perpendicular depth points. In some cases, it was difficult to locate points on the slice across the crack. In such cases, the slope was calculated.

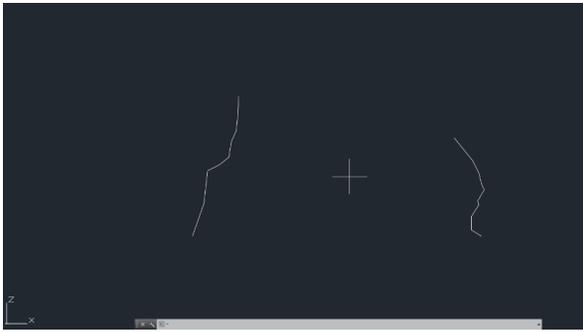
Figure 14. Crack polylines on AutoCAD for Mix#2

- Step [10]: Exporting the crack polylines in the 3D point cloud to the AutoCAD in order to measure the length and width of cracks as shown in Figure 14.
- Step [11]: Assessment of the accuracy of the crack measurements with ZED camera.
