METHODS OF IMPROVING THE EFFICIENCY OF MONITORING OF CHANNEL DEFORMATIONS OF MOUNTAIN RIVERS NEAR BUILT-IN SETTLEMENTS: ON THE EXAMPLE OF THE BUKTYRMA RIVER

Talgat TAUKENOV*, Kulchikhan DZHANALEEVA, Zhuldyz YERZHANOVA

Department of Physical and Economic Geography, L. N. Gumilyov Eurasian National University, Astana, Kazakhstan

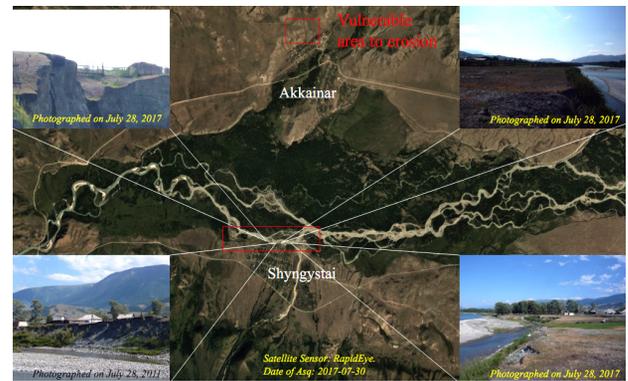
Figure 1. The erosion of the territory of Shyngystai village

In this paper, for the development of the methodology, the section of the Buktyrma River in the area of the Shyngystai village where the erosion of the left-bank ledge of the river has been eroded over the past 40 years has been chosen as an example to effectively solve the problems of channel strain monitoring. At the site currently under study, the riverbank is approaching the dwelling houses of the village, cutting the areas of vegetable gardens, pastures and destroying farm buildings (Figure 1). According to the villagers, in 1985–1990 years several projects have been developed to stabilize the shoreline of the river. However, none of them was implemented, including because of the ambiguous assessment of their effectiveness.

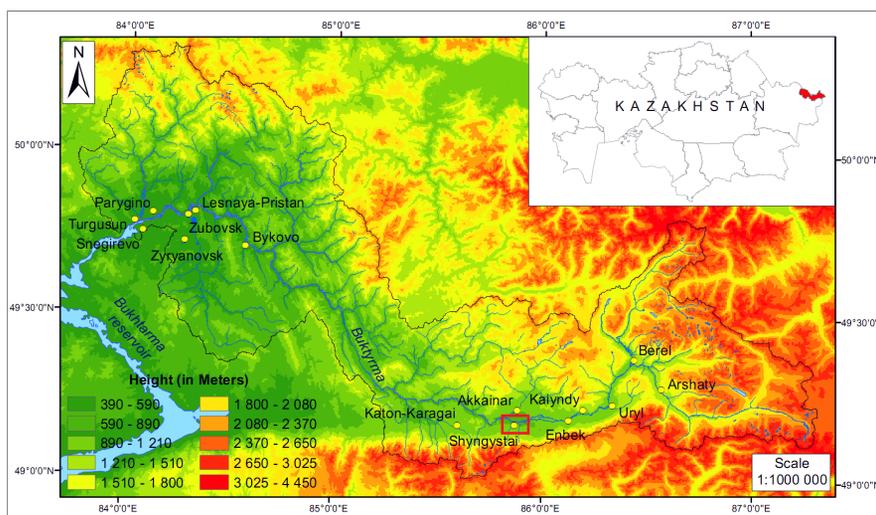
Figure 2. Map of the Buktyrma river basin

The Buktyrma River belongs to the basin of the Arctic Ocean and is the largest of the Altai tributaries of the Ertis River. Its basin is located within the South-Western Altai, in the southern half of the temperate climatic belt. Buktyrma flows into the Buktyrminskoe reservoir on the right (Dzhanaleeva, 2010). Its length, after flooding part of the valley with the waters of the Buktyrminsky reservoir, is 336 km, the basin area is 12,660 km². The structure of river systems, hypsometric characteristics and the catchment area of the Buktyrma river are shown on the map of the river basin (Figure 2).

A map was built based on the SRTM digital elevation model using Spatial Analyst tools of ArcGIS geoinformation system 10.3 (Djokic & Zichuan, 2011).

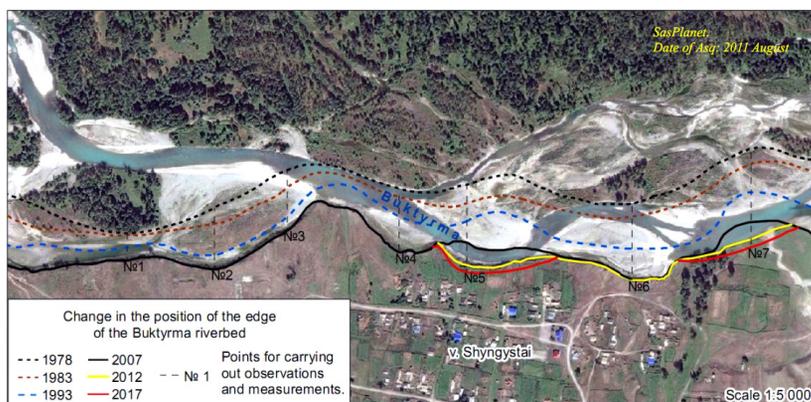
Figure 3. Change in the position of the edge of the Buktyrma riverbed in the area of the Shyngystai village

Evaluation of riverbed deformations. The planned deformation of the riverbed of the Buktyrma River in the investigated area was estimated by determining the displacement of the channel edge for different years. To do this, with the help of geo-information systems Google Earth Pro, SasPlanet and ArcGIS, a comparative analysis of different maps and space images was carried out. During the analysis all cartographic materials were brought to a unified system of coordinates and combined to reveal changes in contours of the riverbed (Figure 3).

The analysis made it possible to establish the direction of the river bank displacement, to identify the points of the most intensive erosions and to determine the quantitative scouring indices for each of them (Table 2).

As a result, it is established that the profile area has been most intensively eroded during the last 39 years. The erosion of the bank has reached 205.7 m. The erosion of the banks in the regions of profiles 5 and 8 was also significant during this period. The displacement of the bank-boulders was 182.7 m and 162.9 m, respectively. Flushing of the banks in the western part of the village occurs at a more moderate rate compared to the eastern part.

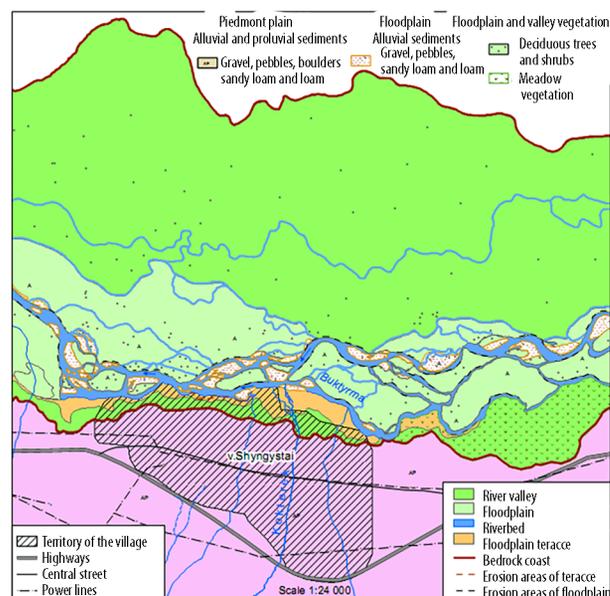
Figure 4. Scheme of eroded areas of the Buktyrma River near Shyngystai village

into account the monitoring of the spatial variation of the riverbed and floodplain streams. In the future, unmilled single-hose riverbeds can branch out and become multi-hosed according to the scheme for the development of the flood-plain multi-hood, and new riverbed islands, overloaded with sediments, also form within individual riverbeds. At the same time, the erosion of the banks will occur both to the right and to the left along the river (Figure 4).
