## PHOTOGRAMMETRIC ANALYSIS OF OBJECTS IN UNDERMINED TERRITORIES

**Abstract.** The Institute of Geodesy and Mine Surveying of the Technical University of Ostrava performs long-term monitoring works and evaluates the effects of undermining in the Ostrava-Karviná coal-field, a major industrial conurbation in the north-east of the Czech Republic. Local extraction of bituminous coal has had significant effects on the surface relief. Actual undermining effects are monitored on selected built objects on a regular basis. Some of them are public buildings, roads, listed historic monuments, and buildings of cultural or historic value. Damage to the buildings, etc. can be eliminated to some extent by prudent planning of extraction works in space and time and by applying appropriate protective measures.

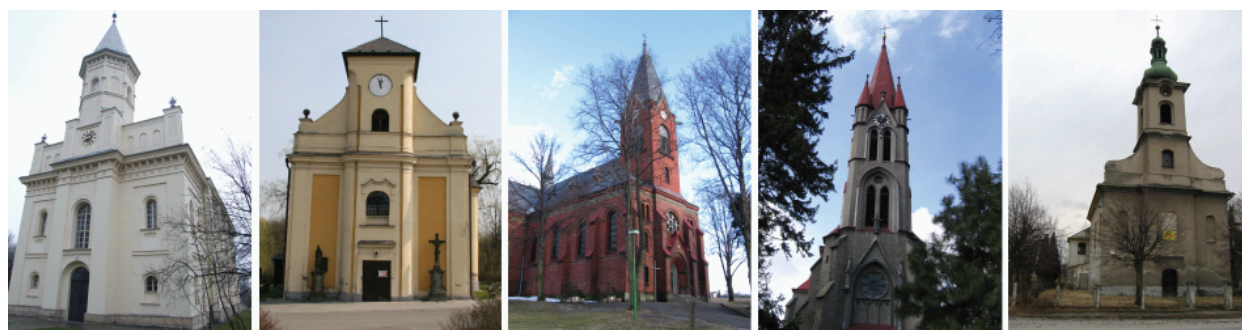
Fig. 1. Surveyed churches of the Ostrava-Karviná coal-field

Outstanding monuments in the Ostrava-Karviná coal-field have been subject to geodesic and photogrammetric surveying. Some of them are the Church of St. Peter from Alcantara in Karviná-Doly; the Augsburg Protestant Church in Orlová; the Mary Magdalene's Church in Stonava; St. Ann's Church in Polanka nad Odrou; St. Barbara's Church in Louky nad Olší (Fig. 1); the road in the area of Doubrava; public buildings in Žolnov, etc.

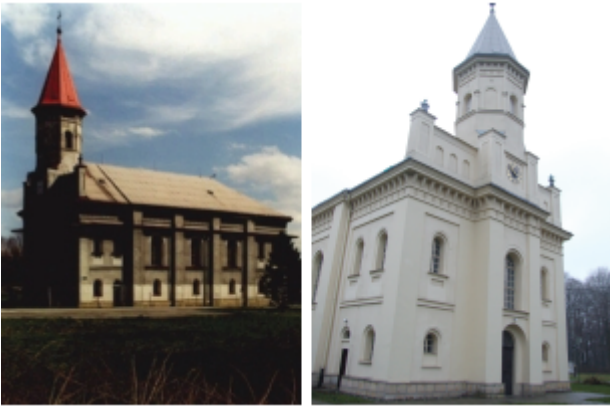
Fig. 4. The Protestant Church in Orlová before and after renovation. Photos courtesy <www.sceav.cz>

The foundation stone of the Protestant Church in Orlová (Loc: 49°50'45.74"N, 18°26'23.63"E) was laid in 1861 and the church was consecrated one year later (Fig. 4). The brick building was designed in the late Classical style with a single ship and a spire that was altered later.

The frontage is rather articulated with many cornices and rosettes. Showing visible undermining effects, the church has been rehabilitated several times. Significant damage was caused by minequakes. The latest large-scale rehabilitation was carried out only in 2005, stabilising the structure by applying modern technologies and renovating the frontage.

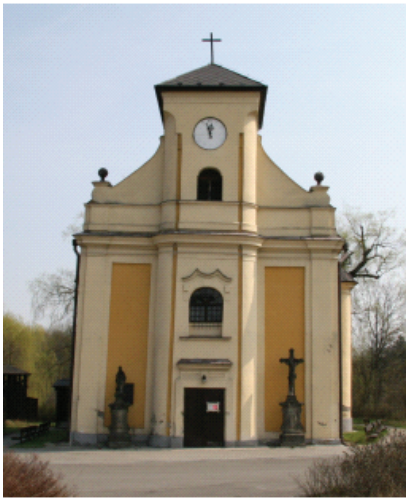
Fig. 3. St. Peter's Church in Karviná, vertical tilt measuring system

St. Peter's Church (Loc: 49°50'3"N, 18°29'20.999"E) is a unique witness to the history of the effects of coal extraction from their very beginning. Situated in the cadastral area Karviná II-Doly alongside the Ostrava-Karviná road (Fig. 3), it finds itself inside the area affected by the activities of two collieries: Československá armáda and Darkov. The baroque church was built in 1736. Coal extraction started in 1854 and 27 seams with a combined thickness of 46 m have been extracted from underneath the church making it sink 32 m and tilt 6.8° toward the north. While coal extraction began in 1854, early mining effects had not become visible until 1891, the date of the earliest written records of mining below the church. The original spire was pulled down during the church reconstruction in 1935. The next round of repairs followed in 1969 including the levelling out of the floor tilt that had reached up to 70 mm per meter. The latest renovations date back to 1994–1995 when a static stabilisation and general repair of the building were made. Minor landscaping and remediation works were done around the church in 1999–2000 (Gavlovský *et al.* 2005). Geodesic surveying from 1995–2009 determined that uneven sinking of the building continued in lengthways and transverse directions. The church survived coal extraction from rather shallow depths of 300–400 m below the surface. This gives us hope that the current fading after-effects of coal extraction at app. 800 m below the surface may not pose an existential threat to the building.

Monument buildings are localized by means of a polygonal network and by brass spikes. Exact elevation measurements have been made since 1995 on a regular basis to evaluate the depression and deformation parameters that describe undermining intensity in technical and legal terms as per ČSN 730039. Another parameter under survey is the vertical deviation of the church's outer walls. The measurements were made in two more or less perpendicular lines of sight: along the portal wall and along the side walls.

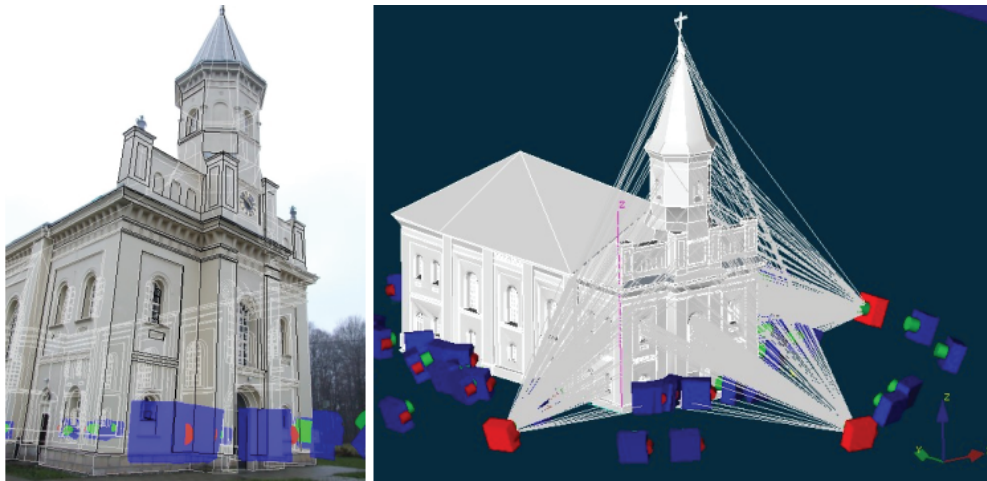
Fig. 8. A 3D model of the Protestant Church in Orlová

Fig. 8 shows a photogrammetric image of the Protestant Church in Orlová combined with a vector drawing and with a model indicating the camera positions and lines of sight. Fig. 9 shows the vector model of the baroque church in Karviná.

A combination of a 3D model enhanced with real textures and geometric data maximizes the information yield. A 3D view can include camera positions with lines of sight to the control points or mean error ellipses. Setting the image planes will visualize the lines of sight and each image will be put in the corresponding camera position. The method provides a perfect visual check of the entire surveying process. Where parts of the object are

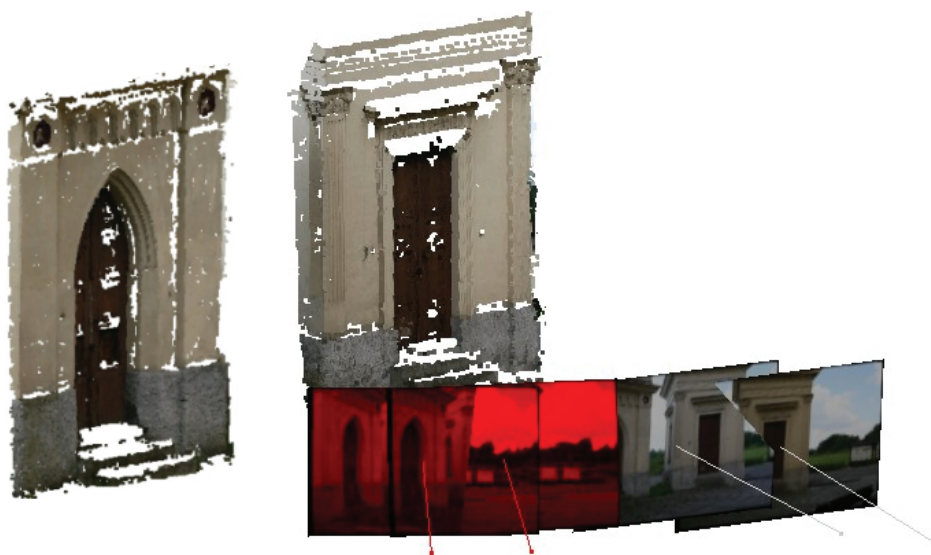
Fig. 11. A point cloud in PhotoModeller Scanner.  
A sequence of point cloud, triangle net and texture

Parallel imaging with 60% overlap was used to generate automatic digital surface models (DSM) consisting of a point cloud (Fig. 11). This is a way of replacing a complex manual generation of models from points and lines. An area for a point field is defined in the image and a calculation is made on the basis of pairs of images. The object is then placed in a coordinate system and DSM planes are generated. Parameters to set, include the point field density, the definition of an area and the matrix radius in pixels. The result is a dense point field that needs optimization. The point field is converted to a triangular network with a texture. The next step of optimization aims at reducing the number of triangles by app. 70% and then the model is smoothed out.
