## HISTORIC AND CONSTRUCTIONAL ASPECTS OF STONE SCHOOLS IN GREECE: THE CASE OF THE ARISTOTLE MUNICIPALITY IN CHALKIDIKI

Vasiliki PACHTA

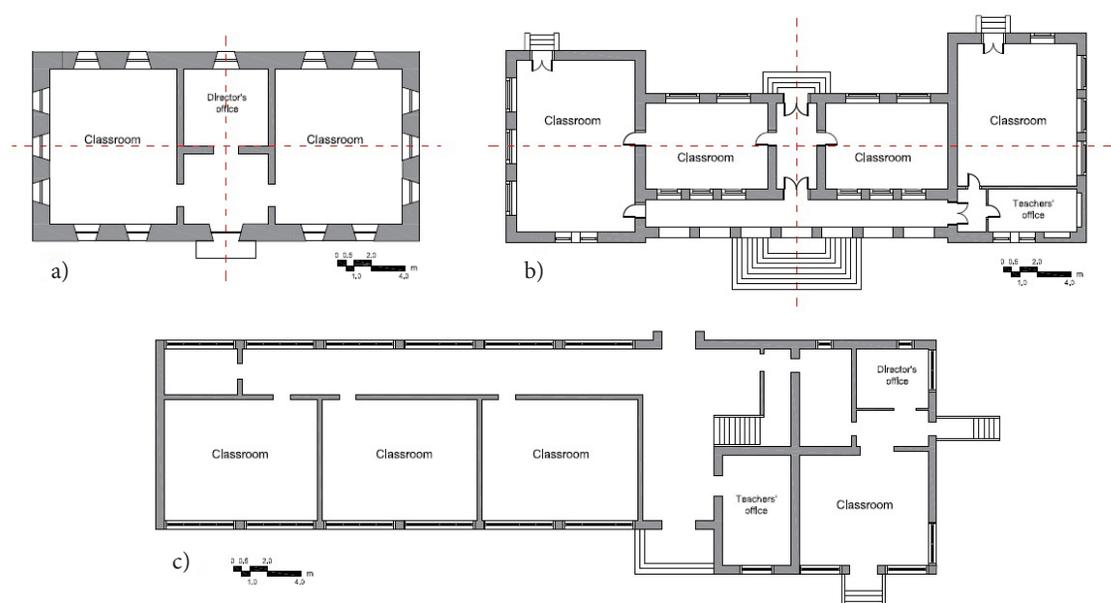
Figure 1. Depiction of the main school buildings' ground plans according to: a) Moraitis, 1880; b) Kallias (Hellenic Polytechnic Society, 1906); c) Karantinos, 1938

In Figure 1, the representative ground plans of school buildings, according to Moraitis (1880), Kallias (Hellenic Polytechnic Society, 1906) and Karantinos (1938) are depicted. From the correlation of the plans, it is asserted that in the first two cases the organization of the inner spaces is symmetrical in both the elongated and vertical axis. In the latter case, classrooms were successively put alongside a corridor, located in the back of the building. The thickness of the external walls was gradually decreased (from 1 m to 0.5 cm), while the openings' size was increased. To this direction, the constructional techniques and materials applied played an important role, as well as the presence of the reinforced concrete elements.

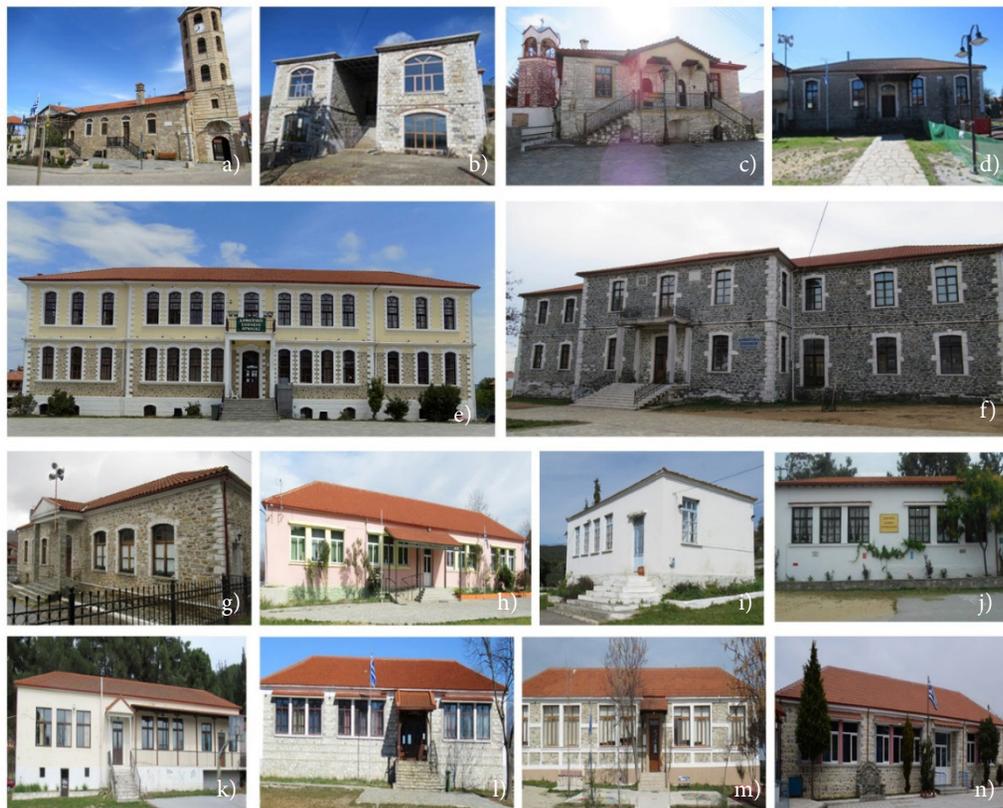
Figure 4. The stone schools of the Municipality of Aristotelis: a) Arnaia, 1871; b) Stratoniki, 1904; c) Varvara, 1909; d) Palaiochori, 1930; e) Arnaia, 1931; f) M. Panagia, 1932; g) Neochori, 1947; h) Ierissos, 1950; i) Pyrgadikia, 1951; j) Ouranopolis, 1951; k) Gomati, 1952; l) Varvara, 1956; m) N. Roda, 1956; n) Stanos, 1958 (source: author)

The characteristics of the studied stone schools are synthetically presented Table 1, while in Figure 4 their main façades are shown. Historically, the buildings were erected in 3 eras, concerning the periods 1871–1909 (3 schools), 1922–1932 (3 schools) and 1947–1958 (8 schools). In the first era, the traditional constructional principles were applied, while in the second and third ones the guidelines given by Moraitis (1880) and Kallias (1894).

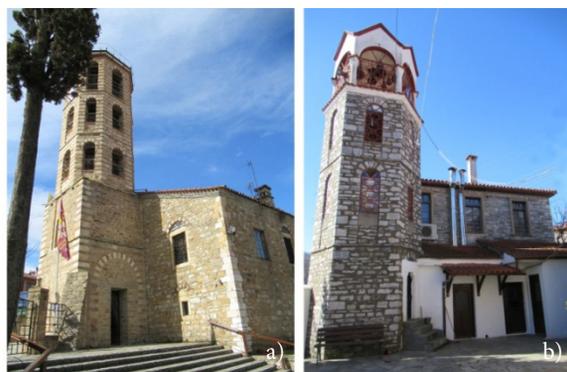
Figure 5. Attachment of the church's tower bell on the back side of the schools (pictures taken from the churches' courtyard): a) Arnaia, 1871; b) Varvara, 1909 (source: author)

In the earlier cases, as in Arnaia (1871) and Varvara (1909), schools were erected next to the central church and attached to the bell tower (Figure 5). It is interesting to notify that both bell towers were built posterior to the schools (Arnaia: 1884, Varvara: 1915). This fact confirms the close relation of the earlier schools of the region with the ecclesiastical community, according to the traditional principles followed at the end of the 18<sup>th</sup> century (Kalafati, 1988). Although in Southern Greece the National Standards of 1881 (Moraitis, 1880; Kalafati, 1988) and 1894 (Hellenic Polytechnic Society, 1906; Kardamitsi-Adami, 1986; Pantazis, 2010) were adopted, in the region of Chalkidiki (released from the Ottoman Empire at 1912), church was still the responsible sector for school construction. The orientation of these schools seems not to be taken into account, probably due to limitations arisen from the plot size. Land was probably allocated by the church, since schools were built in the outer part of their courtyard.

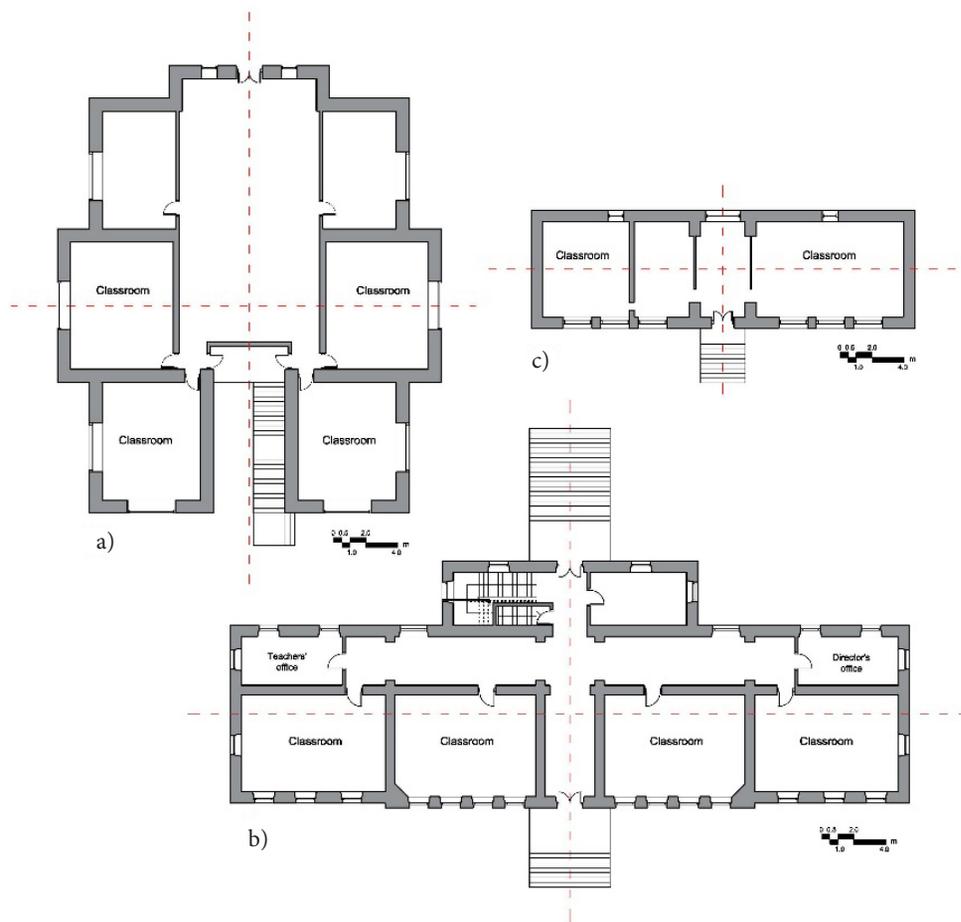
Figure 6. Typical ground plan of the stone schools of the Aristotle Municipality: a) Stratoniki, 1904; b) Arnaia, 1931; c) Gomati, 1952

ground plan was cruciform (Figure 6a), while in Arnaia (1931) and M. Panagia (1932) it could be characterized as semi-cruciform (Figure 6b, 6c). The floors ranged from 1 to 3 (basement, ground floor, 1<sup>st</sup> floor), while in all cases the ground floor was elevated from the ground (around 0.6–1.5 m).

As presented in Figure 6 and according to the aspect ( $l/w$ ) ratio (Table 1), three main ground plan types could be recorded, concerning:

- Long rectangle (aspect ratio  $\geq 3$ ): Arnaia (1931), M. Panagia (1932), Neochori (1947), Ouranoupolis (1951), Gomati (1952), N. Roda (1956)
- Regular rectangle (aspect ratio 2–3): Arnaia (1871), Ierissos (1950), Pyrgadikia (1951), Varvara (1956)
- Wide rectangle (aspect ratio  $< 2$ ): Stratoniki (1904), Varvara (1909), Palaiochori (1922).

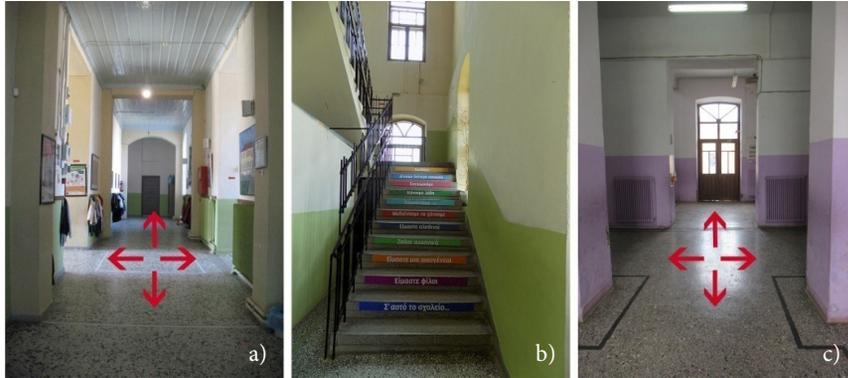
Figure 7. Figures of the inner space of stone schools: a–b) Arnaia, 1931. The elongated corridor of the ground floor, connected with the transversal one; c) M. Panagia, 1932. The transversal corridor of the ground floor (leading to the main entrance), connected with the elongated one (source: author)

a transversal central corridor (with the central entrance) that led to the director's office. In larger buildings, classrooms were put across an elongated corridor (located in the back side) and bilateral to the transversal corridor that led to the main entrance (Figure 6b, 7a, 7c). In case of a second floor, the stair case was put on the backside of the building (Figure 7b). Generally, there was a symmetric organization of the floor plan in both the elongated and vertical axis.

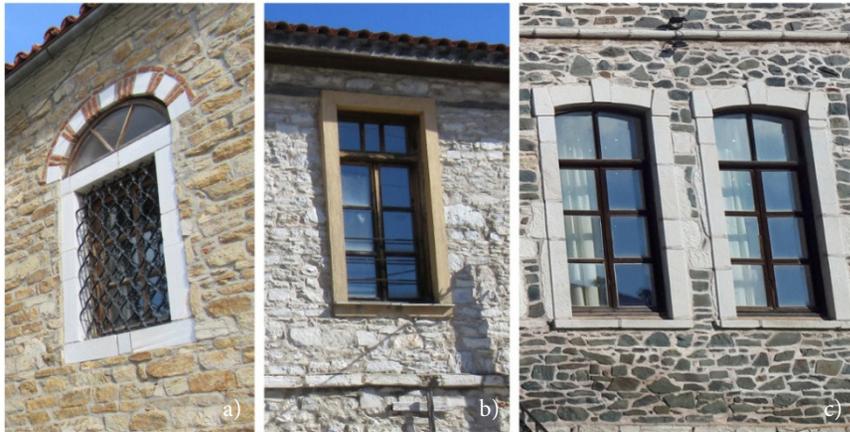
Figure 8. Openings' types of the stone schools: a) Arnaia, 1871; b) Varvara, 1909; c) M. Panagia, 1932 (source: author)

The openings were symmetrically put in the façades, depicting the inner organization of the spaces, according to relevant studies (Martinez-Molina et al., 2017; Perrone et al., 2020). Their dimensions ( $h \times w$ ) could vary ( $1-1.25 \times 1.5-2.4$  m) and their shape were either rectangular or slightly arched (Figure 8). In other cases, an arched relief existed beyond the window, as in the case of Arnaia (1871) (Figure 8a) (Pachta et al., 2021). Their type, dimensions, as well as their in-between distance were stable in each façade. They were usually decorated with a perimetrical frame, made of stone (Figure 8a, 8c) or mortar layers (Figure 8b) that also ensured their form and stability.

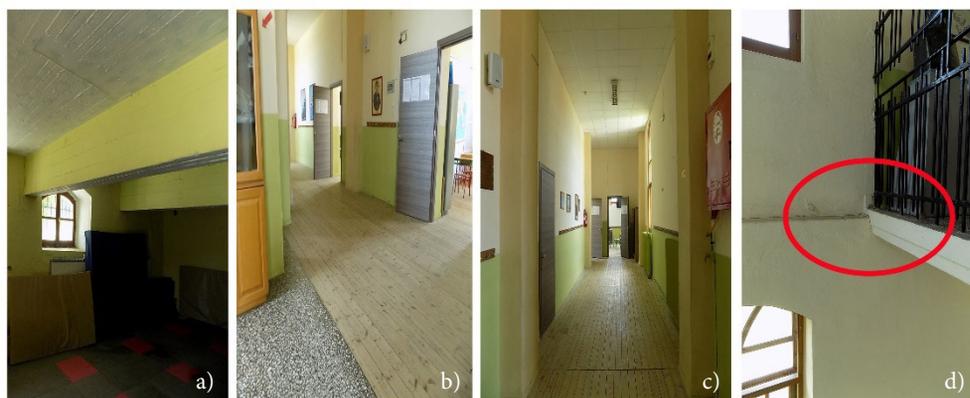
Figure 10. Constructional aspects of the stone school in Arnaia, 1931: a) Concrete slab and beams of the ground floor (image from the basement); b) Concrete slab part and wooden floor of the 1<sup>st</sup> floor; c) Consecutive pillars of the 1<sup>st</sup> floor; d) Setting of the 1<sup>st</sup> floor concrete slab on the wall recession of the ground floor (source: author)

In these cases and until the end of the 60's, the slab of the ground floor was made by reinforced concrete, directly supported on the masonry walls of the semi-basement. Underneath, consecutive concrete beams, ordered width-wise the ground plan, supported the structure (Figure 10a). The slab was covered with the traditional polished cement mosaic (Figure 7), found in many contemporary or posterior buildings (Abreu Marques et al., 2015; Perrone et al., 2020; Pachta & Papayianni, 2017, 2019). In the earlier examples of Arnaia (1931) and M. Panagia (1932), the concrete slab of the ground floor was extended only in the corridors, while the classrooms' floor was made of wood. The staircase was also made of reinforced concrete (Figure 7b), as well as a small part of the 2<sup>nd</sup> floor's corridor (the rest was made of wood) (Figure 10b). In the masonry walls, consecutive pillars extending throughout their whole height enhanced constructions (Figure 10c). They were symmetrically put in the external, as well as

The thickness of both the external and internal walls was reduced throughout their height: the external ranged from 70–85 cm (basement), to 65–75 cm (ground floor) and 50–60 cm (first floor) and the internal from 60–75 cm to 60–70 cm and 50–55 cm respectively. The external walls' recession, throughout the building height, visible in the part of the staircase, is presented in Figure 10d.

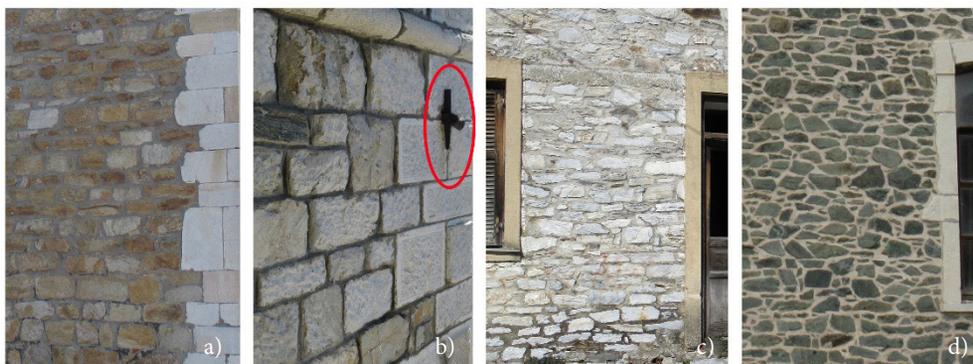
Figure 11. Masonry types of the stone schools: a) Arnaia, 1871; b) Stratoniki, 1904; c) Varvara, 1909; d) M. Panagia, 1932 (source: author)

Semi-ashlar or rubble masonry prevailed with semi-shaped or angular stones of local origin (Figure 11). Their size varied (10–20×20–40 cm) and their origin was mainly calcitic or igneous (Figure 11). The joints' thickness also varied from 2 to 4 cm (according to the masonry type) and probably referred to lime-based mortars, according to former research work (Pachta & Papayianni, 2016, 2017; Papayianni et al., 2016). Externally, especially in the case of rubble masonry, the walls were rendered with successive mortar layers, whose thickness was reduced to the surface, while in the internal, all walls were plastered.

External walls were usually connected with horizontal metallic beams that run throughout the side length. In some cases, external metallic joints were observed in each floor level (Figure 11b).
