# DIAGNOSIS, MANAGEMENT, AND TREATMENT OF A HERITAGE-BUILT ENVIRONMENT IN SOUTH CHILE

**Keywords:** diagnosis assessment, built environment, heritage, timber buildings, South Chile.

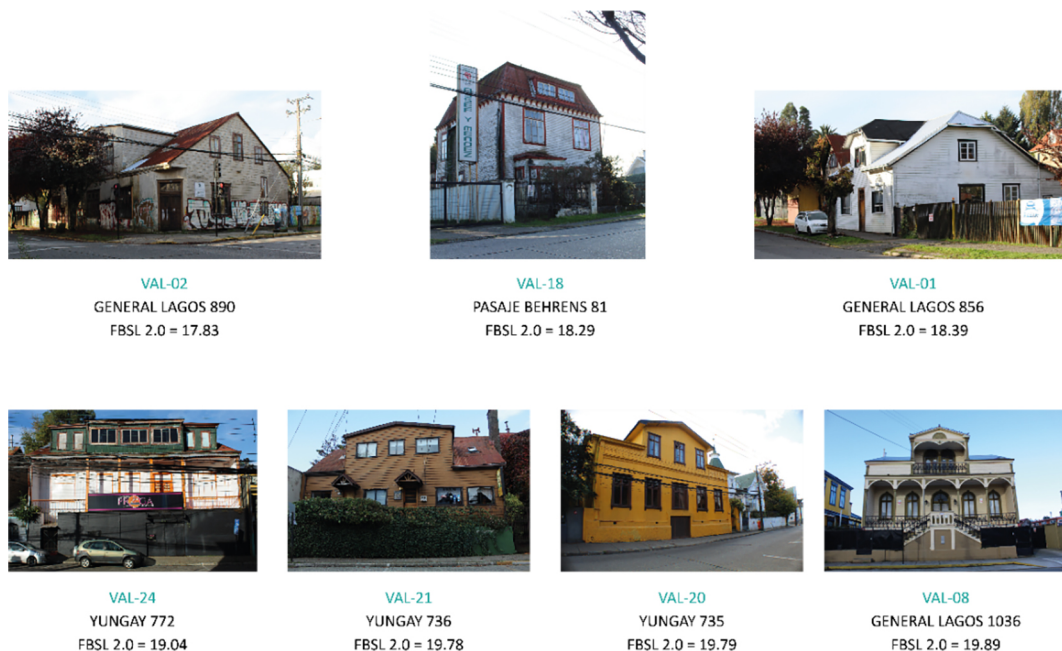
Figure 7. Study cases in functionality condition C

In the seven cases in Condition C, there were at least two anomalies of the type of loss of integrity, including type AB2 (breakage of elements and/or joints), found mainly in frames of openings, cornices, and ornamental elements; and AB10 (material oxidation, pathology present

in galvanised tin cladding and mansards or lofts). In addition, the presence of anomalies of the aesthetic type was observed, such as AA2 (wear or detachment of the last layer, damaged paint) and AA3 (graffiti present mainly in buildings with the presence of a plinth).

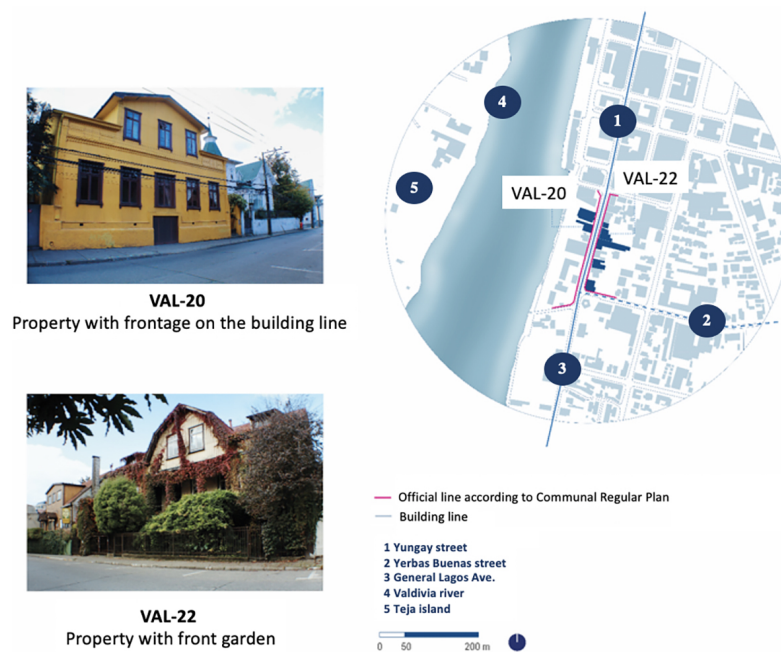
Figure 9. Façade alignment study

served that the percentages of alignment varied depending on the study area. For example, on General Lagos Street, in Zone 1, we found percentages between 20% and 70%, the optimum being 70% alignment and the most unfavourable being 20%. In Zone 2, we found even more diverse percentages, such as some cases with alignment that reached 100% and others with very unfavourable alignment, at 13%, due to the zone being located in the historical centre of the city (Figure 9). This great variability between the percentages of façade alignment is due to the existence of front gardens, as the current regulations of the PRC indicate that in the Zu-7a zone (Typical Zone; Illustrious Municipality of Valdivia, 2004), located on General Lagos Street, the front gardens must be at least 5 m to new constructions (Table 6).

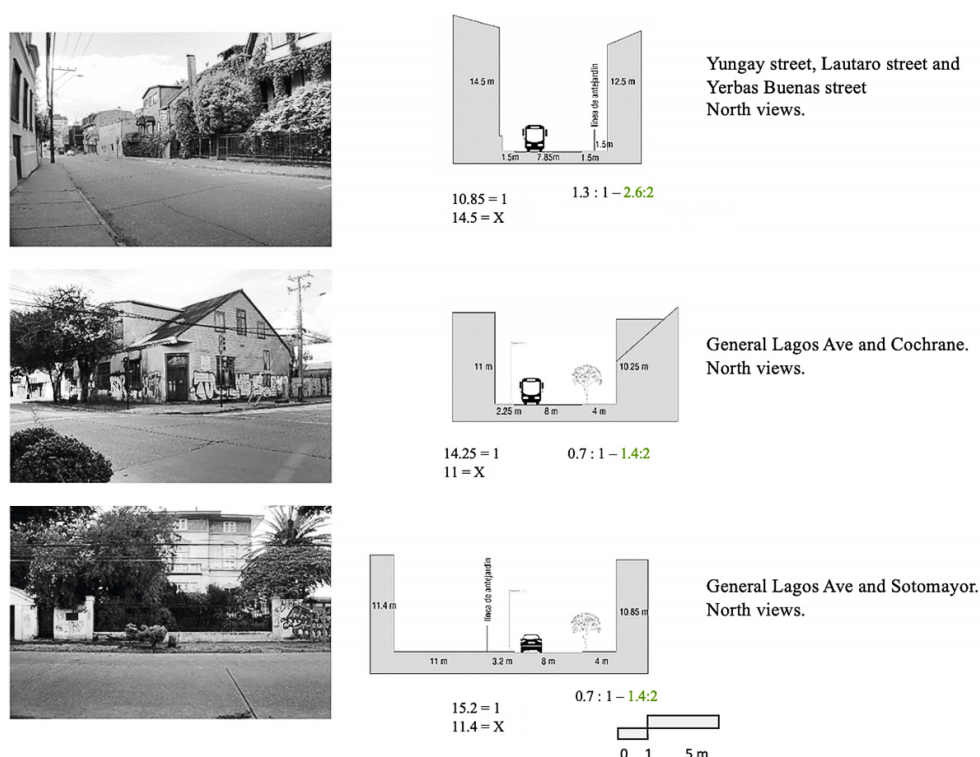
Figure 10. Radio study of height vs. width of street, Zone 1

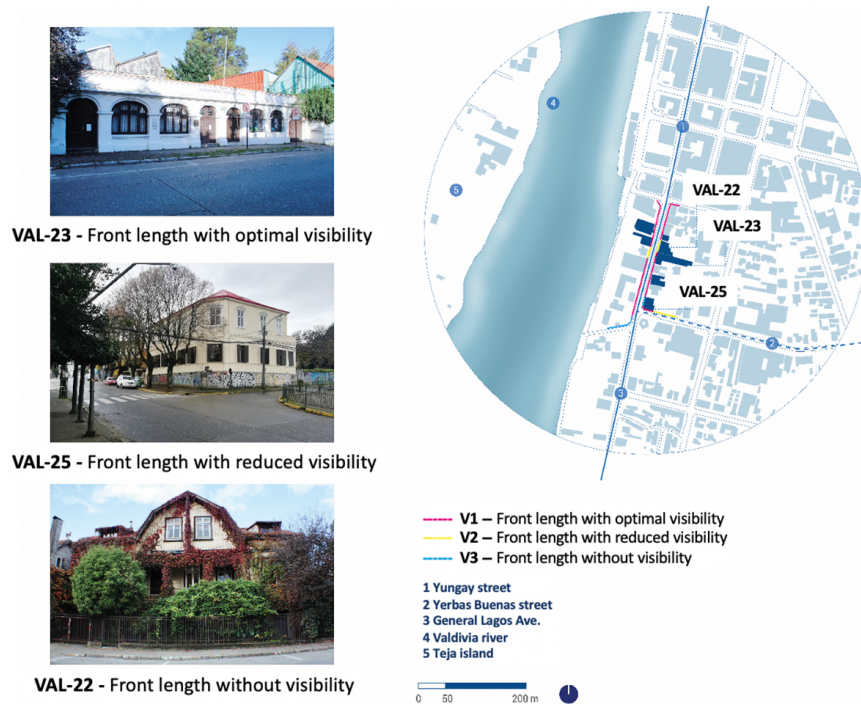
Figure 11. Façade visibility index

Subsequently, an analysis of the six study areas was carried out, from which we obtained positive results. In the blocks studied on General Lagos Street, indices with values between 0.80 and 1 were found, showing that, in general, the properties present a positive relation of visibility with their spatial environment. There were some exceptions, with values close to 0.4; however, these were isolated cases. Most buildings with a V2 classification and a front length with reduced visibility had a visibility index of 0.80. This classification responds to the existence of important spaces of front gardens or vegetation in front of the road, which reduces its visibility from the opposite edge, especially observed on Yungay and General Lagos streets.
