## A MONUMENT OF HISTORICAL HERITAGE – VILNIUS ARCHCATHEDRAL BELFRY: THE DYNAMIC INVESTIGATION

Romualdas Kliukas<sup>1</sup>, Rimantas Kačianauskas<sup>2</sup>, Arūnas Jaras<sup>3</sup>

**Keywords:** dynamic analysis, building structures, historical heritage, dynamic load, response spectra, bells, experimental measurements.

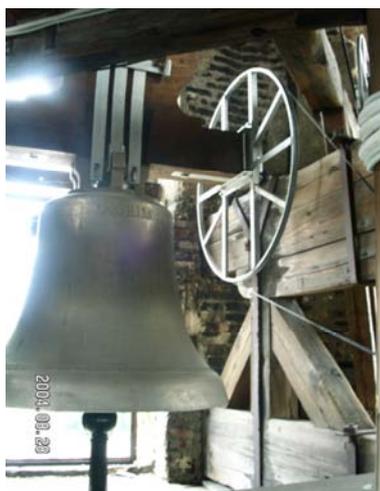
Fig. 3. The biggest bell "Joachim" and its wooden support

This paper focuses on the operation of the bell system installed during the last reconstruction in 2002. The new bronze bell system, including 6 massive bells, was placed at the sixth floor level of the Belfry, 26 m above the ground level. The new bells were provided with 3 supporting frames, located at an angle of approximately  $60^\circ$  to each other (Fig. 4). Each frame carries two bells. The balance of the bells is upset by electric motors and they begin to swing about a horizontal carrying axle until hitting against a vertical bar and starting to ring (Fig. 3).

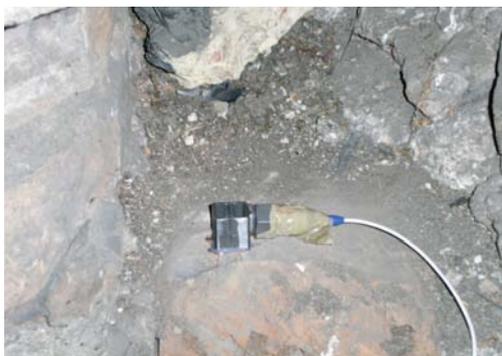
Fig. 5. Accelerometer in the working position

The directional vibrosensors were rigidly fixed to the structural elements of the Belfry, according to purposeful layout schemes (Fig. 5).
