VEGETATION CHANGE IN ROAD SLOPES IN THE MEDITERRANEAN REGION OVER 25 YEARS

Álvaro ENRÍQUEZ-de-SALAMANCA

Supplementary Material-S1: Photographs

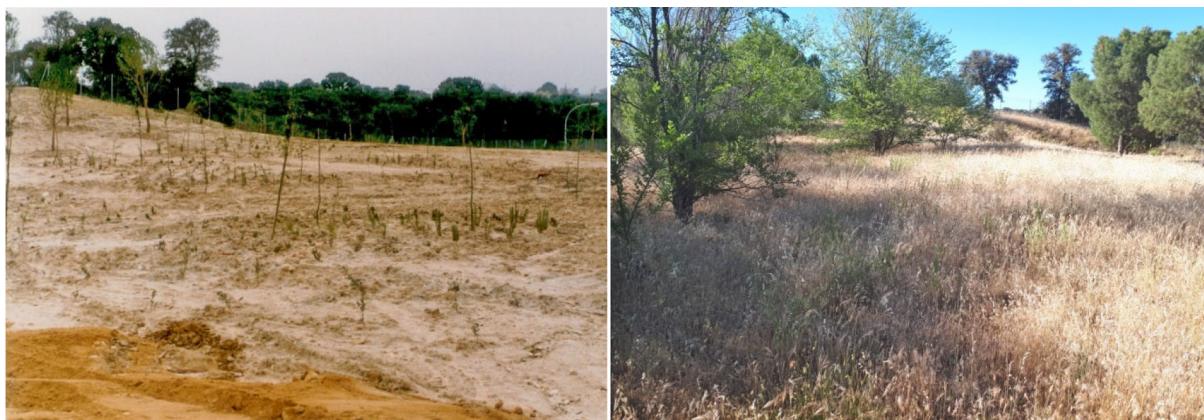
Figure S1. M40 motorway. Soil filling (false tunnel). Left: 1995. Right: 2019. Left trees are *Ulmus pumila*, not planted

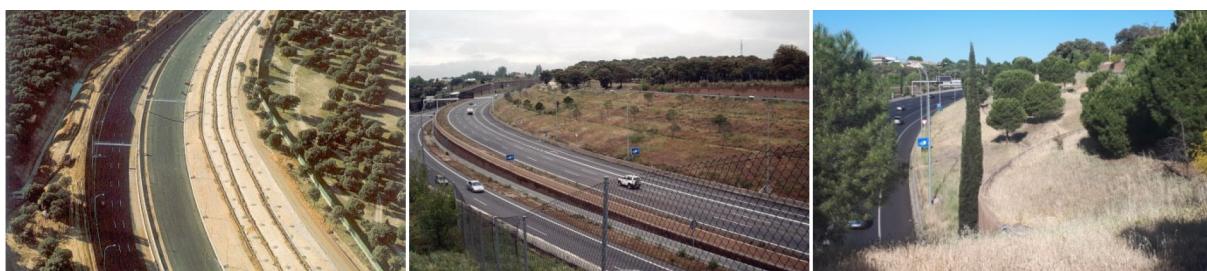
Figure S2. M40 motorway. Cutting. Left: 1994. Centre: 2002. Right: 2019. The slope is frequently mown, making impossible the development of shrubs, and limiting the natural evolution of the slope

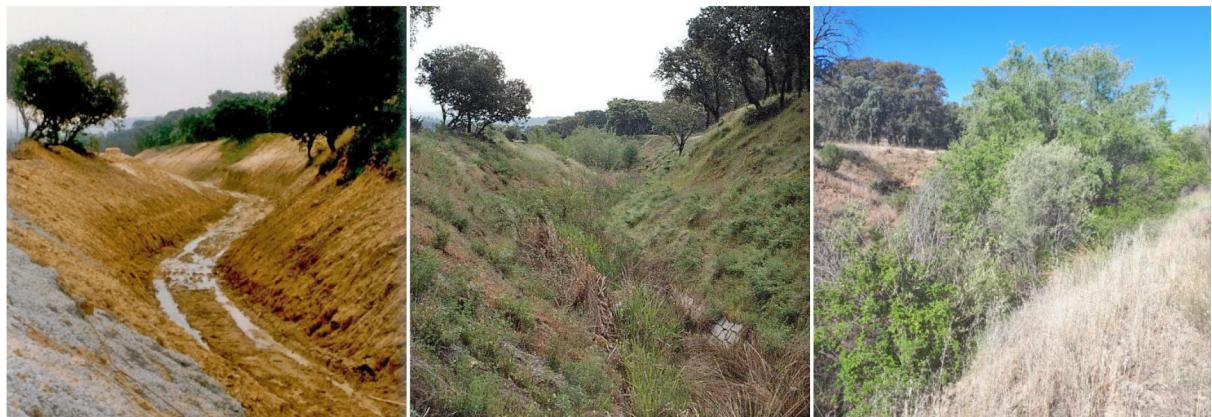
Figure S3. M40 motorway. Creek channelled during road construction. It was revegetated like the roadslopes, with topsoil, hydroseeding and plantations. Left: 1994. Centre: 2002. Right: 2019

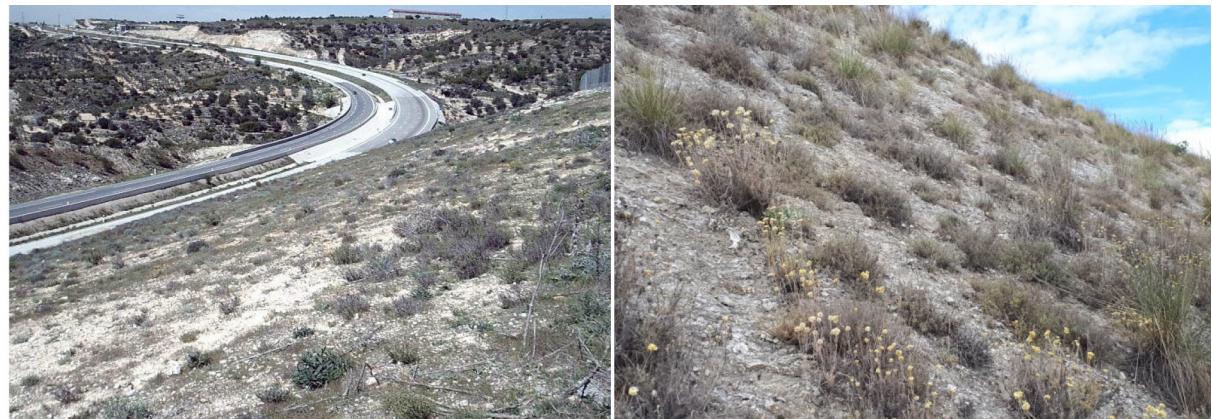
Figure S4. A3 motorway. Gypsum cutting. Left: 2002; part of the vegetation are ruderal species. Right: 2019; gypsophilous scrub

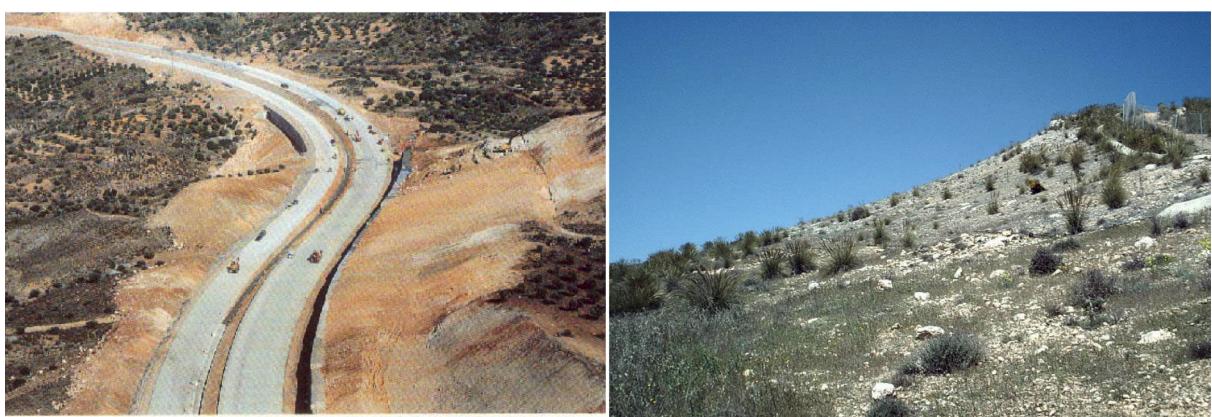
Figure S5. A3 motorway. Calcareous cut (limestone and marls). Left: 1993. Right: 2002

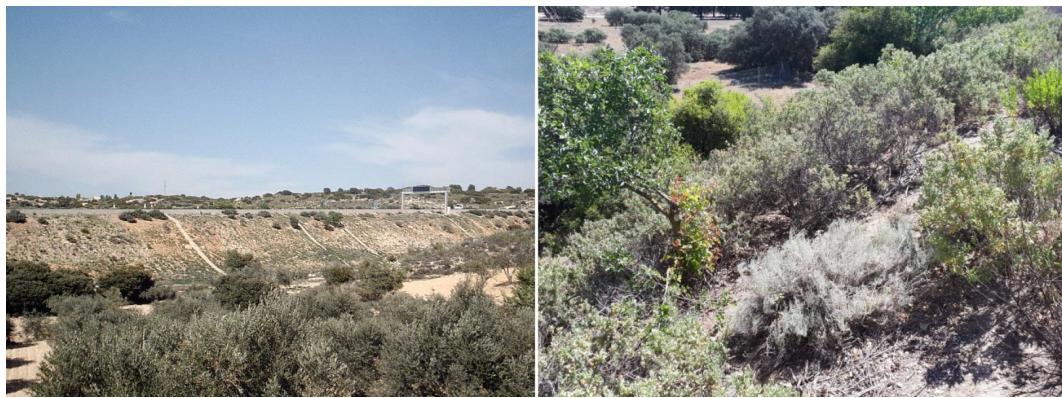
Figure S6. A3 motorway. Embankment in calcareous terrain. Left: 2002. Right: 2019.
All the woody cover came from plants introduced during revegetation

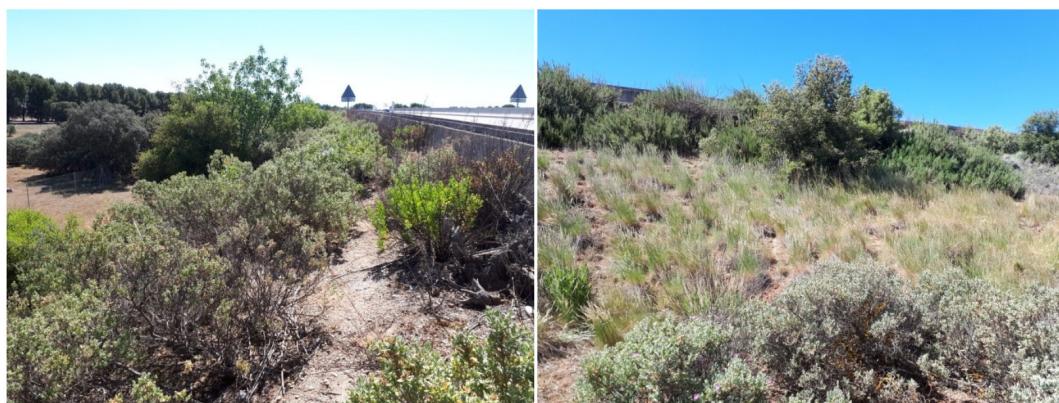
Figure S7. A3 motorway. Embankments in calcareous terrain (2019).
All the woody cover came from plants introduced during revegetation

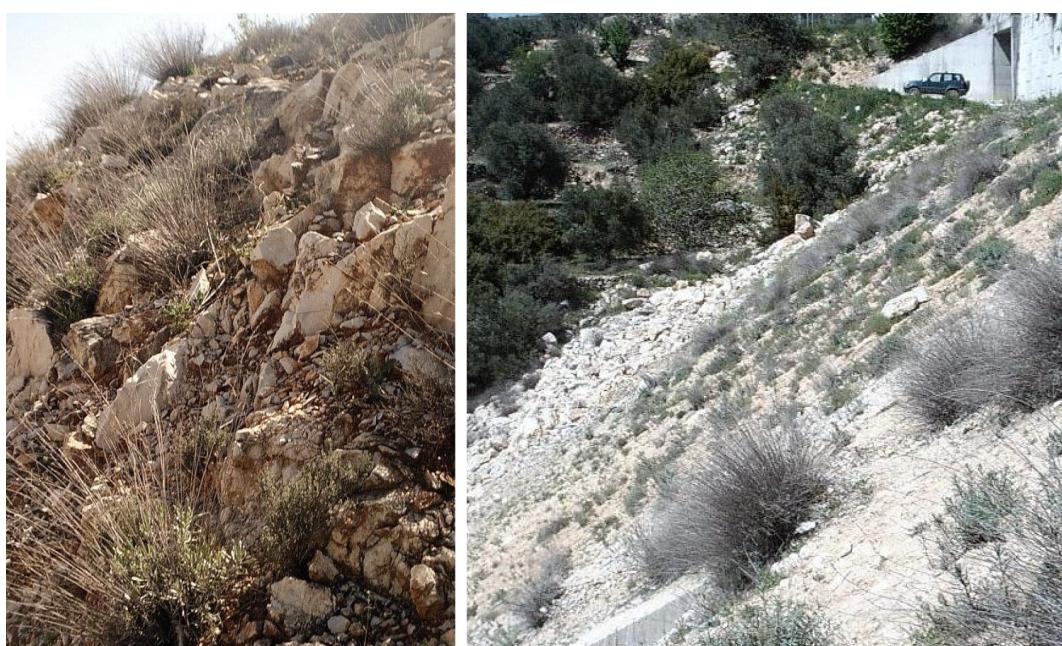
Figure S8. A3 motorway. Left: Rock cutting (2002); the plants observed are *Lavandula latifolia*; seed of this species was included in the hydroseeding, which has allowed the colonization of the slope.
Right: Rock embankment (2002)

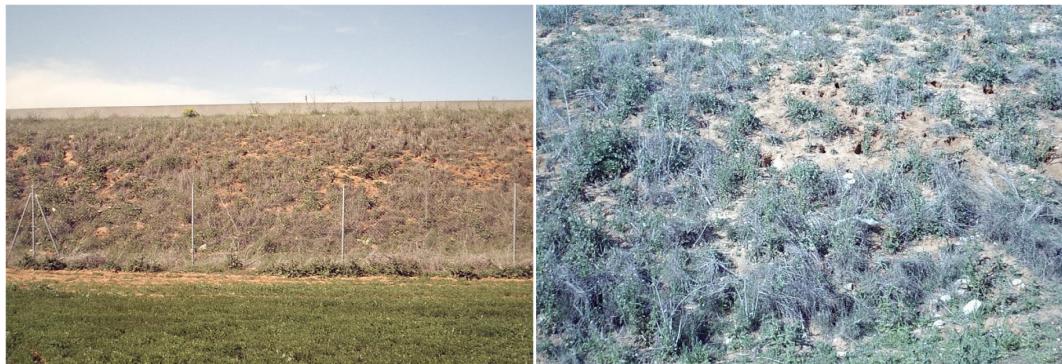
Figure S9. A3 motorway. Rabbit warrens in embankments (2002) may produce a significant loss of herbaceous cover

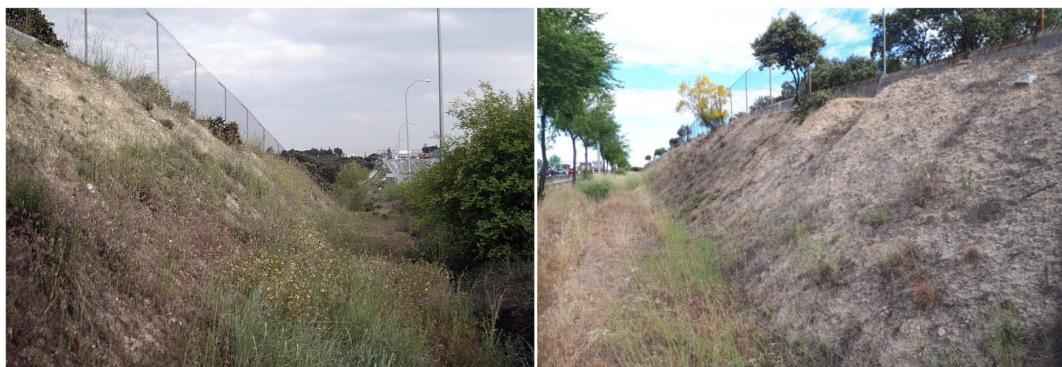
Figure S10. A6 motorway. Cutting in arcoses. Left: 2002. Right: 2019. The evolution has been regressive

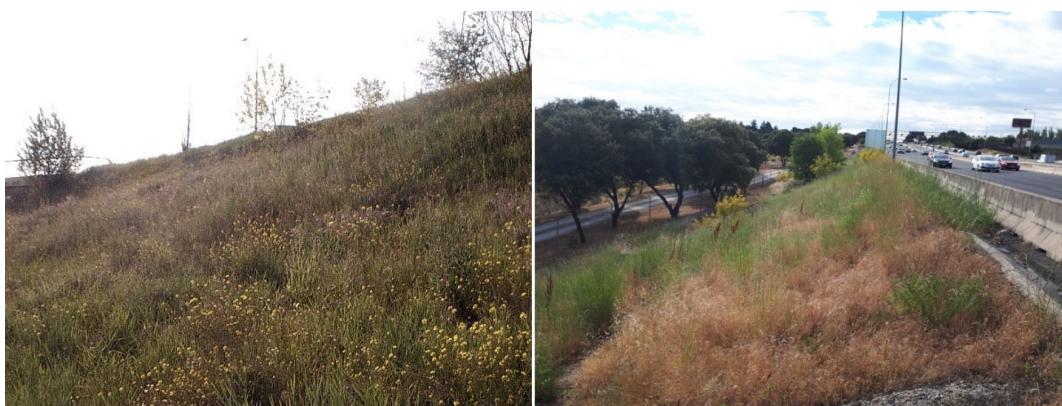
Figure S11. A6 motorway. Cutting in arcoses. Left: 2002. Right: 2019. The evolution has been regressive

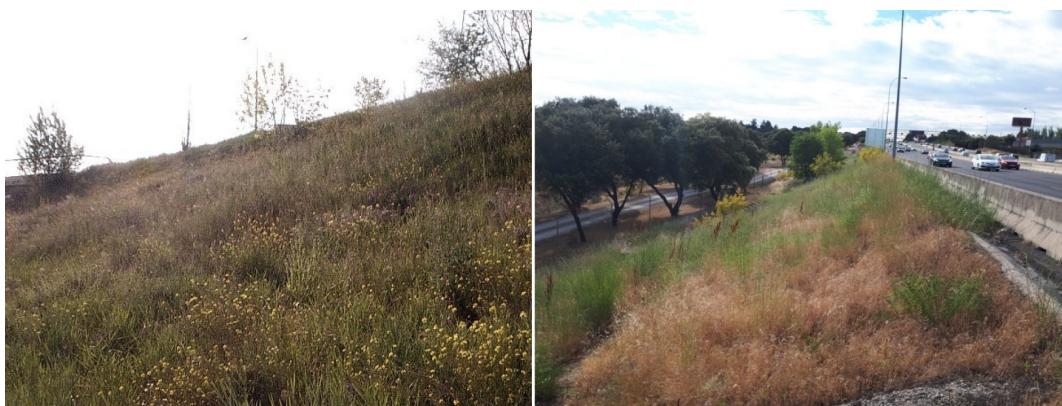
Figure S12. A6 motorway. Embankment in arcoses. Left: 2002. Right: 2019. The situation is quite similar

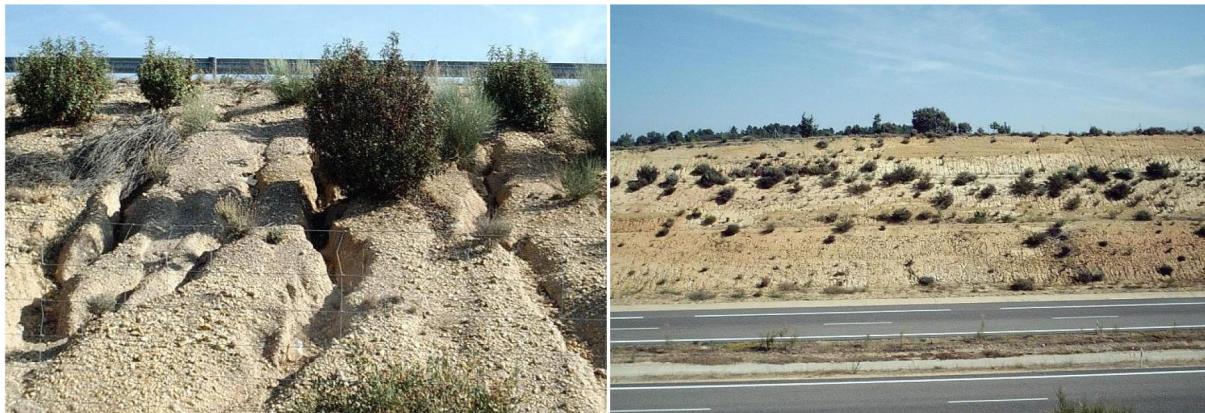
Figure S13. A52 motorway (Zamora, NW Spain, 2002). The slopes have been planted, but not hydroseeded. As a result, erosion problems are intense. Left: Embankment. Right: Cutting

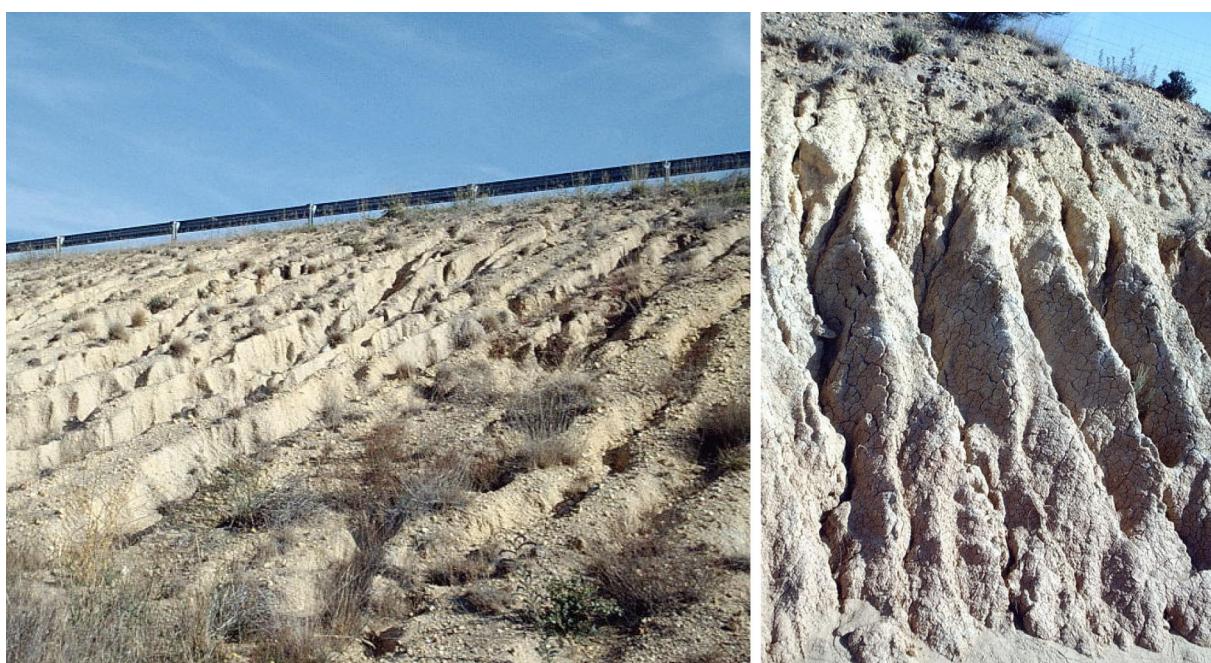
Figure S14. A52 motorway (Zamora, NW Spain, 2002). Erosion in slopes not revegetated. Left: Embankment. Right: Cutting

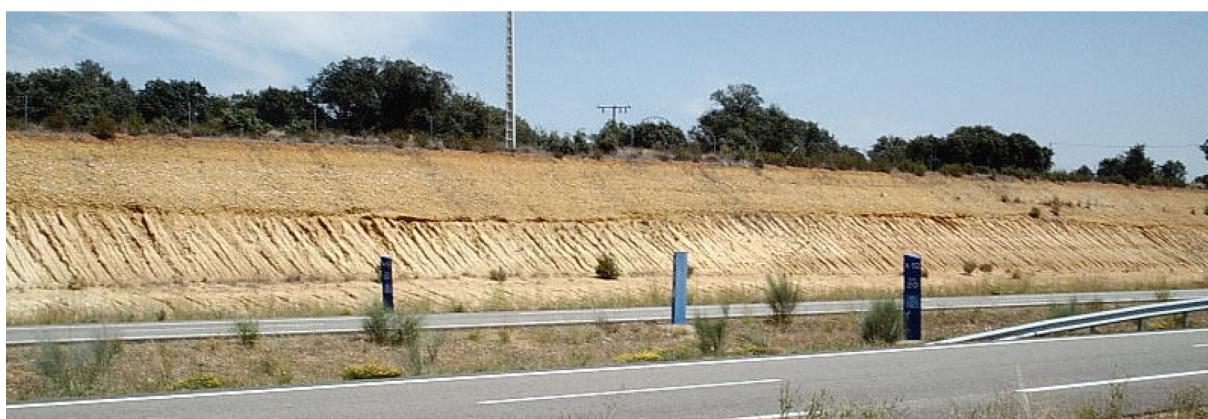
Figure S15. A52 motorway (Zamora, NW Spain, 2002). Differential erosion on a roadcut; the lower part is more eroded
