SUSTAINABLE RECOVERY PLAN FOR AN URBAN-RURAL COMMUNITY AFFECTED BY THE FUNDÃO DAM DISASTER IN BRAZIL

Abstract. The rupture of Fundão Dam spilled contaminated tailings across the Doce river basin, severely damaging municipalities such as the urban Barra Longa and the rural Gesteira. The wave of tailings led to the sediment deposition in rivers margins, causing the loss of riparian forests and cropping areas. Sediment analyses confirmed the presence of toxic compounds (sodium and ether amine) and a very low fertility. In consequence, there was a sharp decline in agro-pastoral production in Gesteira, leading to land abandonment and rural exodus. In the urban area of Barra Longa, the wave of tailings damaged the urban floodplain and the square, which were rehabilitated using grey infrastructure. Alternatively, we proposed a new landscape recovery plan for both Barra Longa and Gesteira based on Nature and Community-based solutions that contemplate the inclusion of green infrastructure, the remediation of toxic compounds, the restoration of soil fertility, permeability and stabilization, riparian forest rehabilitation and the recovery of agro-pastoral productivity, ultimately aiming at

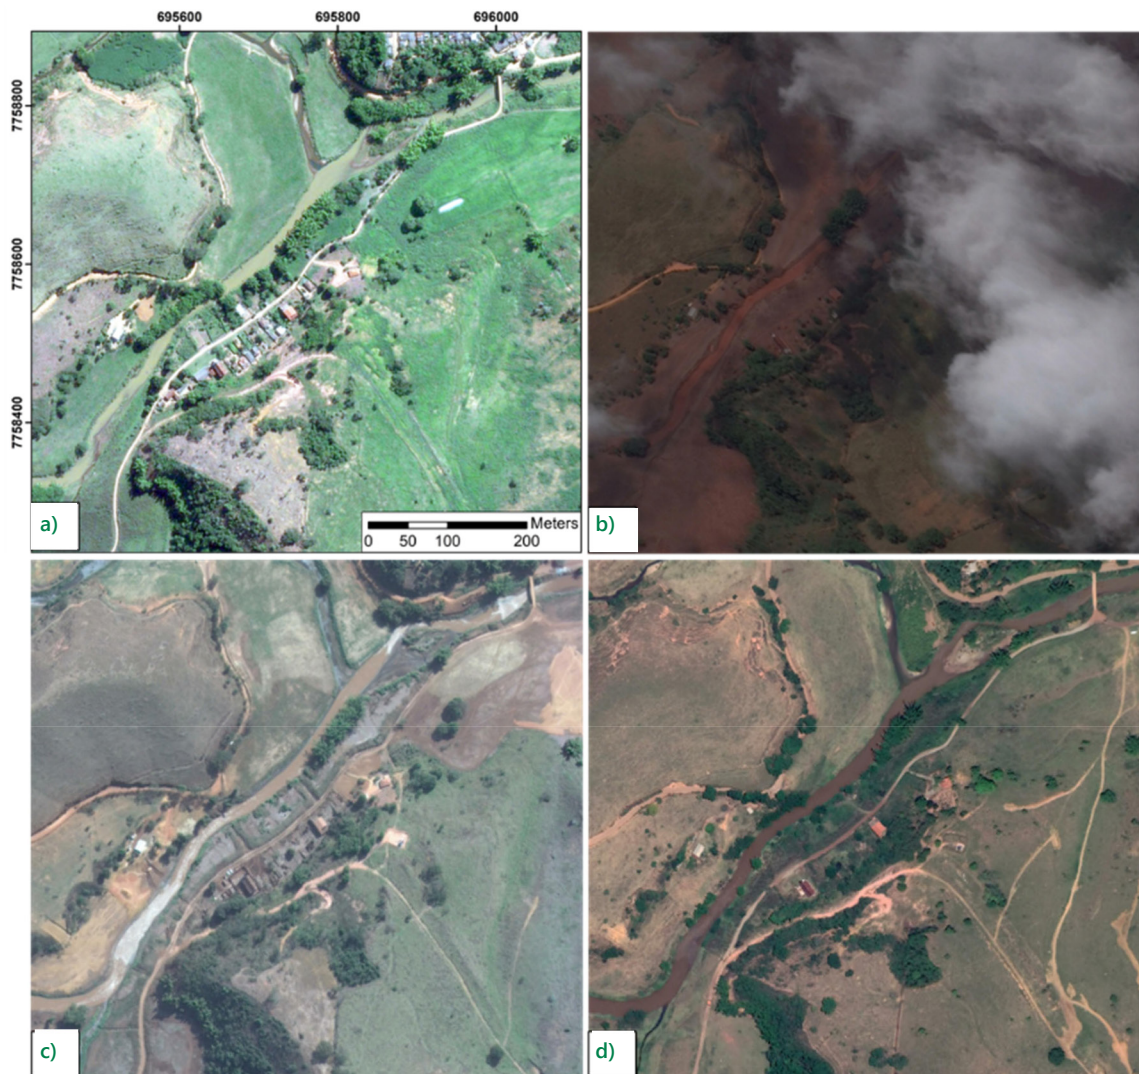
In the rural area of Gesteira, agricultural properties were located along the riparian zone of the Gualaxo do Norte River as observed in Figure 3a, before the disaster. After the dam rupture, around 20,480 m³ of sediment were deposited in this stretch of the Gualaxo do Norte River (Figure 3b). Similar to Carmo River, the sediment deposition in the margins of this river modified the fluvial dynamics with the formation and dislocation of sand bars (Figure 3d). However, the main impact in Gesteira was the massive loss of rural properties in this floodplain (Figures 3b–3d) as well as houses, schools and the Our Lady of Conception church built in 1891 (Jacobs, 2018).

Figure 3. District of Gesteira before the disaster (a) in July 2015 and after disaster (b) in November 2015; (c) August 2016 and (d) July 2020

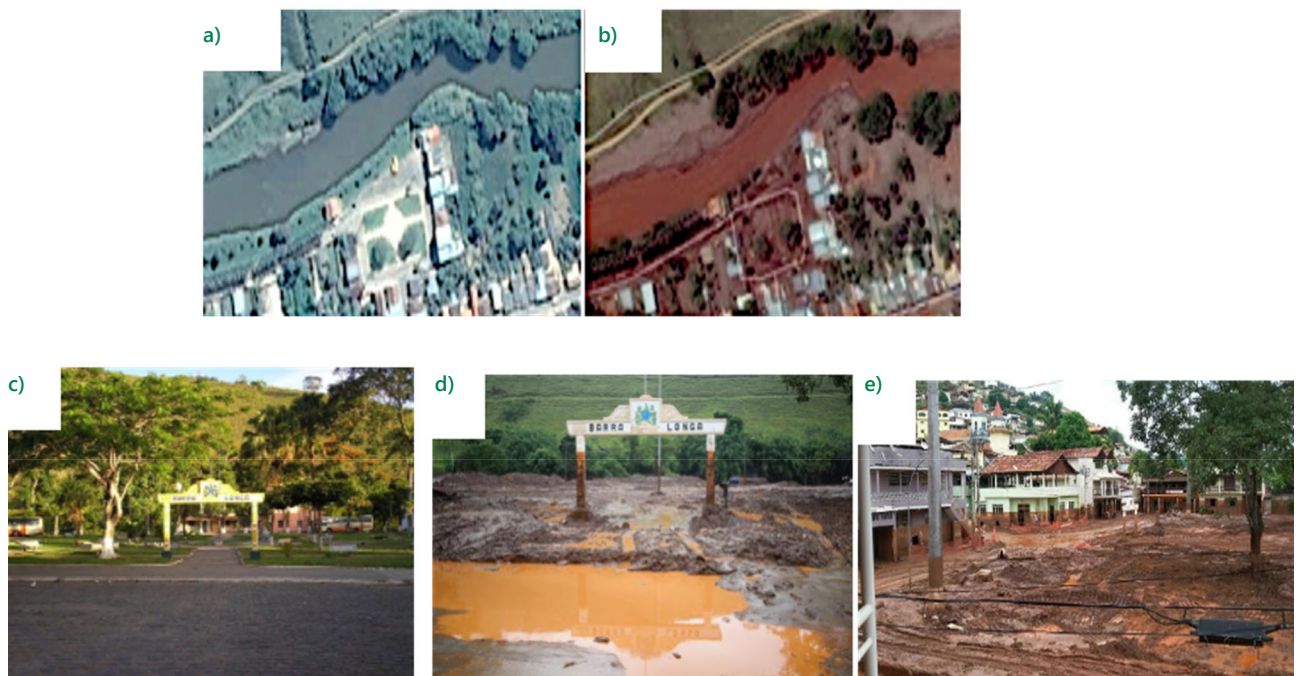
The riparian area of Barra Longa town was entirely covered by dam tailings from the Gualaxo do Norte River, which severely affected its main street (Beira Rio Street) and the main square (Manoel Lino Mol Square) (Figures 5a–5e). The Manoel Lino Mol Square was built in 1971 and constituted the major greenspace of the town with a high density of trees which provided shade and thermal comfort to this warm municipality whose annual mean temperature reaches 26 °C. It was the main leisure area of the town for social, sports and recreational activities (Figures 5a and 5c). However, the wave of dam tailings turned it into a devastating scenario of mud and stones (Figures 5b, 5d and 5e), with only a very few woody species remaining (Figure 5e).

Figure 5. Overview of square Lino Mol before (a and c) and after the Fundão Dam disaster (b, d and e) in Barra Longa municipality

Considering the wishes of the local community and environmental issues regarding the rehabilitation of the Lino Mol Square and floodplain by the Renova Foundation (Figures 6a, 6b), we present a new rehabilitation proposal. First, we propose to remove the grey infrastructure such as the wooden deck (Figures 6d, 6e) and the stone paving (Figures 6f), which should be replaced with greenspaces composed of riparian forests planted with Brazilian Atlantic Forest species as successfully demonstrated by Gomes et al. (2021, 2024). Such riparian forest should be created to form buffer zone systems to improve sedi-

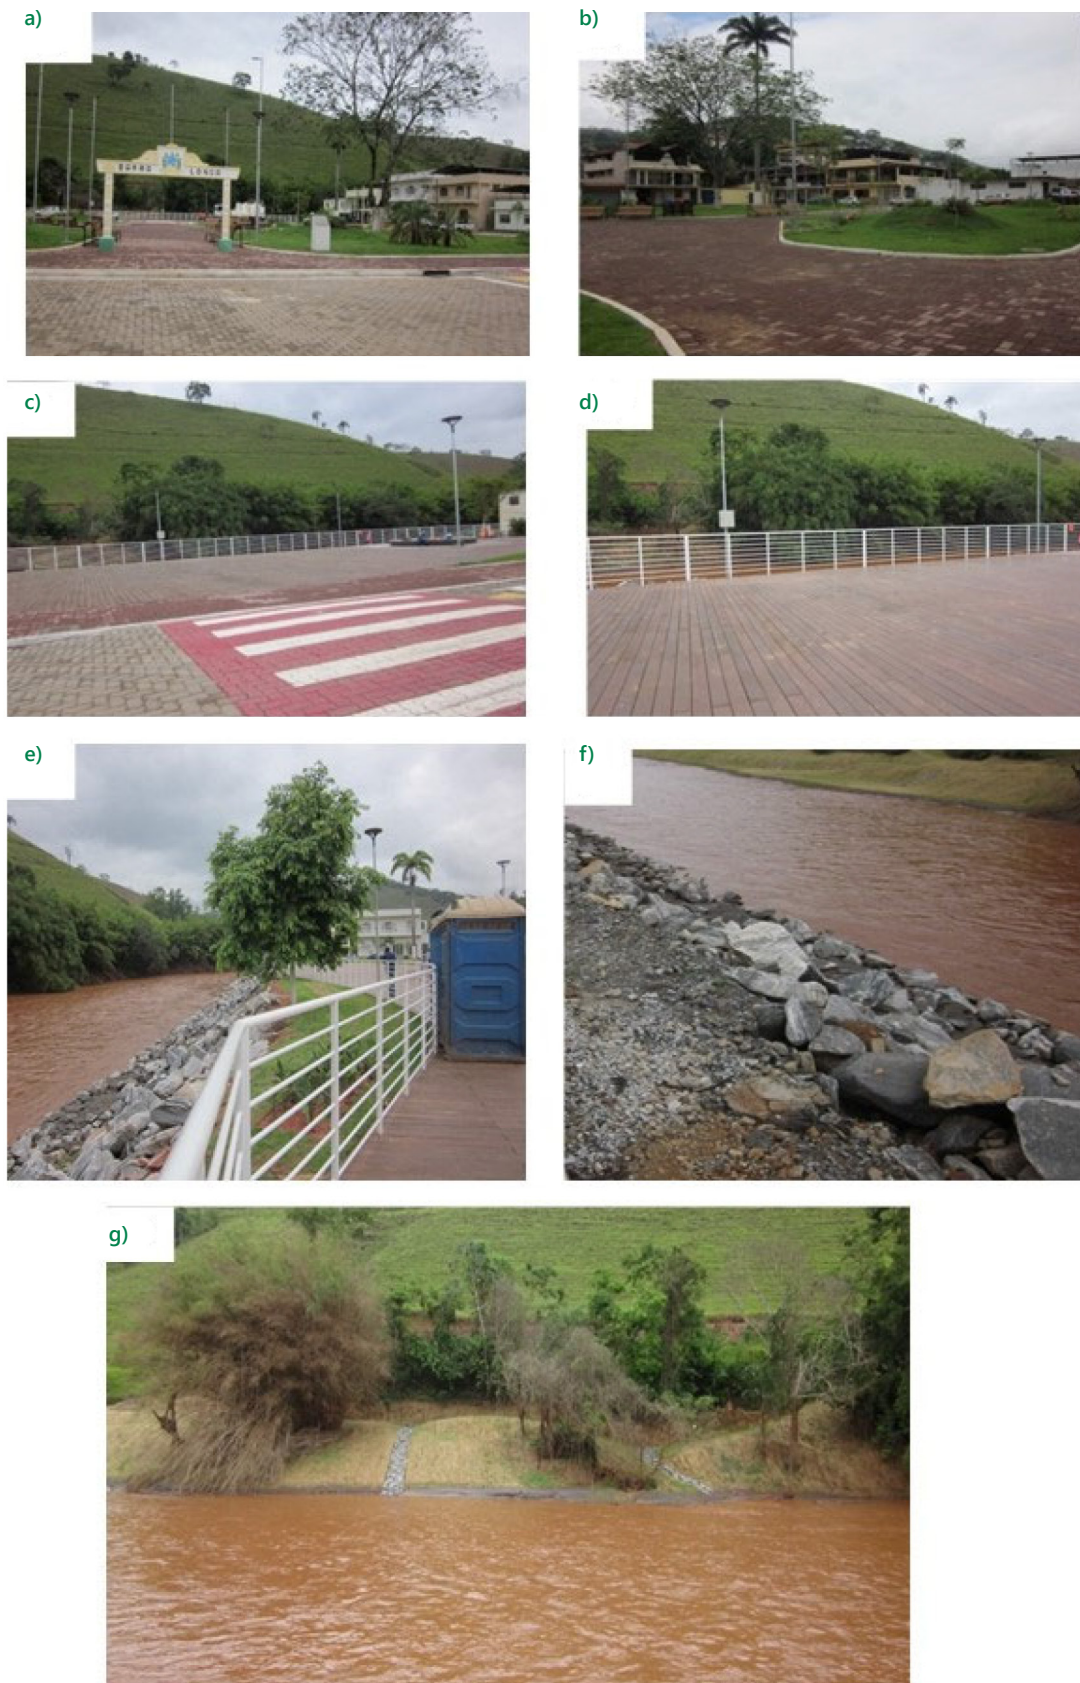
The Renova Foundation has re-constructed the Manoel Lino Mol Square (Samarco, 2017). This project retained a rectilinear design, and communal gardens were constructed with grasses and some shrubs (Figures 6a and 6b). However, the greenspace was greatly reduced to small gardens surrounded by a large area of grey infrastructure as the impermeable paving (Figure 6b). Metal chairs, lighting and gym facilities were installed, and a huge wooden deck was built, stretching from the square to the floodplain (Figures 6c–6e). The aspect of the new square most criticised by the local population was the marked reduction in greenspace, particularly the lack of trees, and its replacement with a large grey space, largely compromising

In addition, the riparian site was unadvisedly covered with wooden decking and stone paving, making the urban riparian area impermeable (Figure 6e). Also, the floodplain along the Carmo River in Barra Longa has been paved with stone (Figure 6f), covered with plant-derived fibre mats (Figure 6g) or even replaced with forest soils brought in from elsewhere (Silva et al., 2015). From the perspective of environmental best practice, such measures employed for flood risk management in Barra Longa are environmentally damaging since they increase the impervious surface, compromising the water dynamics and increasing the impermeability due to the increase of grey infrastructure in detriment of greenspaces (Hamlin & Nielsen-Pincus, 2020; Woodruff et al., 2020). In addition, the fibre blankets and mats used in the riparian rehabilitation procedures (Figure 6g) decomposed rapidly, not allowing the margin area to stabilise (Cordeiro et al., 2022). Such accelerated decomposition rates were attributed to the presence of N-compounds, such as ammonia (NH₃) or N-ammonium, derived from the biodegradation of ether-amines found at high concentration in the dam tailings (Santos et al., 2019), particularly in Gesteira and Barra Longa (Figure 4e).

Figure 6. Rehabilitation of the Lino Mol Square (a and b); coverage of the riparian area with a wood deck (c, d and e), stones (e and f) and plant-derived fibre mats (g)

ment stabilisation, drainage and, ultimately, flood control, as proposed by Kimura et al. (2017). The urban greenspace should also be changed by planting woody species in the Lino Mol Square communal gardens (Figure 6b) in addition to grasses with its branching roots since a balanced combination of trees, shrub and herbaceous species may provide the maximum ecosystem functions (Meraj, 2020) to urban greenspaces (Liu et al., 2018). Prior to both interventions, it is strongly recommended that the remediation strategies described in Scotti et al. (2020) and Gomes et al. (2021, 2024) should be adopted, to reduce ether-amine and sodium toxicity and guarantee tree cultivation success.
