## EXAMINING FAILURES IN RUBBER-CORD COUPLINGS WITHIN ER2 SERIES ELECTRIC TRAINS

Pavels GAVRILOVS<sup>✉</sup>, Dmitrijs GORBACOVŠ, Janis EIDUKS, Guntis STRAUTMANIS, Ali ARSHAD

*Dept of Railway Engineering; Faculty of Mechanical Engineering, Transport and Aeronautics; Riga Technical University, Latvia*

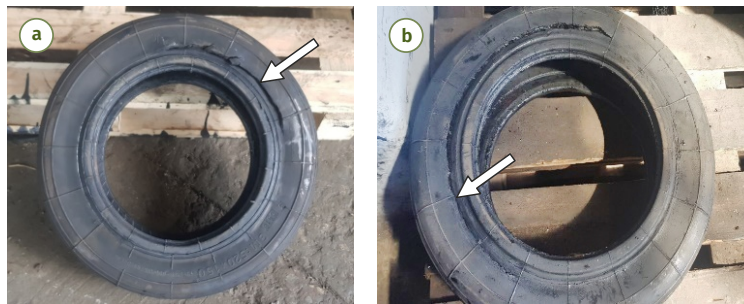
The results of a visual inspection of the failed rubber-cord couplings stated that the cause of a failure was a partial circular rupture of the side surface at the point of attachment to the flange on the traction motor side. This type of damage was found in approximately 10 rubber-cord couplings. Examples of coupling damages are shown on (Figure 4).

- removed from the motor car No 2022-02 (Figure 4a);
- removed from the motor car No 964-04 (Figure 4b).

Figure 4. Rubber-cord coupling damage:  
 (a) – motor car No 2022-02; (b) – motor car No 964-04

- at each scheduled repair, to inspect the rubber-cord coupling. If cracks or tears are found, to prohibit further use of this coupling;
- a prolonged operation of the rubber-cord coupling in the speed range from 0 to 5 km/h due to high torque, which can lead to unstable operation of the coupling, high centrifugal force and, as a result, lead to rupture of its side surface, shall be avoided;

- to reduce the number of failures of the rubber-cord coupling, it is necessary to consider measures to strengthen the side wall of the coupling with a layer of cord up to 10 layers instead of 8, and increase the thickness of the side wall of the rubber-cord coupling to 24...25 mm.

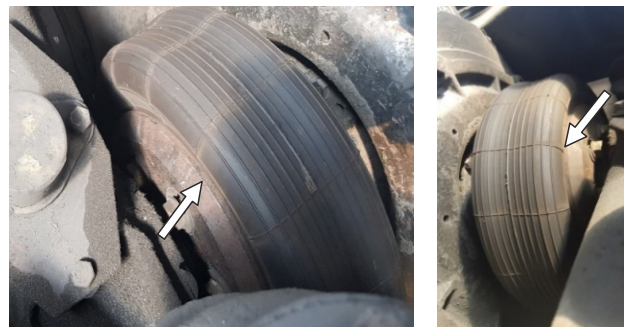
Another possible reason for the failure of the coupling is incorrect installation or incorrect adjustment of the inclination angle of the cord coupling during the type TR-3 repair. An example of incorrect installation of a rubber-cord coupling is shown on Figure 5 (arrows indicate an installation defect). Mileage from type TR-3 repair was 22742 km, defect detected during traction motor replacement on 08/12/2020.

**Figure 5.** Motor car ER2 991-02 – incorrect installation of the rubber-cord coupling

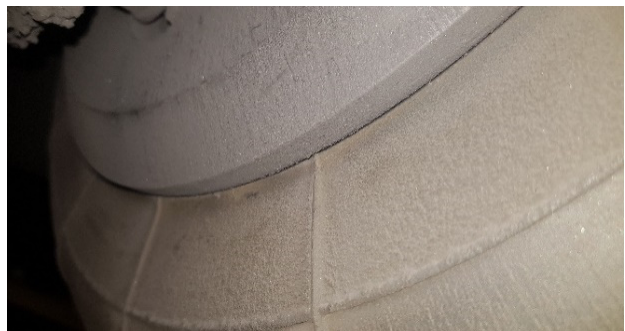
According to the results of a trial trip with the 50...60% occupancy of motor cars, the highest warming of the rubber-cord coupling of the 3rd wheelset was detected, which amounted to  $t = +43.1$  °C. It is possible that under more severe operating conditions, such as the maximum occupancy of motor cars and ambient air temperature, which is more than  $t = +30$  °C, then in these cases the temperature of the rubber-cord coupling can reach more than  $t = +60$  °C. Therefore the condition of not allowing warming of the coupling higher than  $t = +75$  °C is observed. Based on the results of temperature measurement and visual inspection of 12 rubber-cord couplings of the ER2 series EMU train No 1307, it was found out that there are signs of thermal aging, as well as in some places also the presence of small cracks on the side surface of the coupling (shown on Figure 6).

**Figure 6.** Motor car No 991-06, appearance of the coupling from the side of the traction motor

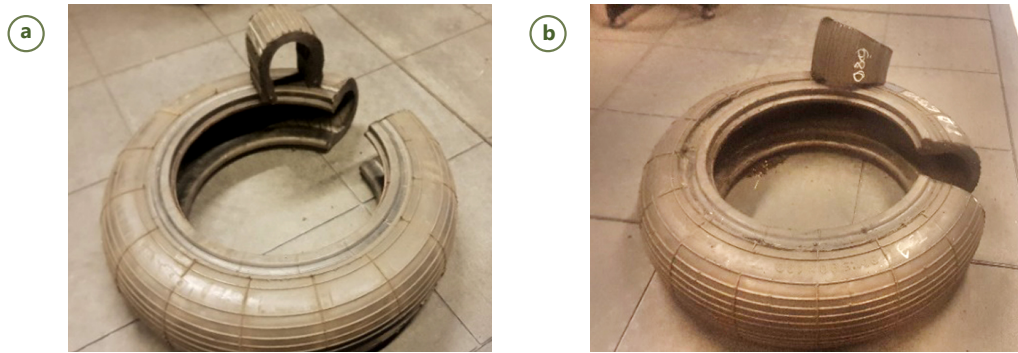
Stage 1 of the study consisted of determining the geometric dimensions of the coupling. To carry out this study, the rubber-cord couplings were removed from motor car No 2022-02 (Figure 7a) and motor car No 964-04 (Figure 7b) and fragments were cut out for research.

**Figure 7.** Preparation of the rubber-cord coupling for measurement:

(a) – motor car No 2022-02; (b) – motor car No 964-04

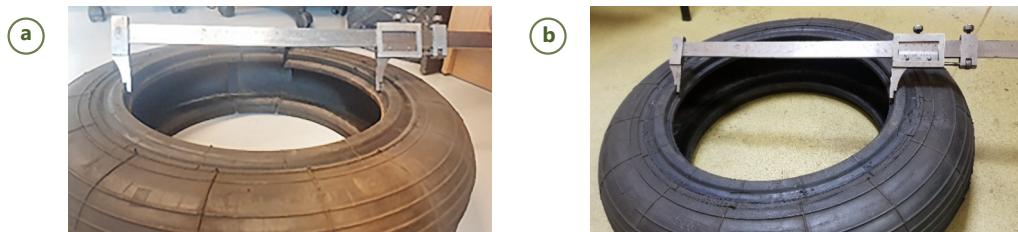
Measurements of the diameter of the outer surface of the coupling, the inner mounting surface diameter and the bead thickness were carried out using a calliper 0...550 mm with an accuracy class of 0.1 mm. The obtained measurement results were compared with the data of ISO 14691:2008 and are given in Table 4 and Figure 8.

**Figure 8.** Measurements of the internal fitting diameter of the couplings:

(a) – motor car No 2022-02; (b) – motor car No 964-04

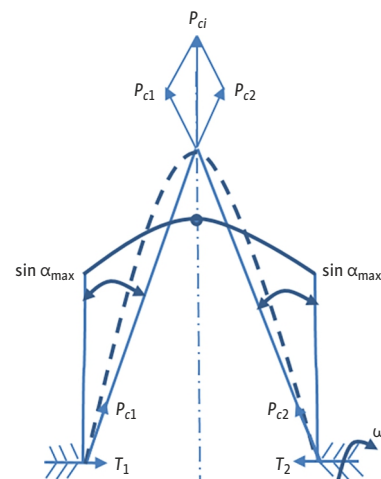
The high value of these forces can damage the rubber-cord coupling, graphic designation and moduli of the forces acting on the rubber-cord coupling are shown on Figure 10 (Savel'ev 1970).

**Figure 10.** The action of forces on the rubber-cord coupling

The value of  $\sin \alpha_{\max}$  was determined graphically taking into account the calculation of the centrifugal force, which increases with increasing speed (at a maximum speed of 120 km/h), graphically determined by the method  $\alpha_{\max} = 8^\circ$ ;  $\sin 8^\circ = 0.139$  (Figure 10).
