DAMAGE TO CONCRETE BRIDGES DUE TO REINFORCEMENT CORROSION. PART I. SITE INVESTIGATIONS

Zenonas Kamaitis

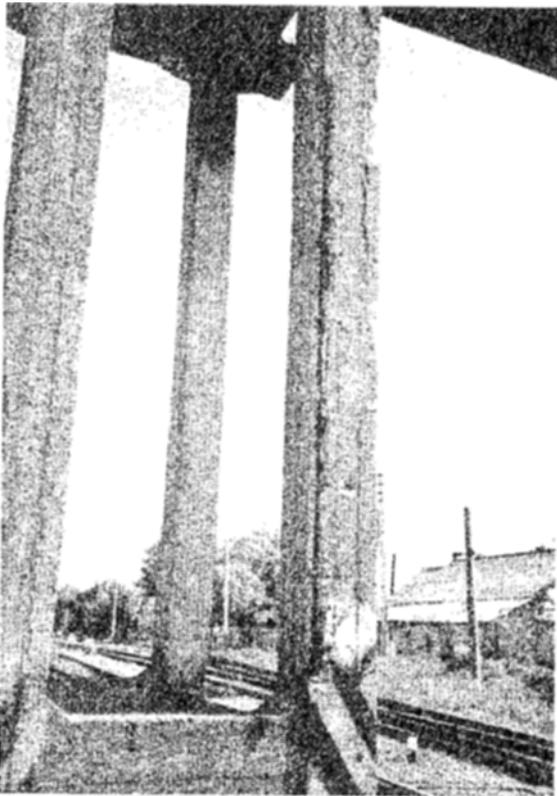
Fig 4. Corrosion of reinforcement of the multiple-column pier accompanied by cracking and deterioration of concrete cover

The measurements confirm that the placing of reinforcement often varies widely. In the investigated bridges poor control of cover was the most frequent cause of early corrosion of reinforcement (Figs 4 and 5). As it is mentioned above it is not uncommon to see delaminated and spalled areas even after few years of service.

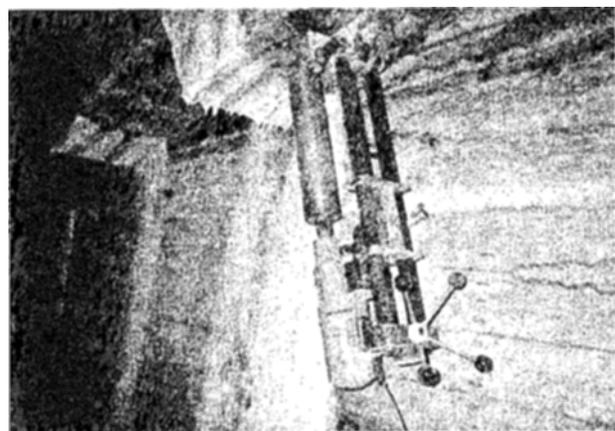
Fig 10. Special coring equipment for inspection of prestressed tendons and their ducts

The detection and evaluation of prestressed tendons condition were performed on existing pre-tensioned and two post-tensioned bridges after 16 and 23 years of service. In post-tensioned structures the inspection 60 and 100 mm diameter holes were drilled (Fig 10) and concrete samples were taken for laboratory analysis (Fig 11). It has been found that in the prestressed concrete precast post-tensioned bridge decks the voids and the water are often present in the ducts. The absence of grout in some parts

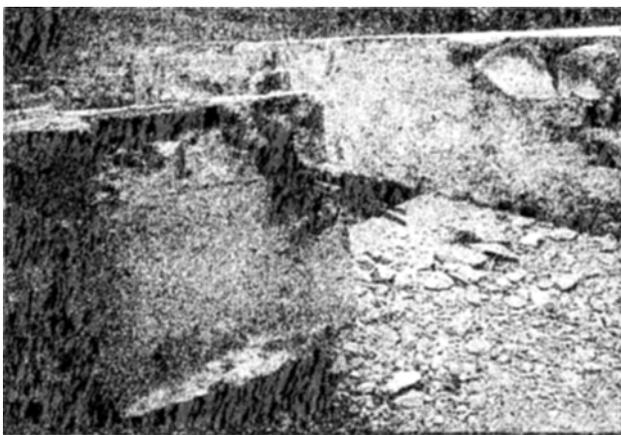
Fig 12. Rupture of bridge staircases due to corrosion of prestressed tendons

port of the UK decided no longer to permit any post-tensioned bridge with grouted duct tendons to be built [5]. In Switzerland three bridges were dismantled after 30 years (in 1992) of service due to significant corrosion damages [6]. Sudden collapse without prewarning of bridge staircases in Vilnius due to prestressed tendons corrosion and rupture can be mentioned (Fig 12).
