## MONITORING OF INTERACTIONS OF A MONUMENTAL HISTORICAL COMPLEX LOCATED ON AN EARTH EMBANKMENT

**Abstract.** The Camaldolese Monastery was built in the seventeenth-century on a man-made hill raised on a Wigry lake island in the north-eastern part of Poland. Over the following two hundred years, the Monastery buildings were subjected to destructive weathering processes and underwent significant demolition during the two World Wars. Subsequently, the complex was reconstructed and renewed. All the Monastery buildings were raised on two earth terraces varying in height from 6 to 8 m. The terraces were formed of crushed bricks and stone debris that filled up the underground structures built earlier. The hill is composed of different geotechnical layers and their influence on the stability of the whole hill, displacement and deformation of the buildings have been monitored. The results of the monitoring are presented in the paper. The thickness of backfilled soil layers varies from 1 to 5 m and an assessment of layer parameters is influencing the actual state and future renovation of the Monastery buildings. In 2004, the Monastery buildings were affected by dynamic forces of an earthqu

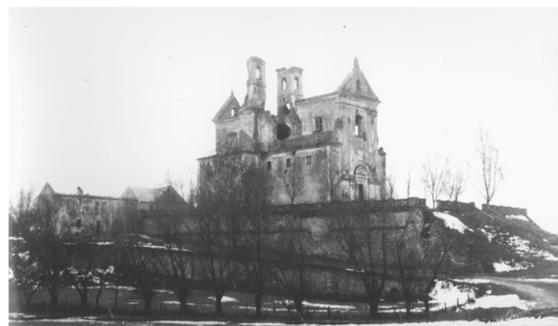
Fig. 2. Camaldolese Wigry Hill after the World War I

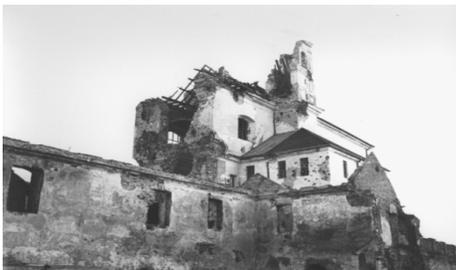
During the World War II, the reconstructed church building was destroyed again by artillery fire, which can be seen in Figure 3.

Fig. 3. The Church destroyed during the Second World War

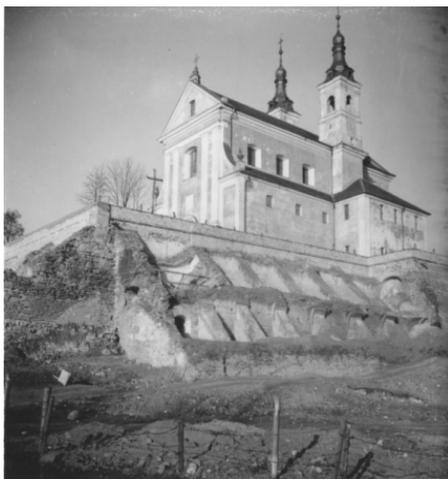
Fig. 4. The reconstructed Church and southwestern view of the retaining walls in 1967

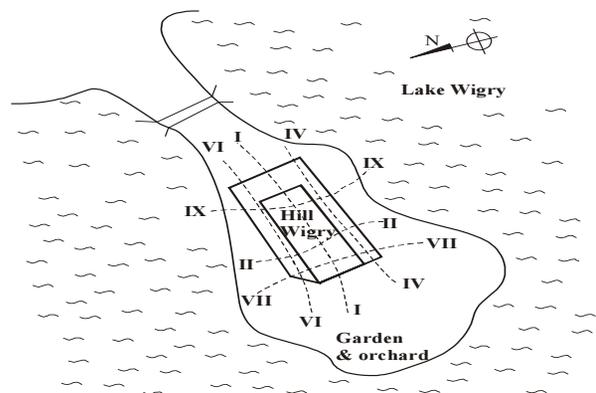
Fig. 5. Arrangement of sub-base investigation bore holes

Analysis of geologically multilayered substratum of the Hill was carried out by digging boreholes in accordance with a planned grid of holes and sections shown in Figure 5. According to the geotechnical reports, the upper substratum is formed by a backfill of low compaction especially in the top layers of the Hill.

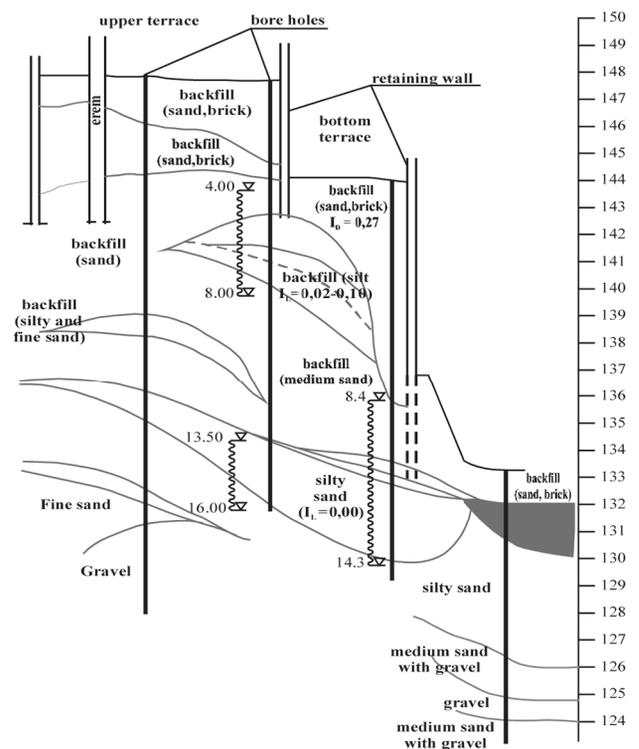
Fig. 6. Geological sections of the Hill

Some chosen sections of the substratum illustrating its laminated composite geology are illustrated in Figure 6.

Soil analysis, investigations and tests made it possible to conclude that the multi-layered substratum considered to have been a backfill was primarily composed of natural mineral sandy soil. Thus, it appears that the older, originally erected Monastery buildings were found

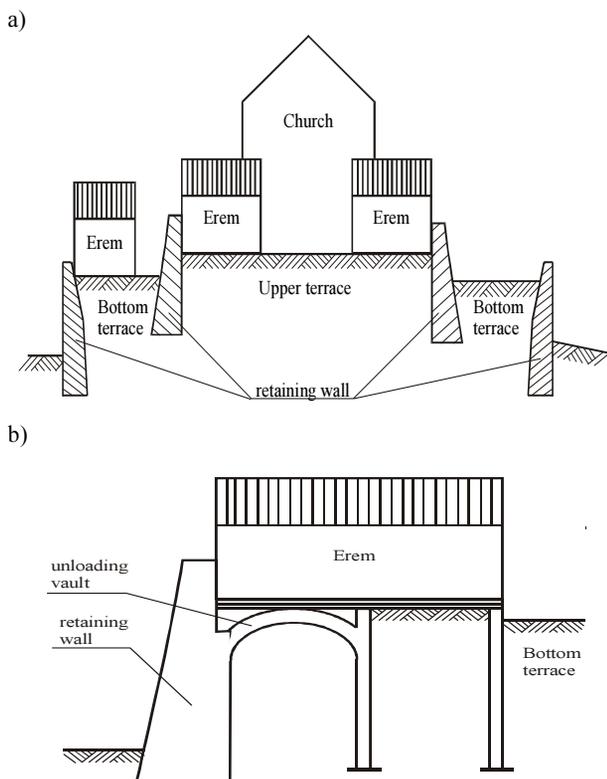
In the reconstruction process, the existing old foundations supplemented with new segments were used as required by the user. Unfortunately, the underground works, foundations, tunnels and retaining massive walls were reconstructed without required design and inventory works, which was discovered as a result of later investigations where all former underground structures were filled with crushed bricks and debris. Cross-section of the Wigry Hill and existing buildings are shown in Figure 7a, while the underground galleries are shown in Figure 7b.

Fig. 7. Cross-sectional diagram of the Hill: a) section for terraces with massive retaining walls; b) unloading sub-structures
