#### **ENGINEERING STRUCTURES AND TECHNOLOGIES**

# STRUCTURAL AND ARCHITECTURAL CHARACTERISATION OF OLD BUILDINGS STOCKS: CASE STUDY OF THE OLD CITY CENTRE OF SEIXAL, PORTUGAL, REBUILT AFTER THE GREAT 1755 LISBON EARTHQUAKE

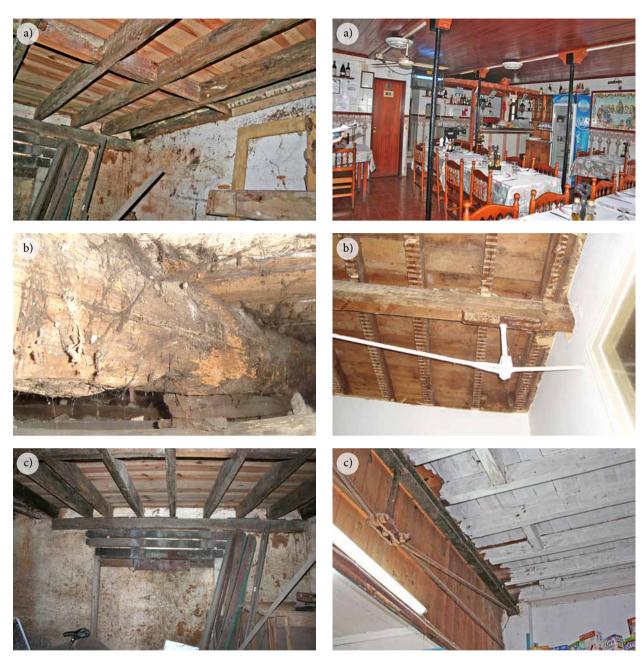
Fig. 7. Types of timber floors

Fig. 8. Original constructive solutions strengthened with metallic elements

Regarding the inspected floors, they were commonly constituted by parallel wood beams spaced about 40 cm to 60 cm (see Fig. 7). However, their cross sections were variable: elements with circular shapes of different diameters were usually associated with ordinary constructions whereas squared elements, with different levels of preparation according to the building characteristics, were associated with more noble and important constructions. Commonly, the dimensions of the rectangular sections ranged between 80 and 140 mm width and between 140 and 160 mm or 200 and 220 mm height, for common (3 to 4 m) and larger spans (>4 m), respectively.

In the old city centre of Seixal, some interesting solutions to strengthen/reinforce the floor structures were verified. It was frequent the use of cast iron columns to overcome large spans, particularly in buildings whose ground floor was intended to be an open space, avoiding partition walls. With the same purpose, there were cases of composite beams, consisting of a timber beam reinforced by two iron rods connected to their ends and linked to an intermediate stanchion, conferring additional in-plane stiffness. Figure 8 presents examples of both solutions described.

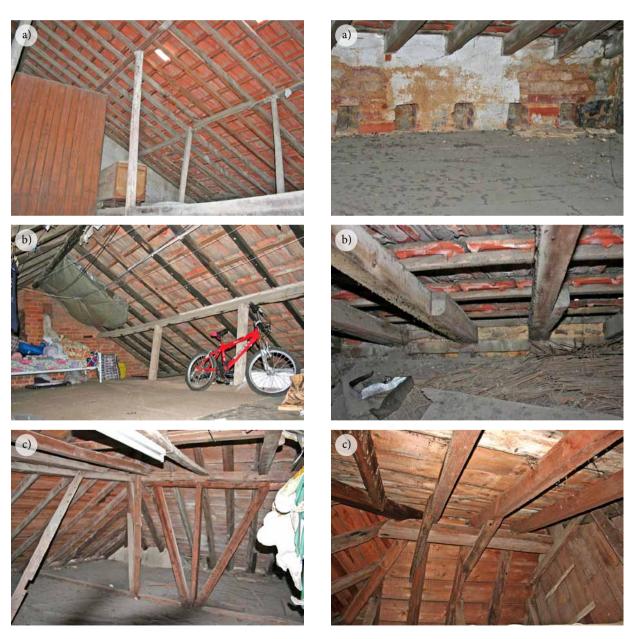
Fig. 9. Examples of different roof structure geometry

Fig. 10. Geometry and constitution of the supporting structure of the roofs

The roofs in the old urban centre of Seixal also present a large number of solutions, varying in relation to the geometry, span, slope and covering material (see Figs 9 and 10). The pitched roofs are clearly predominant over the flat roofs, having different shapes and constitutions. Their slopes vary fundamentally with the location of the building into the urban mesh and the use of the roof space – attics, garrets etc.

The fact that many buildings are built in row, having a reduced width, leads mostly to gabled roof solutions. Amongst them, three distinct configurations were recorded (see Fig. 10): a) the structurally simpler solution, which consists of primary timber rafters parallel to the façade, loading on masonry mid walls; b) a structure of a roof ridge beam and rafters discharging on a lintel at the top of the façade walls, as if they were disposed of braces, king-post and line; and c) simple geometry of closed truss. In the case of bigger dimension roofs – larger spans and more slopes – the structural solution presents more complexity in terms of the connections and geometry.
