STATISTICAL SURVEY ON INSPECTION, DIAGNOSIS AND REPAIR OF WALL RENDERINGS

Gonalo SÁ, Joāo SÁ, Jorge DE BRITO, Bárbara AMARO

IST – Technical University of Lisbon, Av. Rovisco Pais, 1049-001 Lisbon, Portugal

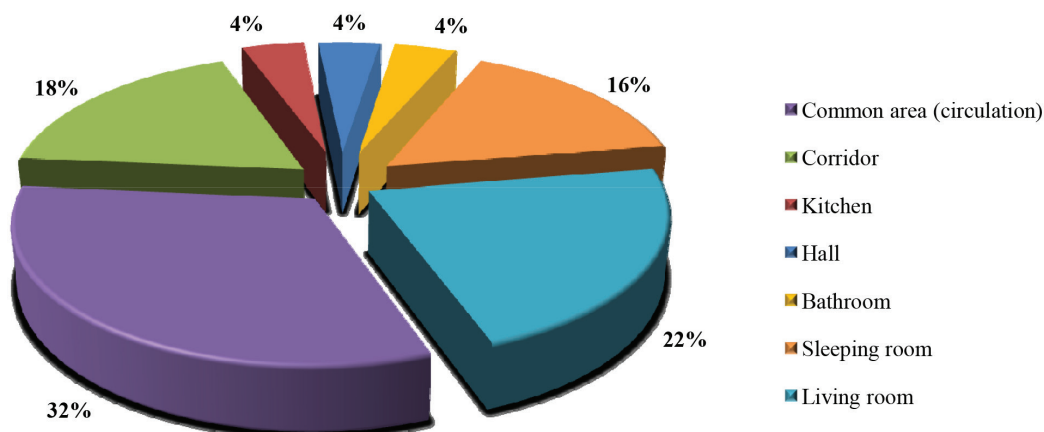
Fig. 1. Characterisation of the sample by type of interior rooms

It was established beforehand that the sample would contain 2/3 of external rendered surfaces (façades) and 1/3 of interior ones (rooms). External renderings were organised by façade type and orientation. Interior renderings were classified by room type (Fig. 1) and orientation of the surfaces where the anomalies occur.

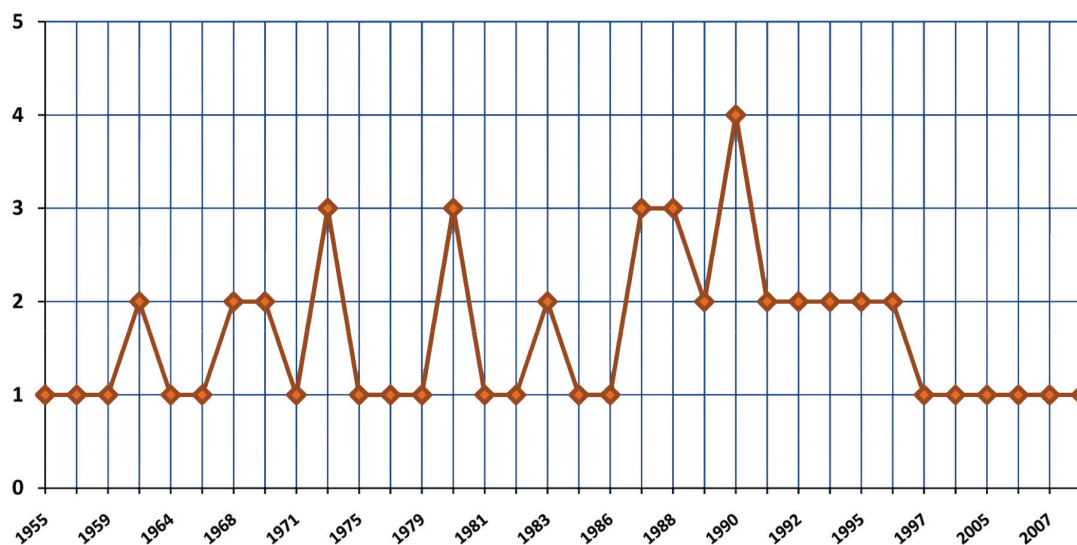
Fig. 2. Construction date of each building inspected (total of 55 buildings)

The sample includes buildings dated from 1955 up to 2009, as shown in Figure 2, taking the construction date as reference, or the last rehabilitation date for those examples in which the intervention on the rendering was integral and deep, thus allowing the age of the renderings inspected to be characterised.

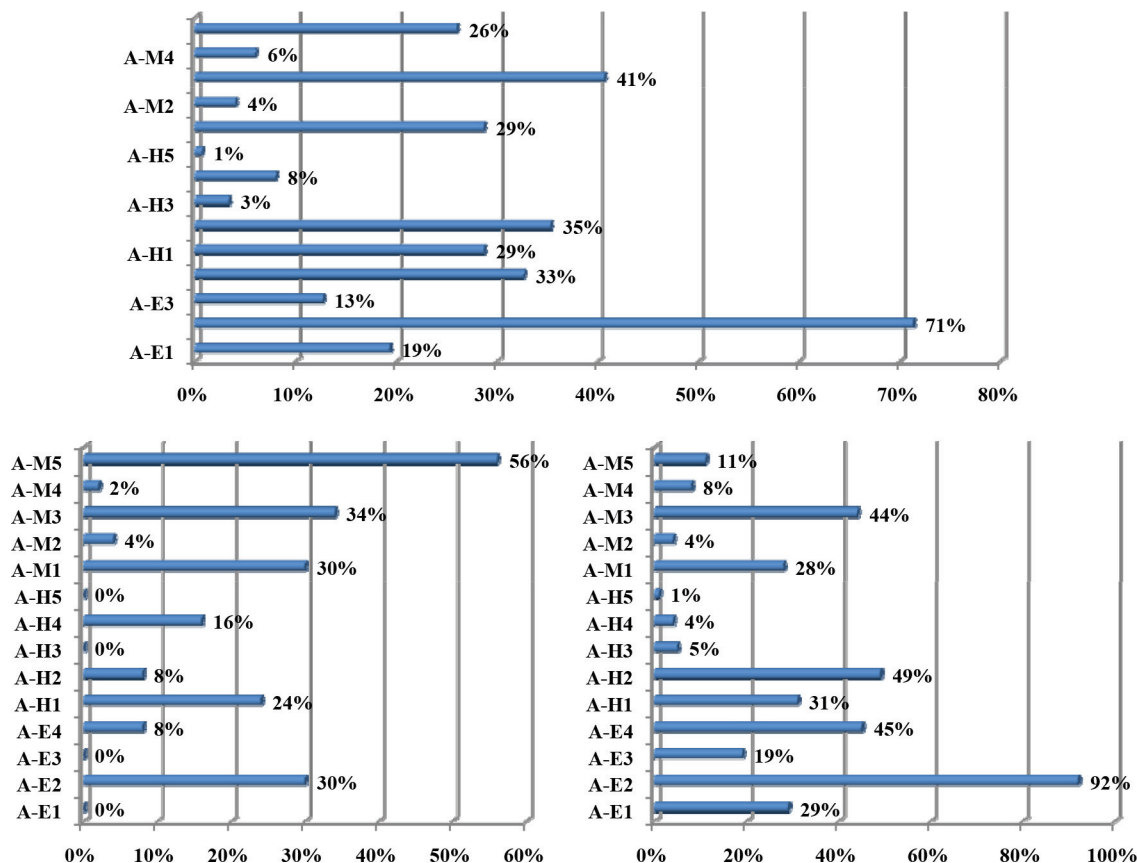
Fig. 3. Probability of finding each anomaly in one wall: considering all surfaces (top), in interior surfaces (down left) and in external surfaces (down right)

Figure 3 graphically compiles the inspection data on anomalies and provides an overview of the probability of the occurrence of each anomaly in a rendered wall within the sample. The most frequent anomaly was dirt/particle deposits (A-E2), which presents a probability of 71% of developing in one wall rendering. It also shows that 92% of this anomaly occurs on external rendered surfaces, decreasing this probability to 30% in interior ones, which was expected given the respective types of exposure. Although this type of anomaly has a high frequency, according to Figure 4, which represents the gravity lev-

On the other hand, over 20% of linear cracking (A-M3) cases, which is the second commonest anomaly according to Figure 3, were assigned to level 0 repair urgency, meaning that an intervention to repair and consolidate the anomaly should be taken within 6 months (Fig. 4). This anomaly was found to have a probability of occurrence in a wall of 41% (Fig. 3) and presents just slightly higher probability of occurring in the external surfaces (44%) than in the interior ones (34%), which again agrees with specialised literature.

Adherence loss/detachment (A-M1) and infiltration/damp stains (A-H1) occur with similar frequency for interior and external surfaces and as often as each other (29%) (Fig. 3). Adherence loss/detachment (A-M1) is very likely to interfere in the render's performance; therefore almost 80% of the found cases imply an intervention within a year (Fig. 4). External infiltration/damp stains (A-H1) (which consist of stains related to the presence of water) occur mostly in North orientated walls due to the lower sun incidence that would otherwise dry some of those stains (Fig. 5). These anomalies must be carefully monitored, in order to evaluate its development. If the stains continue to get worse with time, they will probably originate other types of anomalies. In fact, according to the inter-anomaly correlation matrix developed to provide statistical relationship between the occurrence of one anomaly, in the presence of another, loss of adherence (A-M1), loss of cohesion/crumbling (A-M2), dirt/dust particle deposits (A-E2) and biological colonisation (A-H2) have between 40% and

Graffiti (A-E1), corrosion stains (A-E3), vegetation growth (A-H3) and carbonation (A-H5) characteristically only appear on external rendered surfaces, with a probability of occurrence of 19%, 13%, 3% and 1% respectively (Fig. 3). The anomaly *Graffiti* (A-E1) was given an intervention deadline of 6 months in 90% of the cases (level 0 of urgency to intervene – Fig. 4) because it may conceal other anomalies that must be treated and it becomes harder to eliminate the longer it remains. Since the first step of inspection is through visual appraisal, it is very important to be able to properly evaluate the wall renderings.

Efflorescence/cryptoflorescence (A-H4) occurs on 8% of the rendering inspected, with greater occurrence on interior surfaces (16%) than in external ones (4%) (Fig. 3). Since these anomalies are caused by the crystallisation of salts transported by water these statistics do not contradict the literature, because the water/humidity flux is predominantly from the exterior to the interior. Slightly over 20% of the cases were considered serious enough to prescribe an 1 year maximum intervention delay, due to the small area and its low effect on the render performance (Fig. 4), but it is important to keep monitoring the development of this phenomenon, since it may be the origin of other anomalies.

It is found that cohesion loss/crumbling (A-M2) occurs equally often on external and interior surfaces (4%) and that map cracking (A-M4), as expected, occurs more on outer surfaces (8%) than interior ones (2%) (Fig. 3). This relates to the fact that environmental actions are more intense on the outside and application and curing conditions are less well controlled.

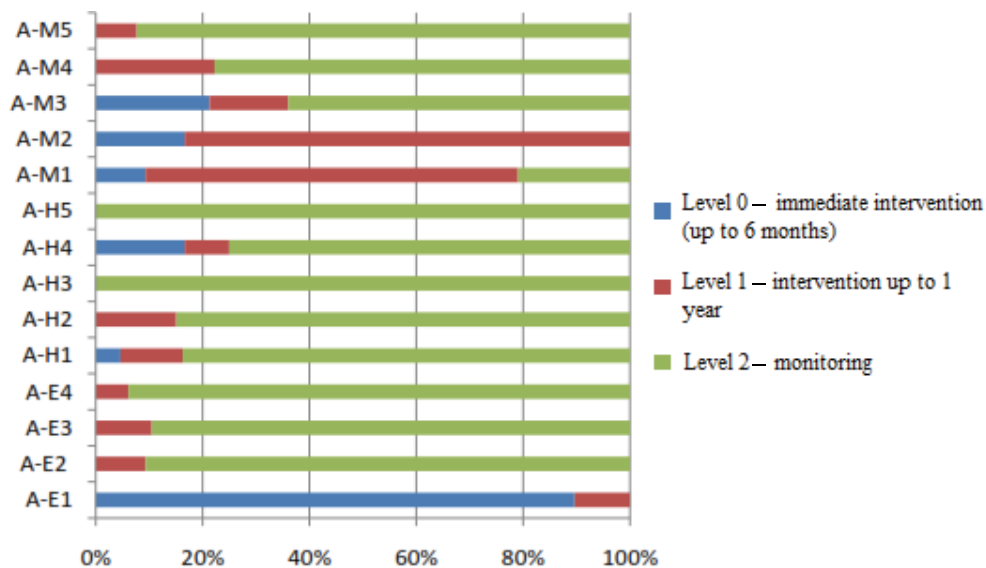
Fig. 4. Urgency to intervene/gravity of anomaly levels, according to the anomalies identified in the sample

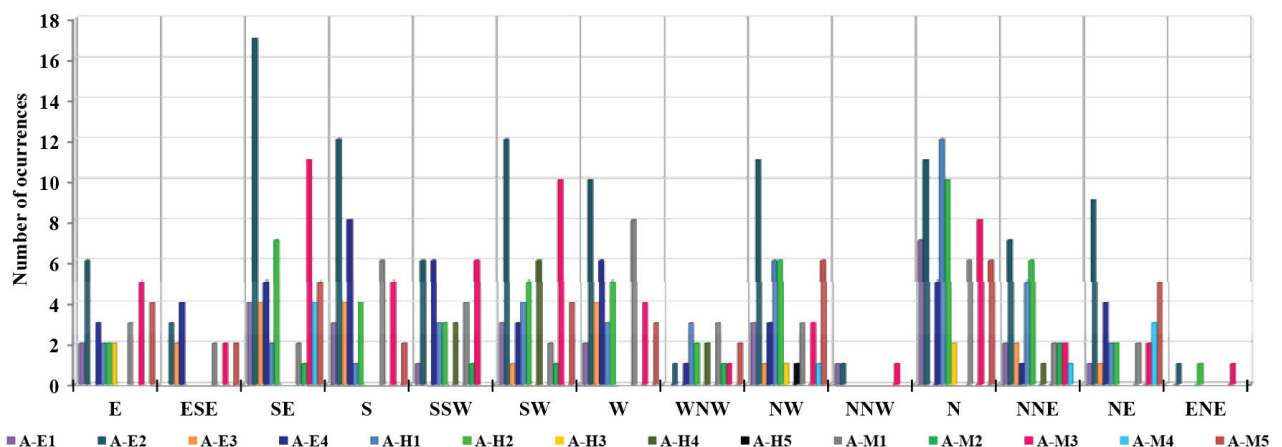
Fig. 5. Occurrence of each anomaly according to the façade orientation, within the sample

As expected, biological colonisation (A-H2) owes its frequency (35%) mostly to manifestations on external surfaces (49% versus 8% on interior surfaces), which is understandable since they are directly exposed to environmental action and typically difficult to access for cleaning, and are thus more prone to colonisation phenomena. Also, the absence of solar radiation, allowing humidity to settle and not dry in external walls is another aspect that influences the development of biological colonisation. Therefore, North orientated façades show higher presence of this anomaly, as shown in Figure 5 (which associates façade orientation with the occurrence of anomalies). Just like A-H2, colour change/discoloration (A-E4) occur much more on external surfaces (45%) than interior ones (8%) (Fig. 3) but, unlike the former, they are often associated with high solar incidence (which is one of the sources of colour changes), therefore presenting higher frequency in South orientated façades (Fig. 5).

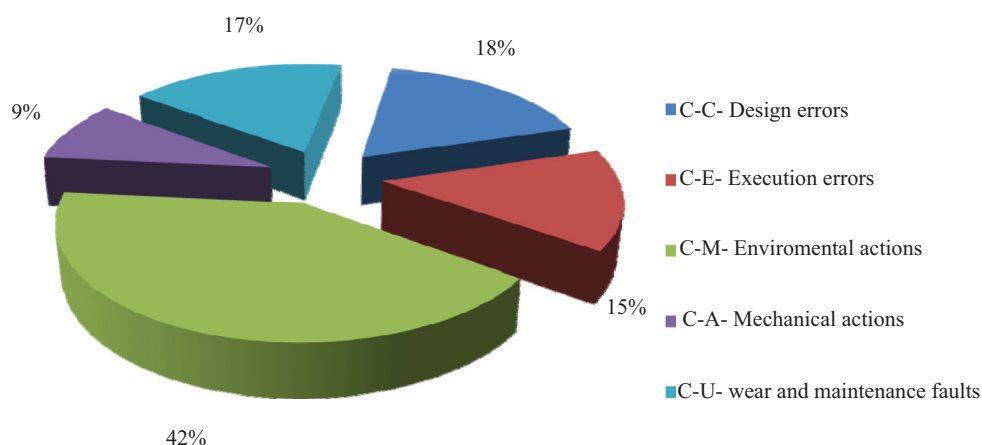
Fig. 6. Relative contribution of each group of causes to the anomalies detected

mechanical actions (C-A) and wear and maintenance causes (C-U). During fieldwork for each anomaly one or more probable causes were registered, which further on allowed studying the origins of the anomalies. Figure 6 represents the contribution of each group of causes to the occurrence of anomalies in wall renderings, according to the fieldwork.

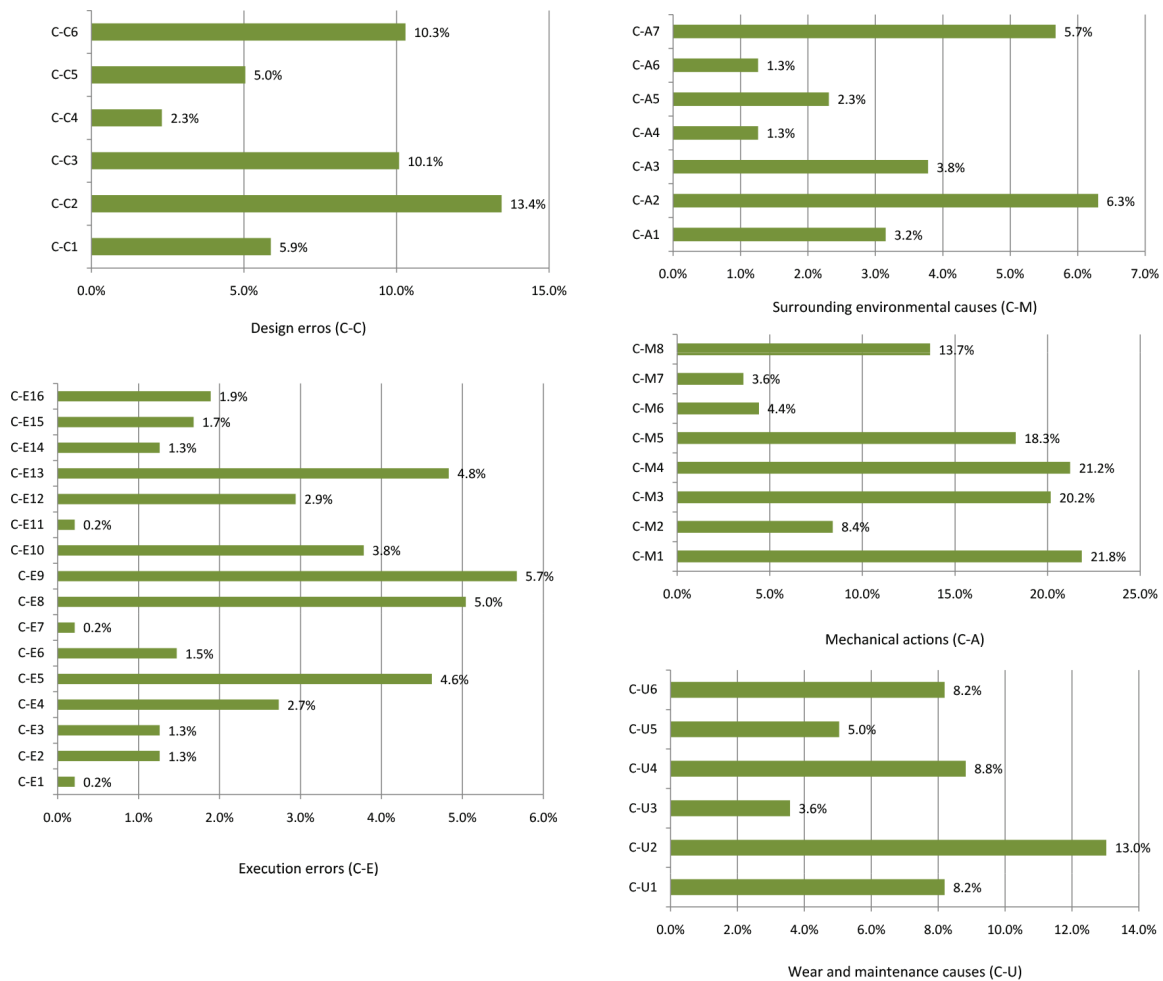
Fig. 7. Relative contribution of each group of causes to the anomalies detected

The results show that the greatest contributor is environmental actions (C-M), with 42% of occurrences. This was expected since most of the inspected renderings are external and therefore exposed to the aggressions of the environment throughout their service life. According to Figure 7, which presents the frequency of each cause related to the 476 anomalies found (organized by grouping), the study reveals that the commonest causes are airborne dirt particles (C-M1), wind and/or rain action (C-M3) and the presence of water/water vapour (C-M4). It is not surprising that these causes are related with the most common anomalies: A-E2 – dirt/particle deposits; A-H1 – infiltrations/damp stains; A-H2 – biological colonisation. The fact that almost half of the found causes for anomalies in wall rendering are environmental actions reinforces the importance of a good maintenance plan, in order to keep the correct performance of the wall render during its service life.

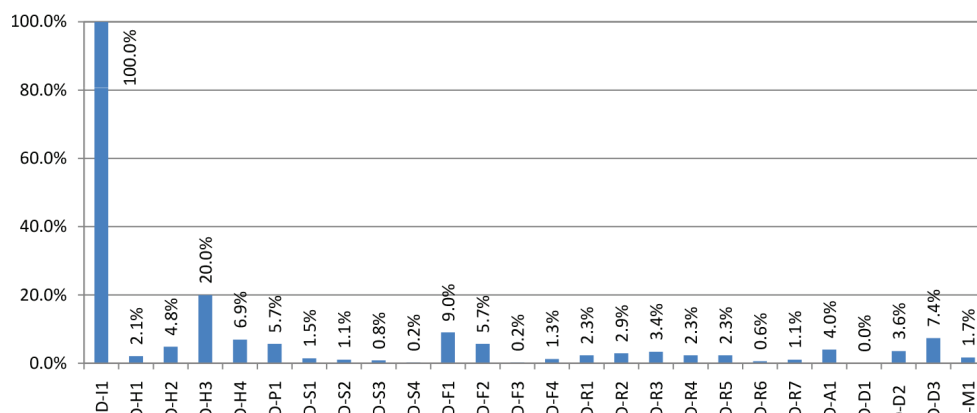
Fig. 8. Relative frequency of the diagnosis methods proposed

Figure 8 presents the results of the data analysis for the prescribed diagnosis methods. Not surprisingly the most frequent is visual inspection and macroscopic analysis (D-I1), prescribed in every instance. This also concerns the nature of the inspections performed, based solely on visual observation.

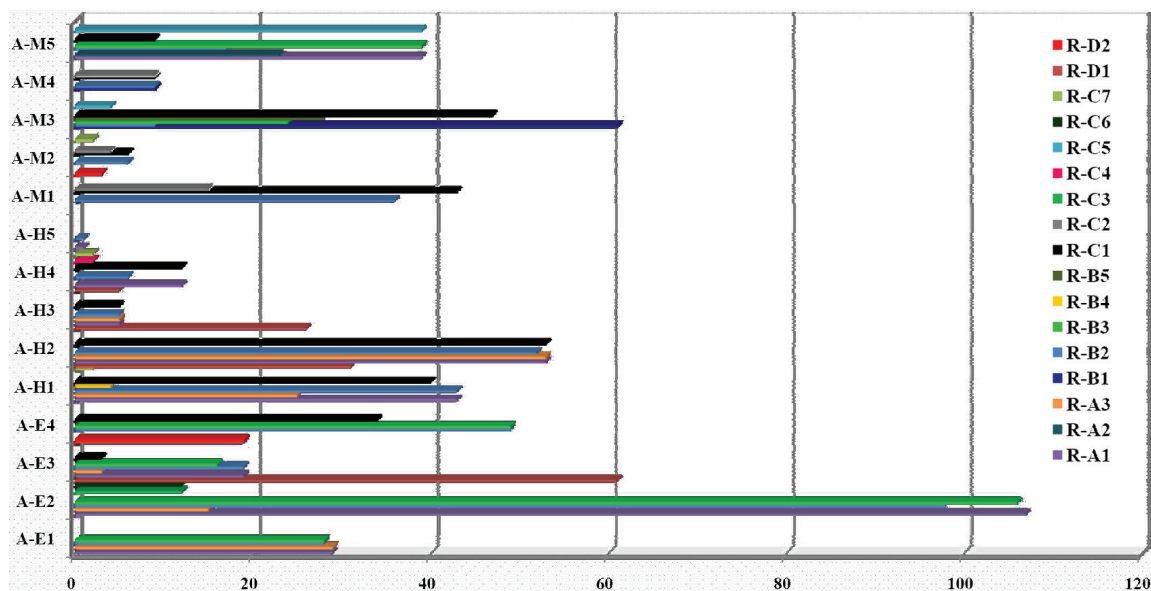
Fig. 10. Absolute frequency of each repair technique as a function of the anomaly type

Figure 10 results from cross-referencing data concerning the anomalies and repair techniques prescribed, allowing the study of relationships between them.
