## STATISTICAL SURVEY OF THE PATHOLOGY, DIAGNOSIS AND REHABILITATION OF ETICS IN WALLS

**Abstract.** This paper presents a statistical survey on the pathology, diagnosis and rehabilitation of ETICS (external thermal insulation composite system) in walls. The development of an expert-knowledge inspection and diagnosis system for this type of cladding implied the creation of classification lists of anomalies, most probable causes, diagnosis methods and repair/maintenance techniques. The collection of data through field work where the tools developed within the proposed system were applied was the basis for this statistical survey. The field work consisted of the visual inspection of 146 façades with ETICS cladding located in various areas in Portugal and aged from 3 to 22 years. The data obtained enable anomalies to be related to their causes and so conclusions can be drawn on the best way to minimize the development of the former and eliminate the latter, at the design and application stages. The study further revealed the main sensitive issues of the cladding system during its service life, highlighting the importance of a correct maintenance plan.

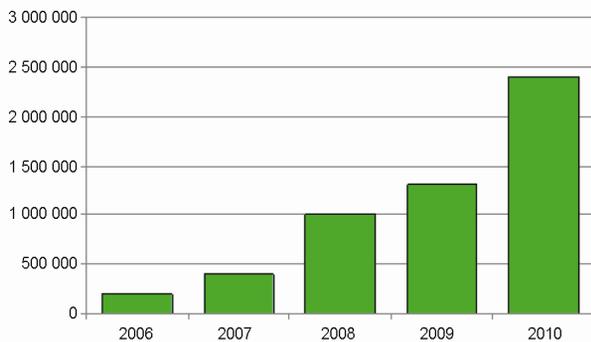
Fig. 1. Evolution of the application of ETICS (in m<sup>2</sup>) in Portugal (Duarte 2011)

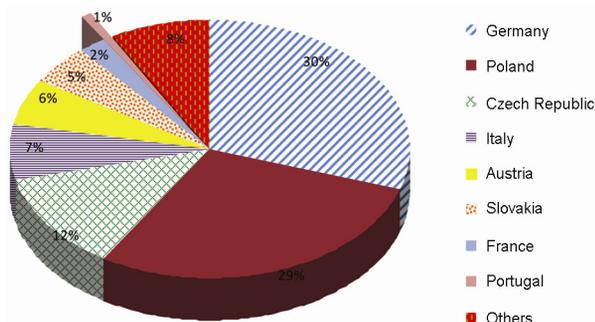
Fig. 2. Application of ETICS (in relative area) in Europe in 2008 (Duarte 2011)

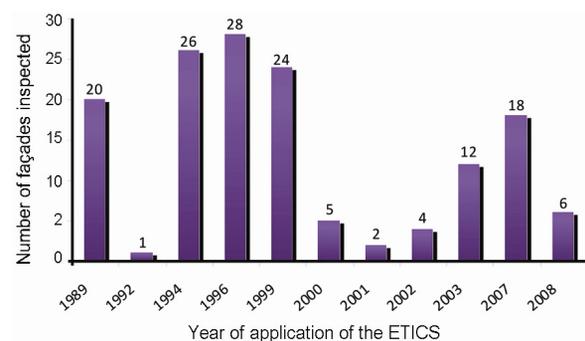
Fig. 4. Age distribution of the sample

ETICS are a relatively novel technology in the Portuguese construction sector, having only really expanded in the 1990s. The 146 façades inspected comprise ETICS applied between 1989 and 2008, thus the data collected had a considerable range of parameters. Considering that the validation of the inspection and diagnosis system should focus on the oldest possible ETICS to show their pathology, 20 façades over 20 years old were inspected, plus 84 between 10 and 20 years old and 42 less than 10 years old. Figure 4 shows the number of façades inspected by age of application of the system, giving an average of 13 years.

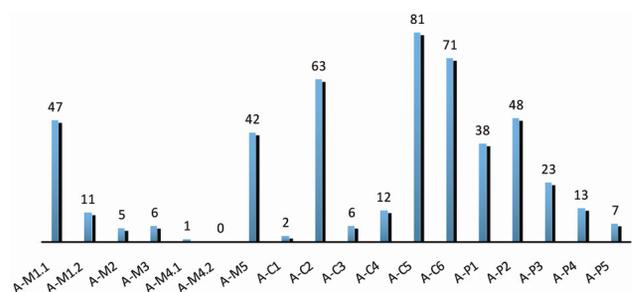
Fig. 5. Anomalies within the sample

The data for this section is represented graphically in Figures 5, 6 and 7, which cope with the contribution of each anomaly and group of anomalies within the sample.

Figures 5 and 6 indicate that the commonest anomalies are **A-C5** – *Biological growth* (present on 55.5% of the façades inspected), **A-C6** – *Other colour changes* (48.6%) and **A-C2** – *Runoff marks* (43.2%). All three commonest anomalies belong to group **A-C** – *Colour/Aesthetic anomalies*, which is not usually associated with dire consequences in terms of thermal capacity.

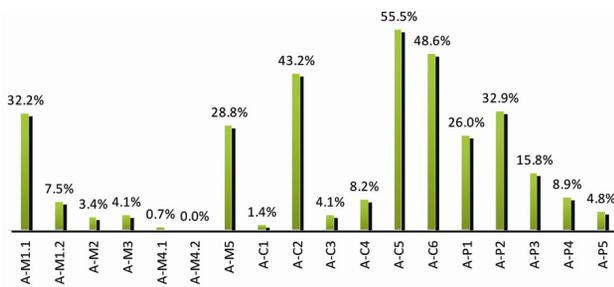
Fig. 6. Incidence of the anomalies in terms of probability of occurring in a façade

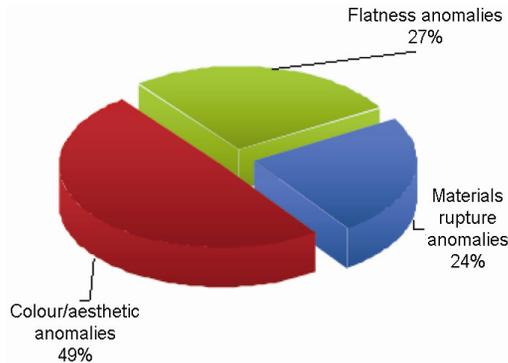
Fig. 7. Contribution of each anomaly group to the grand total of anomalies detected

This is why this group of anomalies has a higher incidence relative to the other groups, as seen in Figure 7.

The graphs further show that group **A-M** – *Materials rupture anomalies* is the least frequent in the sample (24% of the total). No case of loss of adherence of the whole system and only one of partial adherence loss were detected in the sample (anomalies **A-M4.2** and **A-M4.1**, respectively). This is a positive finding since these anomalies represent the worst scenarios of ETICS' defects and have very severe consequences for the thermal behaviour of the building. However, according to French statistics based on insurance companies' reports relative to 211 anomaly examples in ETICS between 1979 and 1985 (Freitas 2002), the incidence of loss of adherence of the whole system was 12% and of partial adherence loss was also 12%, indicating much higher incidence than found in this study, even though the French study is much older (ETICS' reliability has improved over the years). It is concluded that the non-observance of loss of adherence

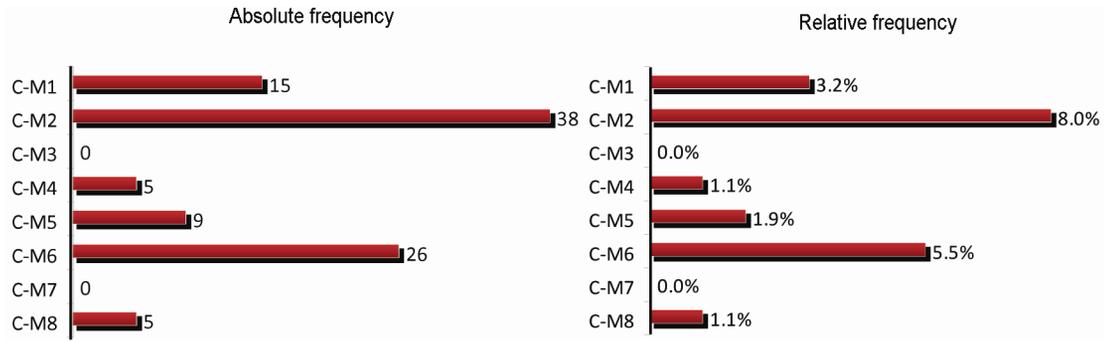
Fig. 8. Absolute and relative incidence of materials selection errors

Figure 8 concerns the causes related to materials selection, with an overall contribution of 9% to the grand total of causes. Though it would be reasonable to regard these defects as design errors, by setting them apart it was possible to highlight problems specific to the materials. Causes **C-M2** – *Inadequate protection against micro-*

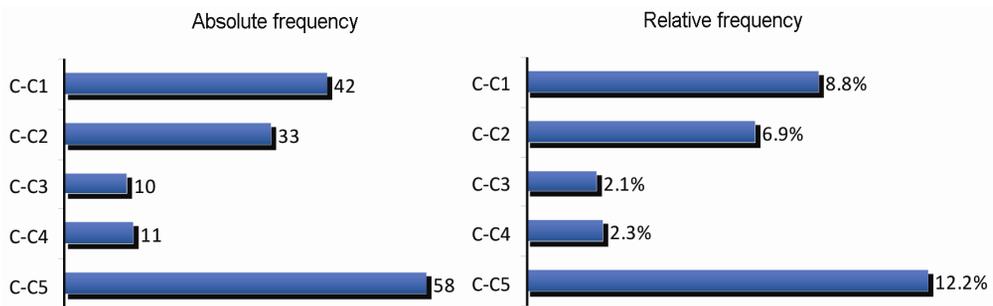
Fig. 9. Absolute and relative incidence of design errors

Figure 9 shows that cause **C-C5** – *Inadequate design of sills, flashings or on the ground-floor* has the highest incidence in the group, and has been attributed (as direct or indirect cause) to 58 anomalies in the 146 façades. As a matter of fact this error was associated several times with the development of regular water runoff paths that lead to efflorescence and the growth of microorganisms due to water accumulating on the wall. In other cases the non-existence of tail-ends led to various anomalies. The second most frequent cause in the design errors group was **C-C1** – *Insufficient thickness of the base coat*. Even though the appropriate thickness of each coat is stated in the European technical approval guideline for commercially available ETICS (ETAG 004 2000), lower values are often specified at the design stage, especially for the base coat, which leads to an overly thin coat (1 mm). Sometimes the thickness is omitted and application criteria are dictated by the applicators. The main consequence is the subsequent susceptibility of the system to impacts and perforations that expose the inner coats. In some cases the glass fibre grid was exposed instead of being embedded in the base coat, because the latter was too thin. It is also important for the designers to strengthen the reinforcement, especially in areas subjected to tensions that cause cracking, such as window openings and corners. Cause **C-C2** – *No reinforcement* was related to 33 cases of cracking. Causes **C-C3** – *Deficient interface between the system and other elements* and **C-C4** – *No primary coat* were the least frequent within the group, with a total of 10 and 11 attributions, respectively. Figure 15 shows that design and application causes (called “initial stages”) prevailed over the other groups as causes of materials rupture anomalies and flatness anomalies. This reveals the sensitivity of the system to the planning and application tasks.

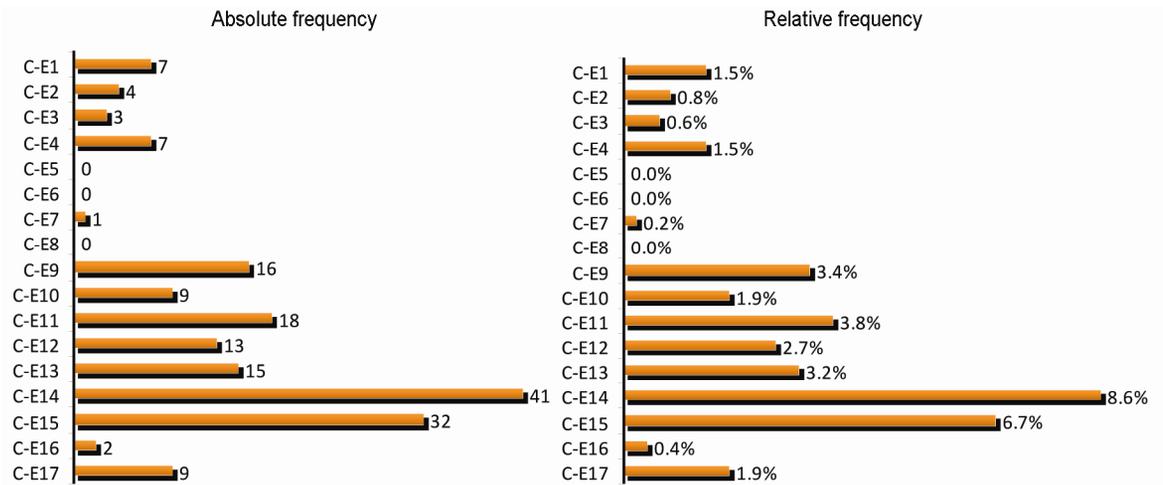
Fig. 10. Absolute and relative incidence of application errors

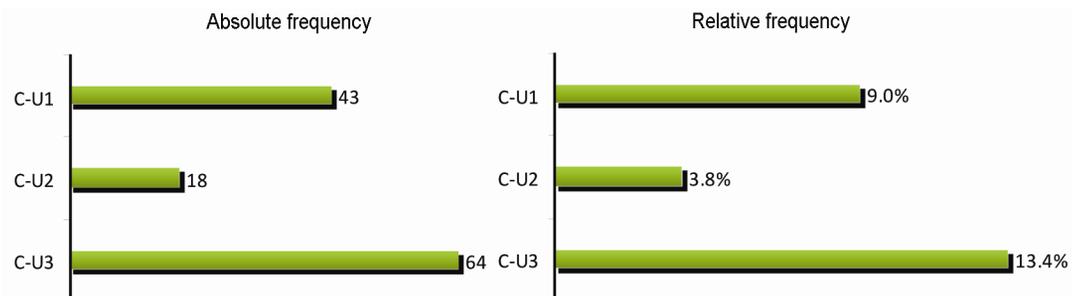
Fig. 11. Absolute and relative incidence of maintenance errors

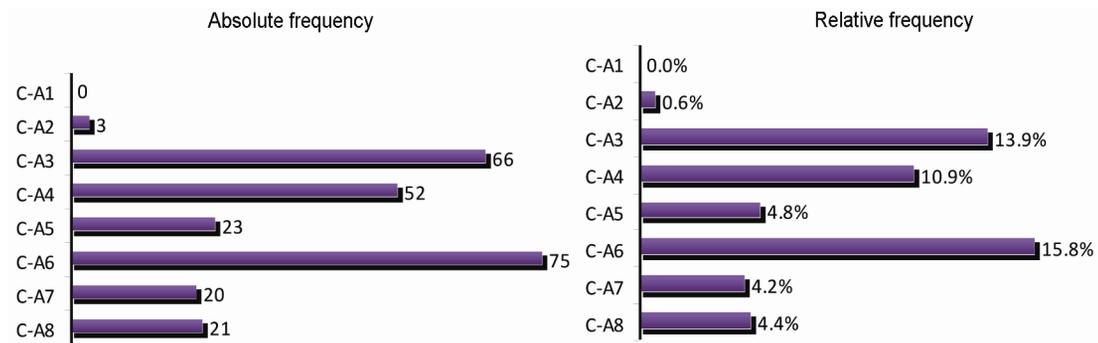
Fig. 12. Absolute and relative incidence of environmental actions

In Figure 12 causes **C-A6 – Surface condensation damp** and **C-A3 – Rain action** stand out, because they come second and third in terms of frequency of attribution in the whole sample. In fact these two causes are directly related to the commonest anomalies since they propitiate the development of micro-organisms, the adhesion of dirt to the wall and the formation of water runoff marks. Another sensitive aspect of this system is thus highlighted – the propensity of the façade to suffer long periods of damp, thus allowing the related anomalies to develop.

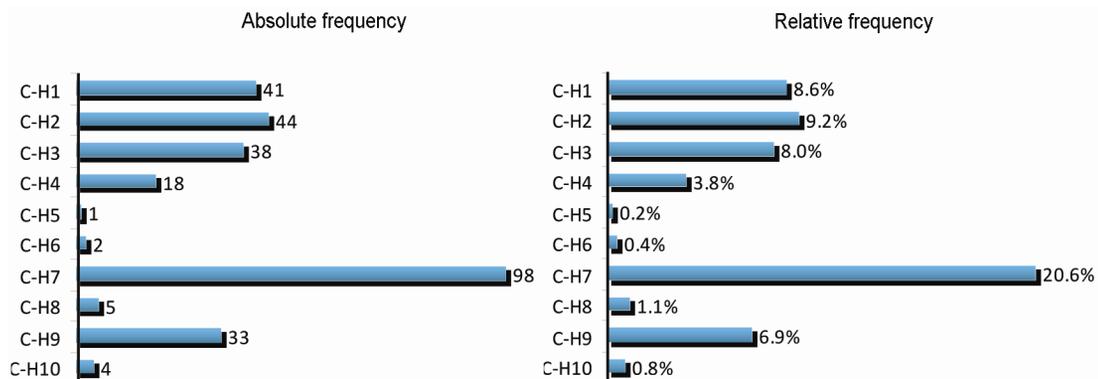
Fig. 13. Absolute and relative incidence of external mechanical actions

The cause considered to be at the root of anomaly development most often was **C-H7 – Dirt build-up (dust)**, with a grand total of 98 occurrences. In fact the accumulation of dust particles or pollution can be associated with a variety of factors, including very rough cladding, atmospheric pollution/particles driven by wind/rain, the boundaries between areas of different flatness or any situations resulting from the façades getting wet, and this cause is thus directly or indirectly related to various anomalies.

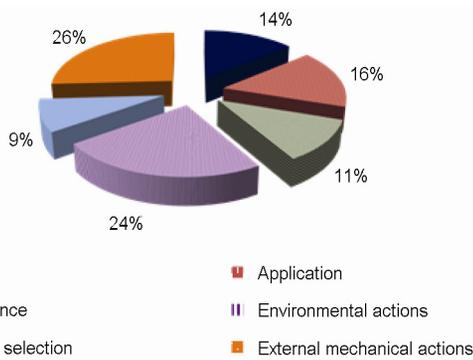
Fig. 14. Contribution of each cause group to the grand total of causes attributed

Figure 14 shows that group **C-H – External mechanical actions**, which includes the causes mentioned, accounts for the greatest proportion of all causes registered with 26% of the total. Similarly group **C-A – Environmental actions** represent 24% of the grand total of causes attributed. The causes within this group can be associated with the climatic conditions during application of the system and with subsequent in-service actions. The

Figure 14 shows that 39% of the anomalies in ETICS can be prevented by proper design, application and choice of materials, especially the materials rupture anomalies and the façade flatness anomalies. It is also concluded that implementing a plan of periodic inspections and maintenance helps to prevent early degradation from environmental and external mechanical actions during the service life, with special emphasis on the control of colour changes.

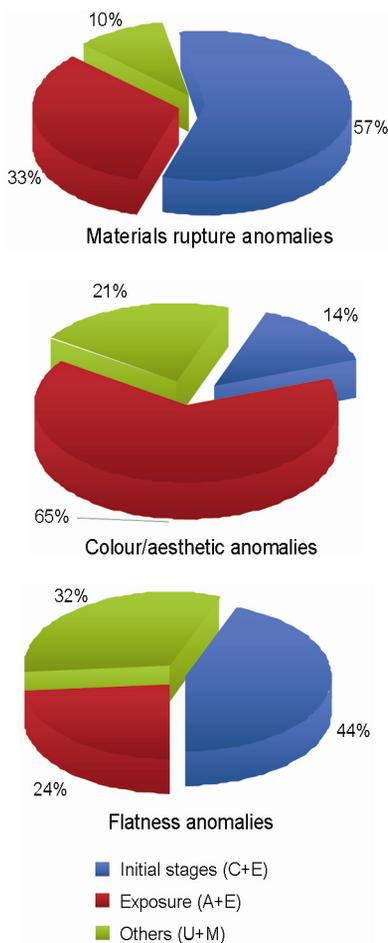
Fig. 15. Contribution of each cause to each anomaly group

The data that relates to the contribution of each cause to all the anomalies observed is found in Figures 8 to 13, where each figure corresponds to a group of causes. Figure 14 shows the contribution of each group to the set of anomalies in the sample. Figures 15 and 17 represent the contribution of the groups of causes, divided in terms of "initial stages" (design and application), "exposure" (environmental and external mechanical actions) and "others" (the other groups).

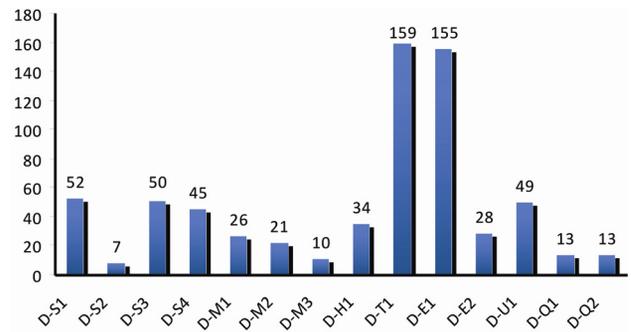
Fig. 16. Recommended diagnosis methods within the sample

Figure 16 shows the number of times each test was recommended, with a grand total of 662 diagnosis methods for the 146 façades, and Figure 17 gives the incidence of each method relative to the 476 anomalies. There are more tests than there are anomalies since all except anomaly **A-C4** – *Graffiti*, to which no specific method was assigned, could need the coupling of various *in situ* tests for a complete diagnosis.

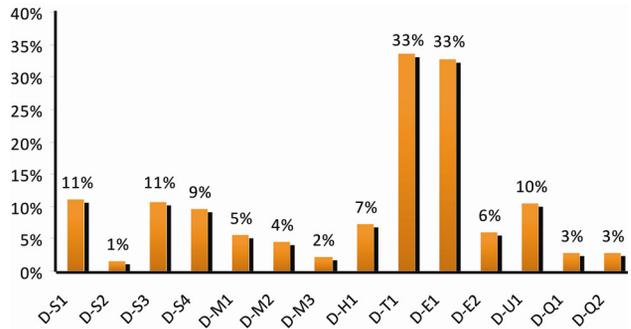
Fig. 17. Contribution of each method to the anomalies diagnosed

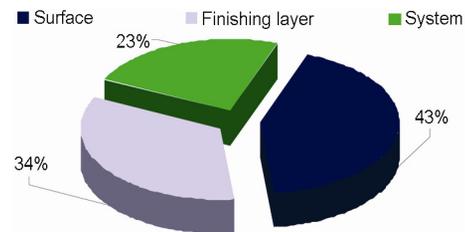
Fig. 18. Contribution of each repair technique group to the grand total of techniques prescribed

Figure 18 shows that 43% of the repair techniques prescribed belong to the group of surface techniques (**TR-A1** and **TR-A2**). They can be seen as maintenance and are directly related to the colour/aesthetic anomalies that represent around half of all the anomalies detected. On the other hand, the repair techniques concerning deeper interventions make up 24% of the universe, coinciding with the 24% of the materials rupture anomalies group, even though some of the techniques are prescribed for other anomalies, i.e. those concerning flatness deficiencies.

Figure 18 also shows that the technique **TR-A1** – *Cleaning* was the most often recommended because of the large number of colour/aesthetic anomalies, in particular leakage and biological growth. This has to do with the usually light colour of the system and lack of periodic maintenance as well as with the incorrect handling of singularities in the walls, such as sill drip edges and parapet capping, which allow biological organisms and other stains to build up on the façade.

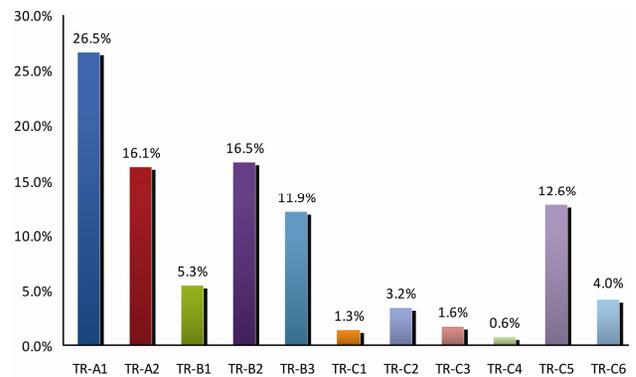
Fig. 19. Incidence of the repair techniques prescribed

Based on the data collected during the inspection campaign the frequencies of each repair technique were correlated with the various anomalies, as seen in Figure 19. The techniques aimed at repairing the anomalies and/or eliminating their causes.

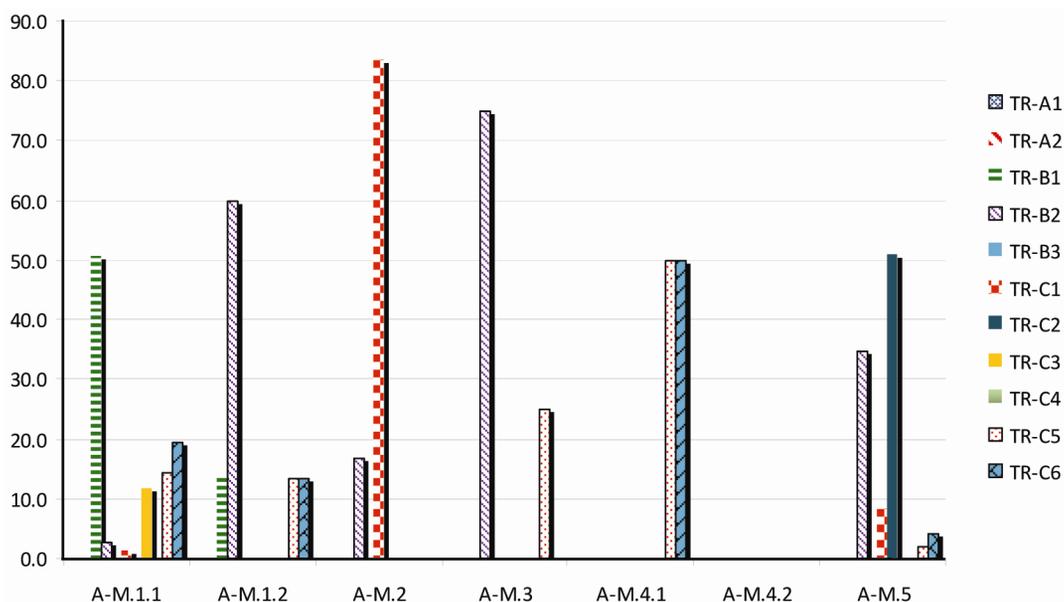
Fig. 20. Incidence of each technique to repair materials rupture anomalies

Oriented cracking (A-M1.1) was mostly solved by technique **TR-B1** – *Filling/clogging of cracks*, and in some cases by partial/whole replacement of the system (**TR-C6**), usually when plates coincided with the profiles' joints. Non-oriented cracking (A-M1.2) was usually handled by technique **TR-B2** – *Partial/whole replacement of the finishing coat*, given the superficial nature of the anomaly, though techniques **TR-C6** or **TR-C5** – *Correction of geometrical constructive features* were occasionally chosen if the anomaly was considerably extensive or resulted from an incorrectly fitted construction element (Fig. 20).

The best technique for the deterioration of the covering of reinforcement cantilevers (A-M2) was TR-C1 – Protection of protruding edges, as expected, given its specificity. For slight deterioration of the finishing technique TR-B2 – Partial/whole replacement of the finishing coat was recommended. The same technique was prescribed 75% of the times to remedy anomaly A-M.3 – Detachment of the finishing even though it was sometimes complemented by technique TR-C5 – Correction of geometrical constructive features, since replacing the finishing solves the anomaly and correcting the tail-end elements eliminates the possible cause (Fig. 20).

case resorting to back wrapping and replacement/installation of the bottom profile. The material gaps (A-M5) observed were mostly handled using technique TR-C2 – Filling of material gaps/perforations, whenever the perforation gap reached the insulation plate or the substrate (51% of cases). For more superficial gaps that only reached the reinforced mortar but did not damage the grid, partial/whole replacement of the finishing coat (TR-B2) proved to be sufficient. Technique TR-C1 was prescribed locally to treat protruding edges when the location of the material gap near the edges justified the treatment of that area and the installation of corner profiles was not considered (Fig. 20).

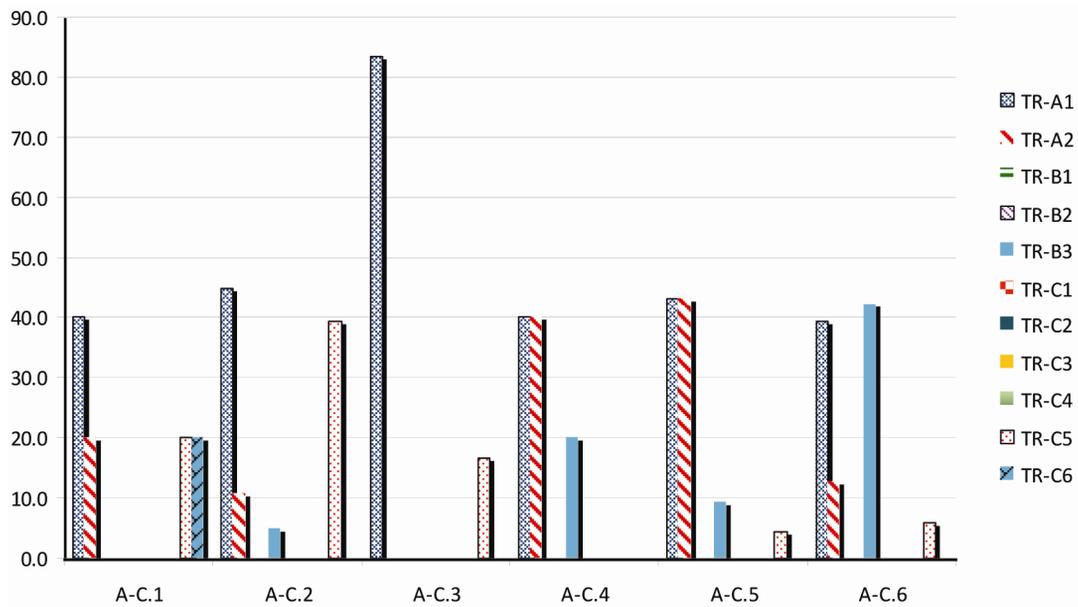
Fig. 21. Incidence of each technique to repair colour/aesthetic anomalies

A-C1 – Efflorescence and A-C3 – Corrosion stains were rare in the sample analysed, representing less than 2% in total. With the exception of a single case of efflorescence, where no deeper intervention was deemed necessary, both anomalies were solved by surface cleaning (TR-A1), in both cases over a small area, and correction of geometrical constructive features (TR-C5) (Fig. 21).

Runoff marks (A-C2) and biological growth (A-C5) represent 61% of the colour/aesthetic anomalies and 30% of all anomalies. In the first case, cleaning (TR-A1) was most often prescribed to eliminate the marks. But to eliminate the causes, correction of geometrical constructive features (TR-C5) became fundamental. As for the manifestation of micro-organisms on the system's surface, cleaning (TR-A1) and complementary application of surface protection (TR-A2) were the techniques chosen to eliminate the anomaly and prevent its recurrence. In both cases, more severe problems were repaired by painting the wall, thus justifying the incidence of technique TR-B3 in both cases (Fig. 21).

*Graffiti* (A-C4) strongly affects the aesthetics of a façade and is not always easy to remove. Consequently, combining cleaning (TR-A1) and the application of an anti-graffiti barrier (TR-A2), repainting the wall (TR-B3) was deemed necessary in 50% of the situations when this anomaly was detected. Depending on the characteristics, damp and dirt stains, surface decolouration, and other problems within anomaly A-C.6 – Other colour changes, were solved through simple cleaning (TR-A1). In the case of dirt stains (e.g. due to atmospheric pollution), cleaning plus the application of water repellent (TR-A2) was the technique used for runoff marks, and the application of a new finishing/painting (TR-B3) for other colour changes, especially those caused by incorrect surface repairs (Fig. 21).

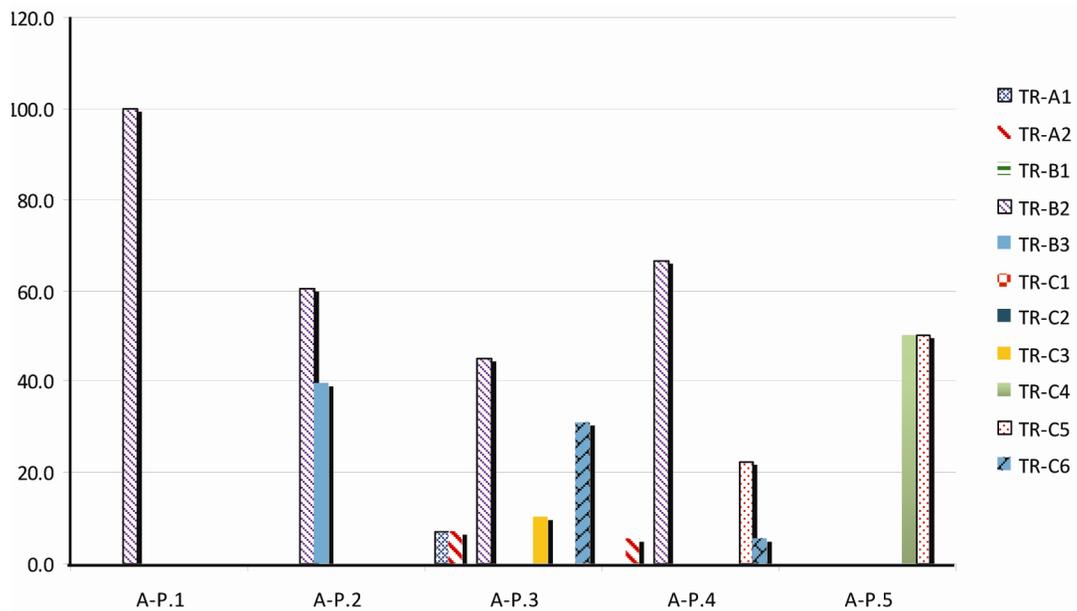
Fig. 22. Incidence of each technique to repair flatness anomalies

Flatness anomalies are mostly due to incorrect characteristics or application of the finishing coat or damage to it. Apart from swelling of the insulation plates (A-P5) which implies another level of intervention, the first four anomalies of the group require an intervention to the finishing coat, usually by partial/whole replacement (TR-B2). In fact anomaly A-P1 – Flatness deficiency was dealt with solely by this technique, which was considered sufficient given the causes established. This anomaly has a sizeable incidence (8%) and in almost all instances its origin was a deficient overlapping of the finishing coat (86%) during the system's application. Depending on the height of the scaffolding when the system was installed, it could have been applied in horizontal coats. The transition between a new coat and the previous one must ensure the greatest possible homogeneity at the level of overlapping of the finishing coat. Surface irregularities (A-P2) come from uneven texture of the finishing coat, from incorrect interventions or from small superficial material gaps. The replacement of the finishing coat (TR-B2) and the application of a new finishing on top of the existing coat (TR-B3) were the preferred techniques to rectify this anomaly (Fig. 22).
