## THE TECHNICAL STATE OF EARTH DAMS IN LITHUANIA

Raimondas Šadzevičius<sup>1</sup>, Vitas Damulevičius<sup>2</sup>, Rytis Skominas<sup>3</sup>

**Abstract.** Dams are ageing out as all constructions do, and inaccuracies during the field survey, designing and construction, as well as defects of building materials and deterioration due to environmental impacts accelerate the aging process. The article presents the technical state assessment comparable results of 260 Lithuanian earth dams performed in 2002–2009 and 368 dams in 1997; the analysis of character and causes of the main deteriorations and defects. The typical causes of failure (according to their danger to the stability of the entire hydroscheme) are: diverse intensity of seepage water leakage at the downstream slope and the tailwater of dam; landslides and deformation of the slopes of the dams; bigger cracks, deformation, tilt in shaft spillway; scour, deformation of dam slope protection slabs, concrete cover layer deterioration, collapsing of junctures are mainly caused by the environmental (frost cycles; ice, wave blows; moss, grass, bushes roots; periodical wetting, etc.) impacts.

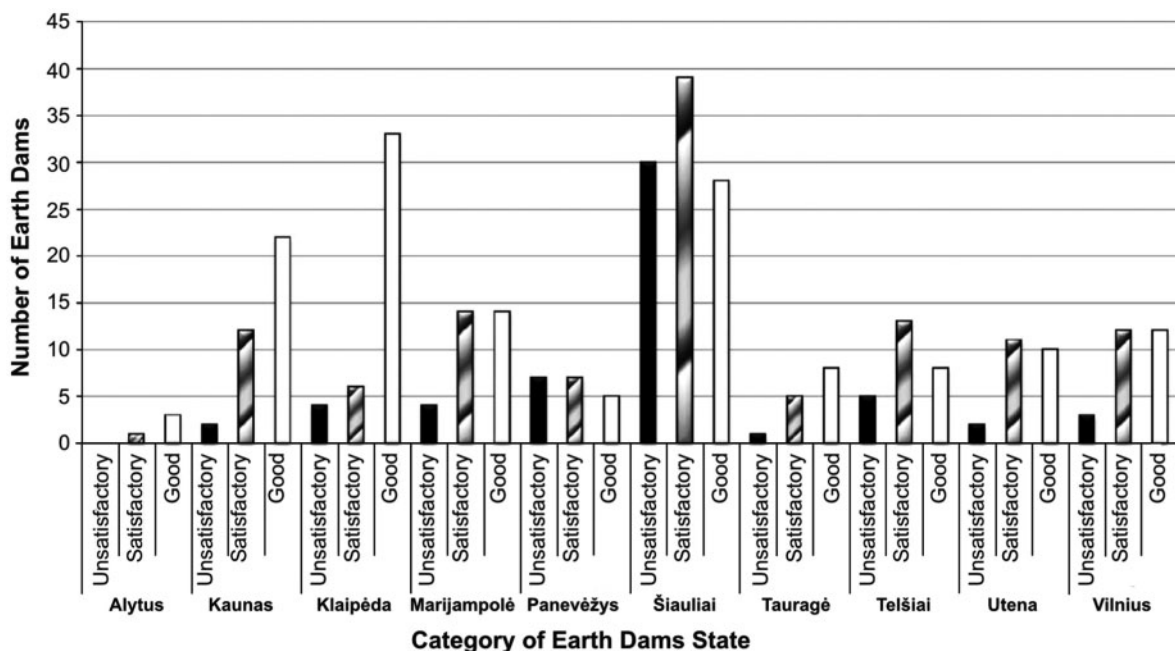
Fig. 1. Distribution of the category of dams' technical state in 1997 by county

Graphically research results of the state of ED (in 1997) by county are shown in Figure 1.

The analysis of ED state investigation carried out in 2002–2009 results (presented in Fig. 1 and Table 1) shows that ED in the critical state are mainly in the Kaunas county (15 objects). The biggest number of dams in unsatisfactory and critical condition is also in Kaunas County (total number of these state categories ED is 37). These hydroschemes are dangerous to the surrounding and must be repaired immediately.

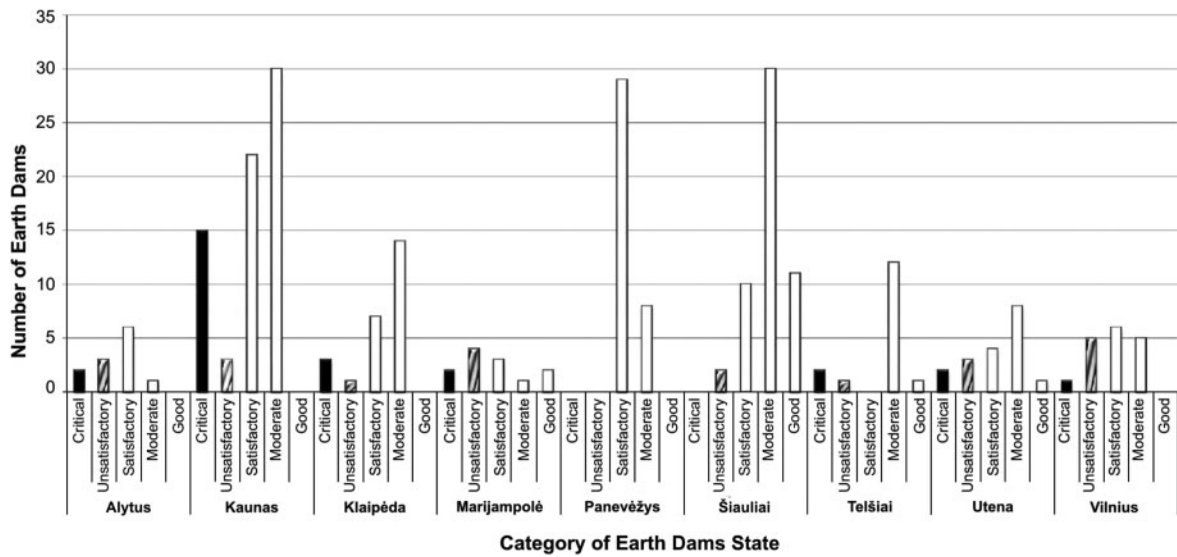
Fig. 2. Distribution of the technical state category of investigated dams in 2002–2009

The results of ED technical state research are shown in Figure 2.

The analysis of ED technical state research (in 1997) results (in Fig. 2) shows that most of dams of unsatisfactory condition (30 ED) was found in Šiauliai County. This county has a maximum total number of unsatisfactory and satisfactory ED (69).

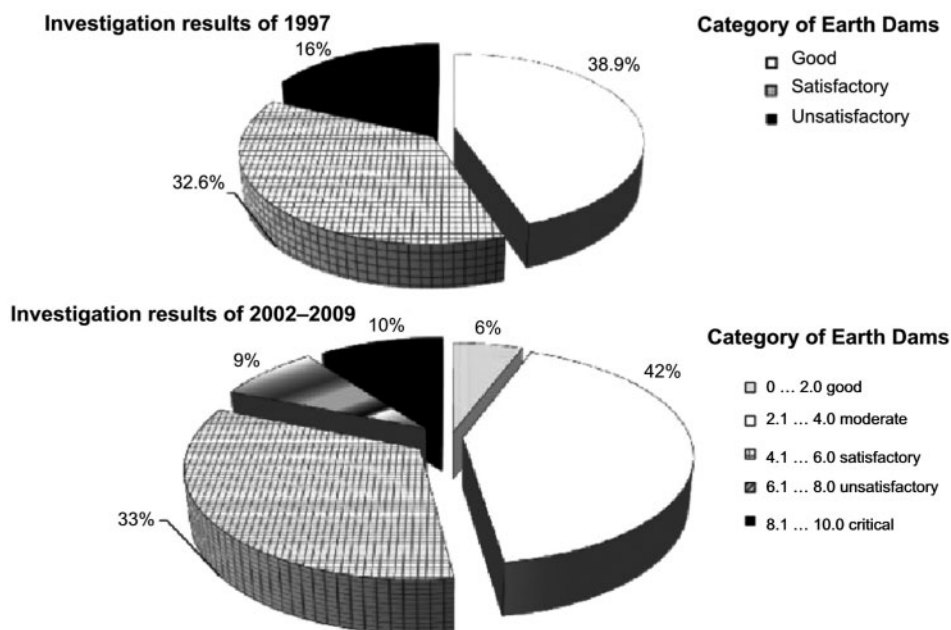
Fig. 3. 1997 and 2002 to 2009 years ED technical state assessment comparative results

ED technical status as it was evaluated in 1997 and 2002–2009 is graphically presented in Fig. 3.
